INVESTIGATION REPORT
ON
THE COLLAPSE OF THE BALCONY
AT 1/F OF THE BUILDING
AT 50 GILLIES AVENUE SOUTH, KOWLOON
ON 21 JUNE 2017

Buildings Department
October 2017

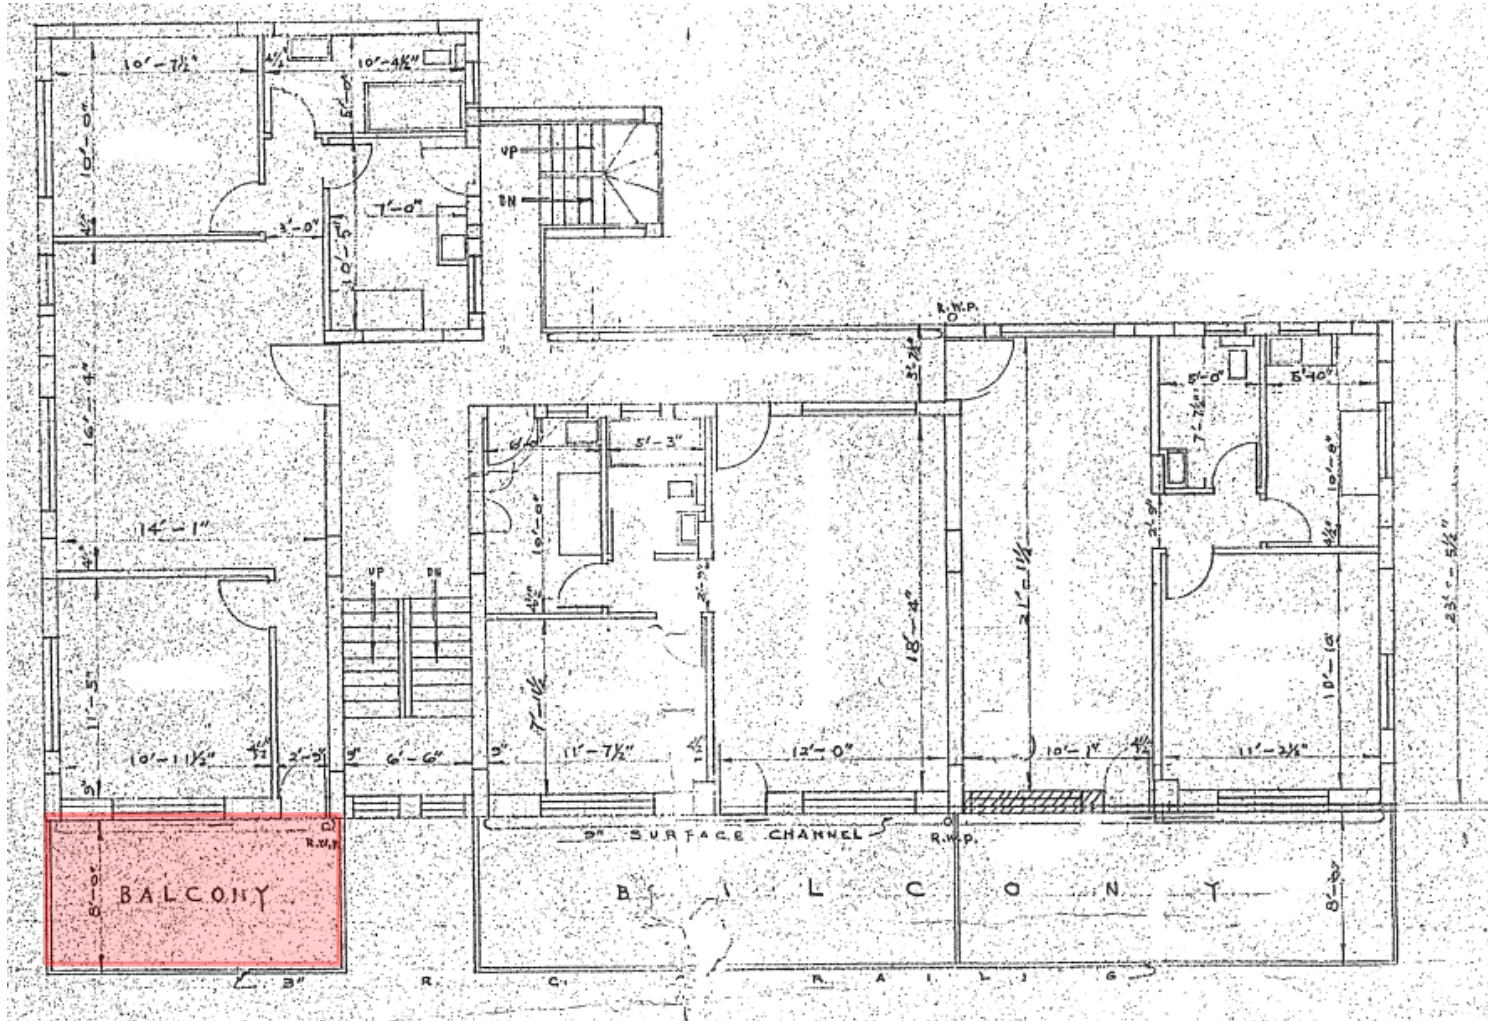
Approved First Floor Plan

Partially collapsed balcony

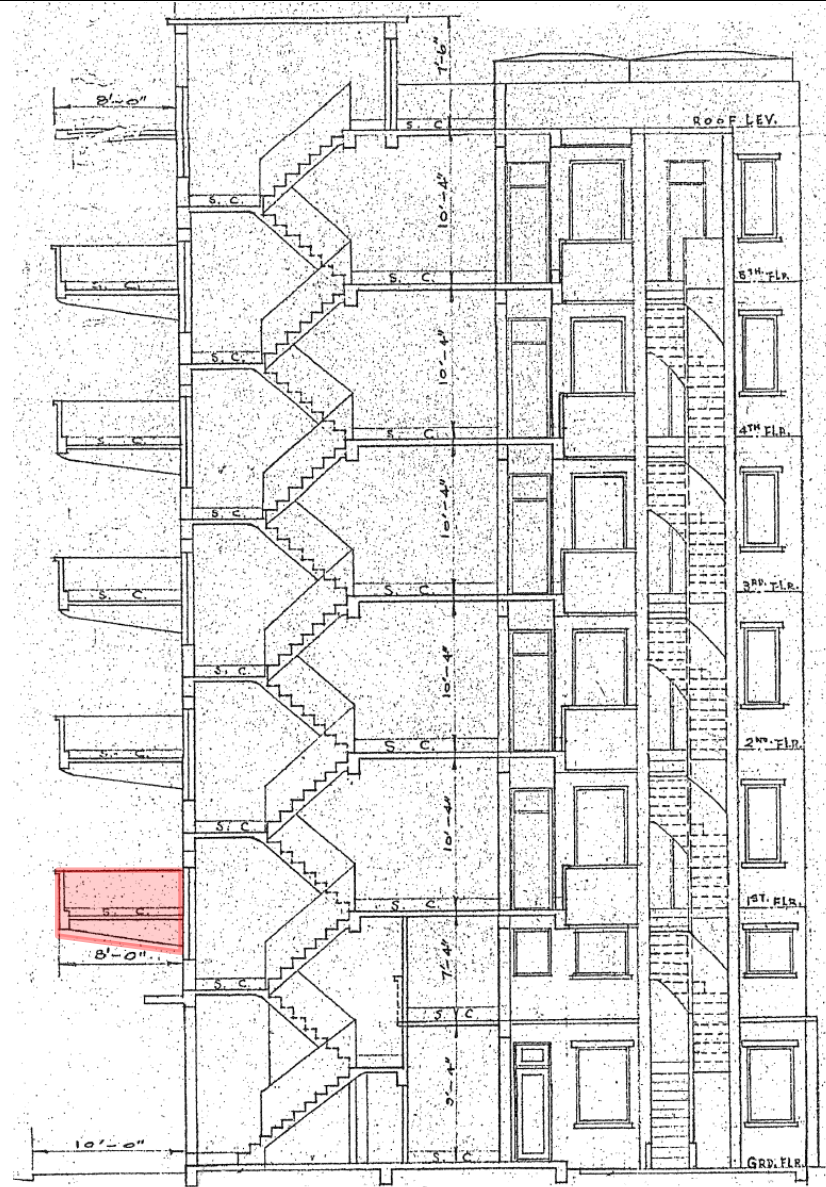
Approved Section

Partially collapsed balcony

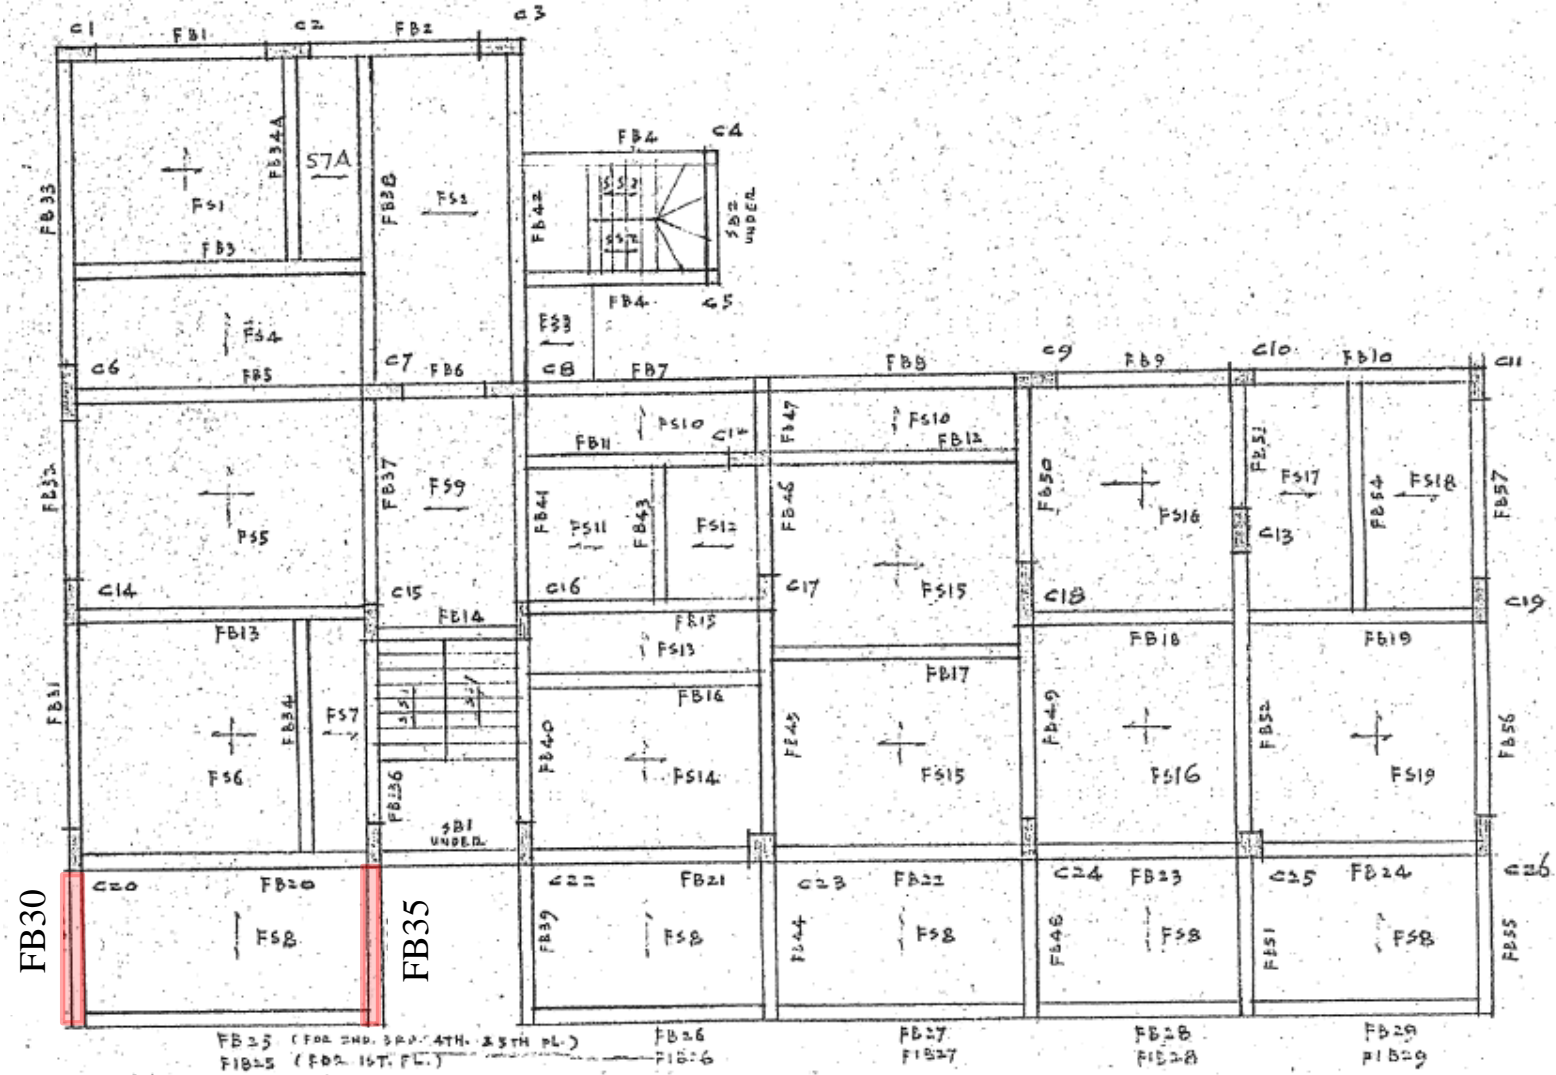
Approved First Floor Framing Plan

- (a) There was no submission of any alteration and addition works or minor works related to the collapsed balcony. According to the occupants, no building works were recently carried out to the balcony;
- (b) Beam FB35 and about half of the balcony slab collapsed with its steel reinforcement bars exposed. Beam FB30 remained in place but spalling, cracks and rusted steel reinforcement bars were noted;

9. As revealed from the above investigation and structural assessment, the shear strength of Beam FB35 had been reduced due to declined concrete strength, corrosion of steel reinforcement bars and prolonged lack of maintenance. Coupled with the additional loads of the raised floor finishes and rendering on the parapet and the installation of aluminium windows, the collapse of the balcony was triggered by shear failure of Beam FB35.
