INVESTIGATION REPORT
ON
THE COLLAPSE OF PORTION OF
THE MARRIED INSPECTORS' QUARTERS BUILDING
AT
THE CENTRAL POLICE STATION COMPOUND
ON 29 MAY 2016

Buildings Department
May 2017

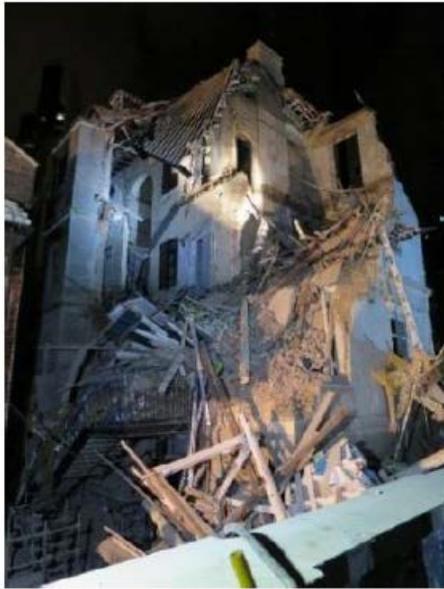
View towards Northwest Elevation

1. On 29 May 2016 at about 22:05 hours, the northwestern corner of the Married Inspectors' Quarters Building (MIQ Building) (i.e. Block 4) of the Central Police Station (CPS) Compound at 10 Hollywood Road, Central, Hong Kong collapsed. No casualty was reported in the incident. The Buildings Department (BD) subsequently conducted an investigation on the incident.
