**INVESTIGATION REPORT
ON THE COLLAPSE OF THE CANOPY
OF A BUILDING
AT 3 Kin Kwan Street, Tuen Mun – T.M.T.L. 87
on 9 June 2011**

Buildings Department

July 2011

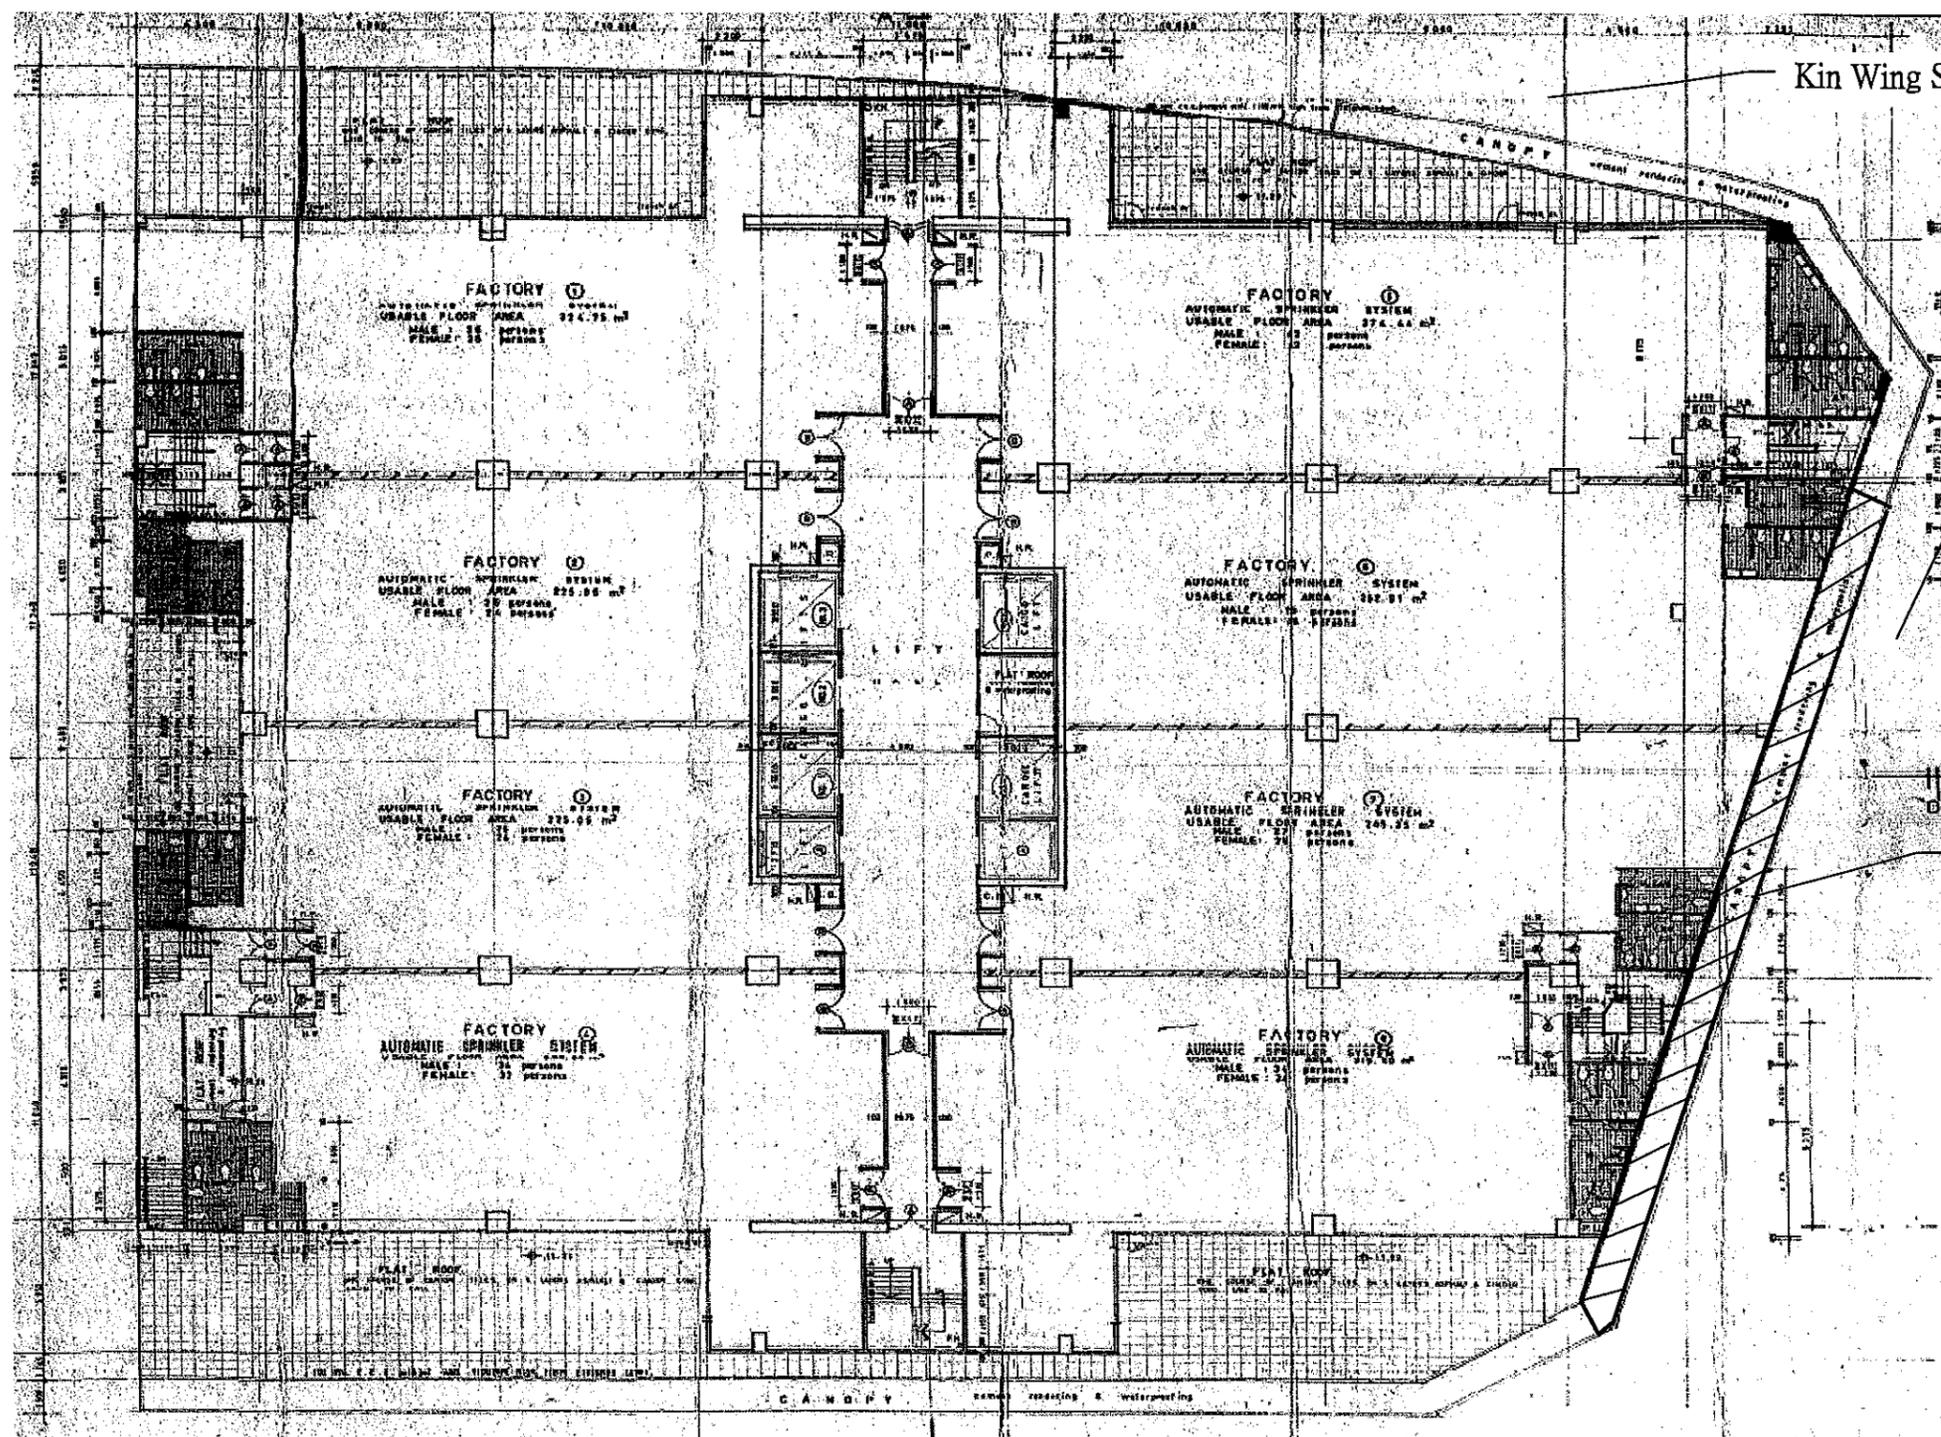
Title: Approved 1st Floor Building Plan

2. The subject building is an industrial building of 13-storey high with occupation permit issued on 2 November 1979. The building has long frontages on Kin Kwan Street and Kin Wing Street. There was a 1.5 m span cantilevered slab reinforced concrete canopy at 1/F level of the building. The canopy ran continuously along the southern and eastern elevations (along Kin Kwan Street) and about 1/3 of the northern elevation (along Kin Wing Street) of the building. A portion of the canopy about 40 m long on the east elevation of the building collapsed onto the pavement on 9 June 2011 (see Annex).

Collapsed Portion
