FINAL INVESTIGATION REPORT
ON
THE COLLAPSE OF ROOF STRUCTURE OF
CHAN TAI HO MULTI-PURPOSE HALL OF
HU FA KUANG SPORTS CENTRE OF
CITY UNIVERSITY OF HONG KONG
TAT CHEE AVENUE, KOWLOON
ON 20 MAY 2016

(The Redacted Version)

Buildings Department

May 2017

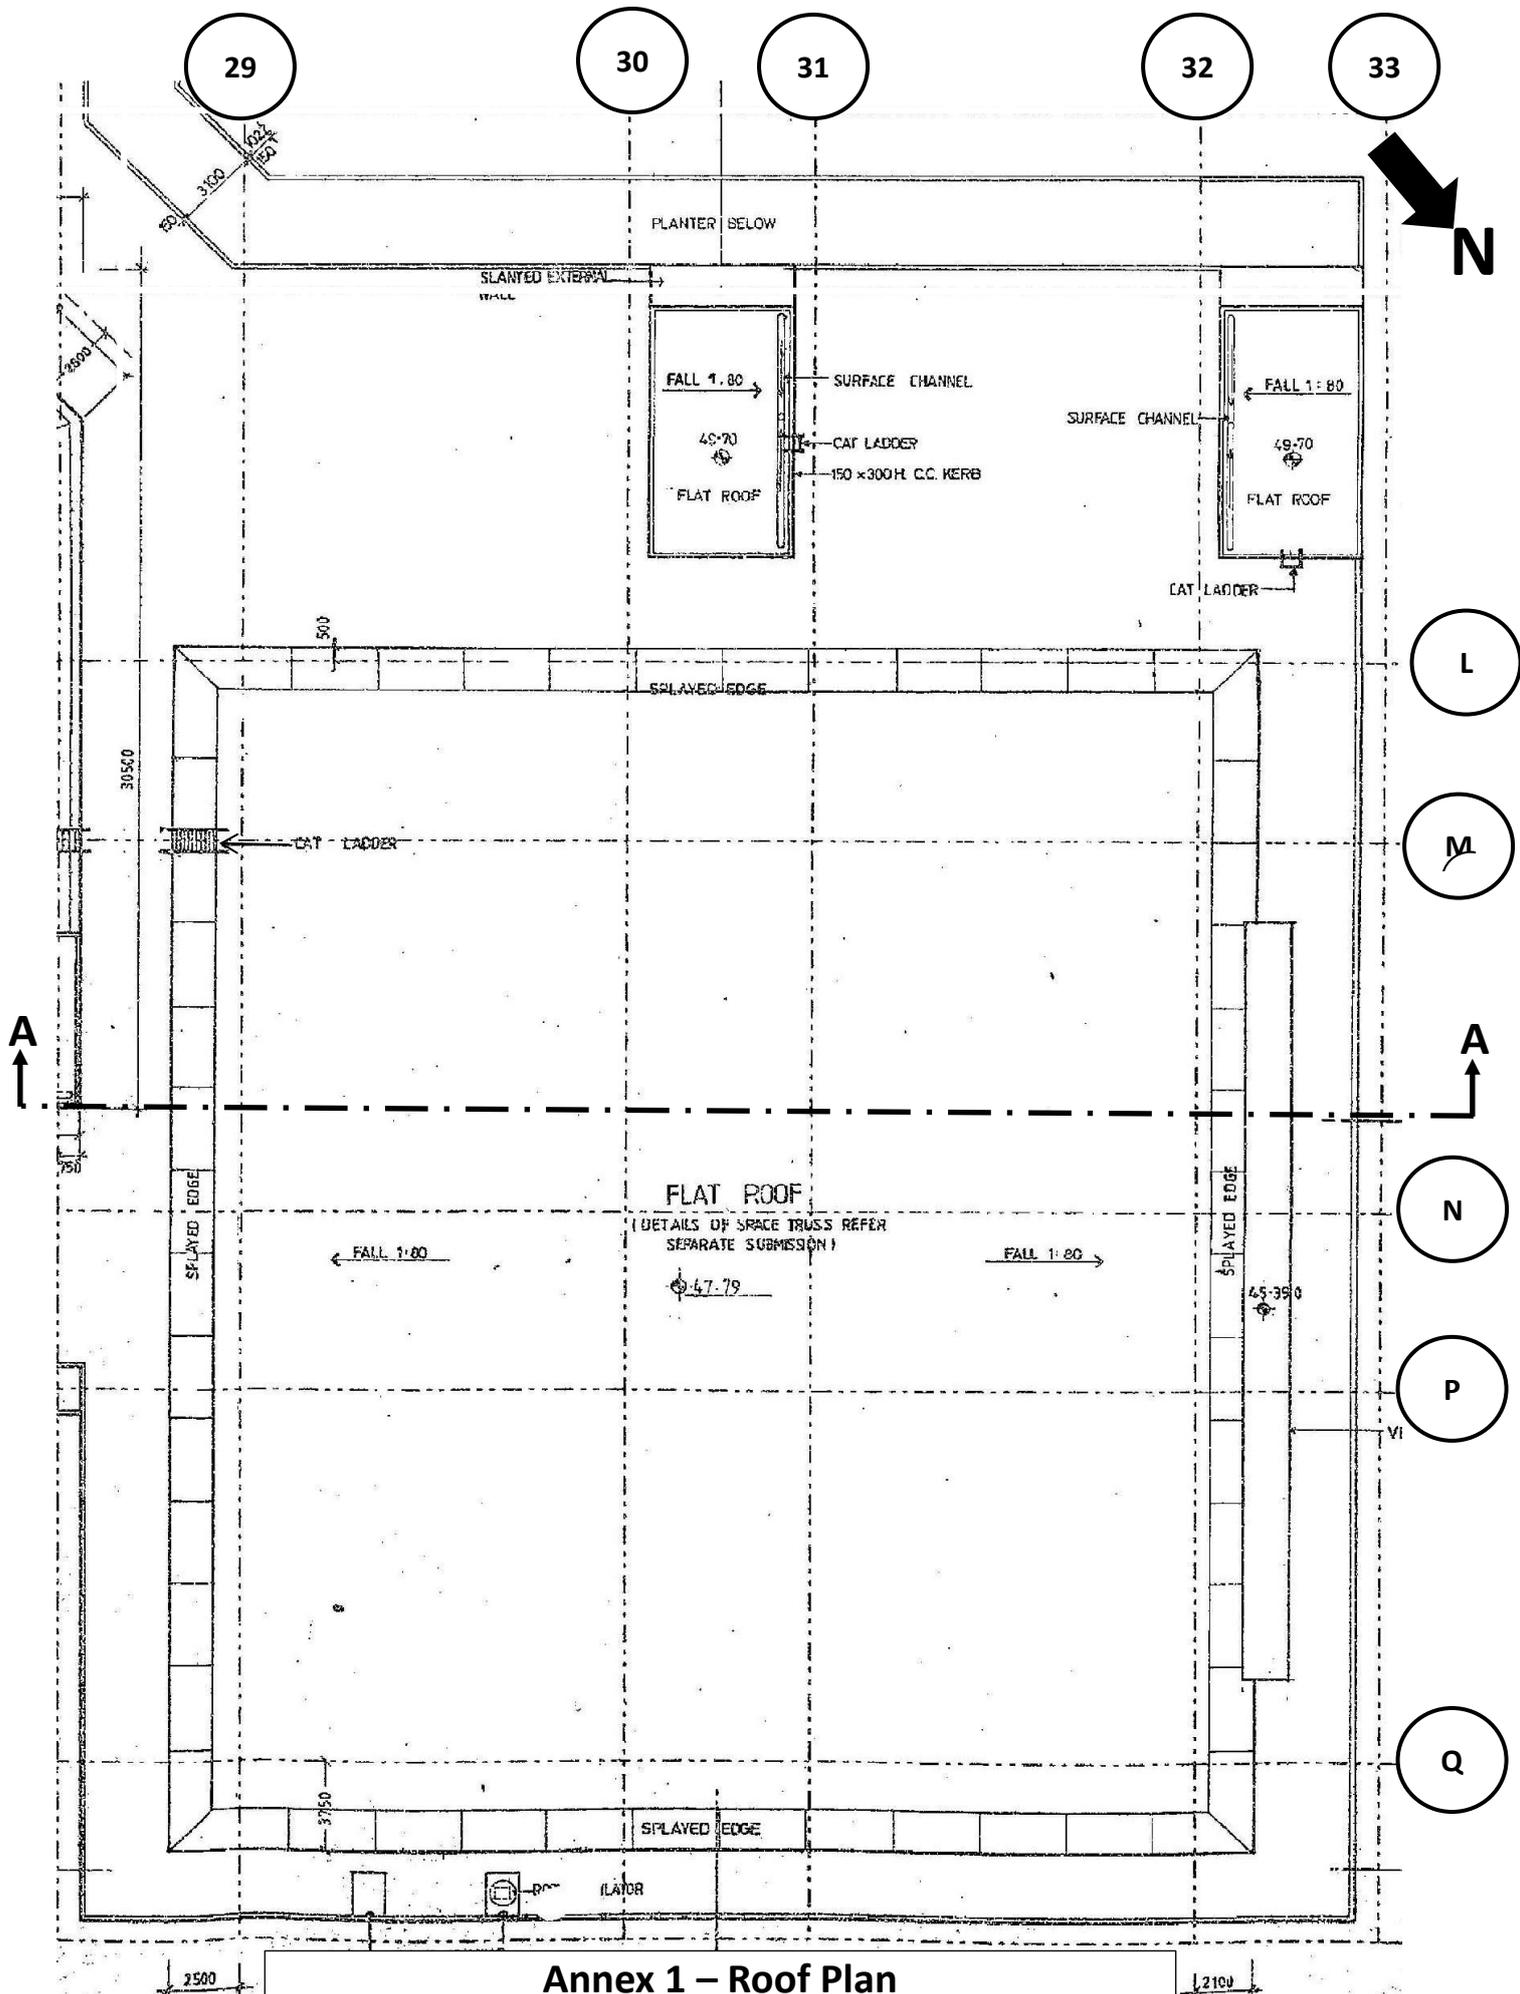
Annex 1 – Roof Plan
附件 1 – 屋頂圖則
 (Floor 08 / 08 樓)

7.2 The Roof measured 39m long and 33m wide having an area of 1,287 m², was accessible via a cat ladder from the Main Roof only. Neither protective barriers at its periphery nor surface channels or gutters was provided. According to the Approved Plans, the Roof was designed to have a fall in a gradient of 1 in 80 towards two opposite sides for discharge of rainwater onto the Main Roof where drainage outlets and surface channels were provided. (*Annex 1 – Roof Plan, Annex 2 – Section A-A*)

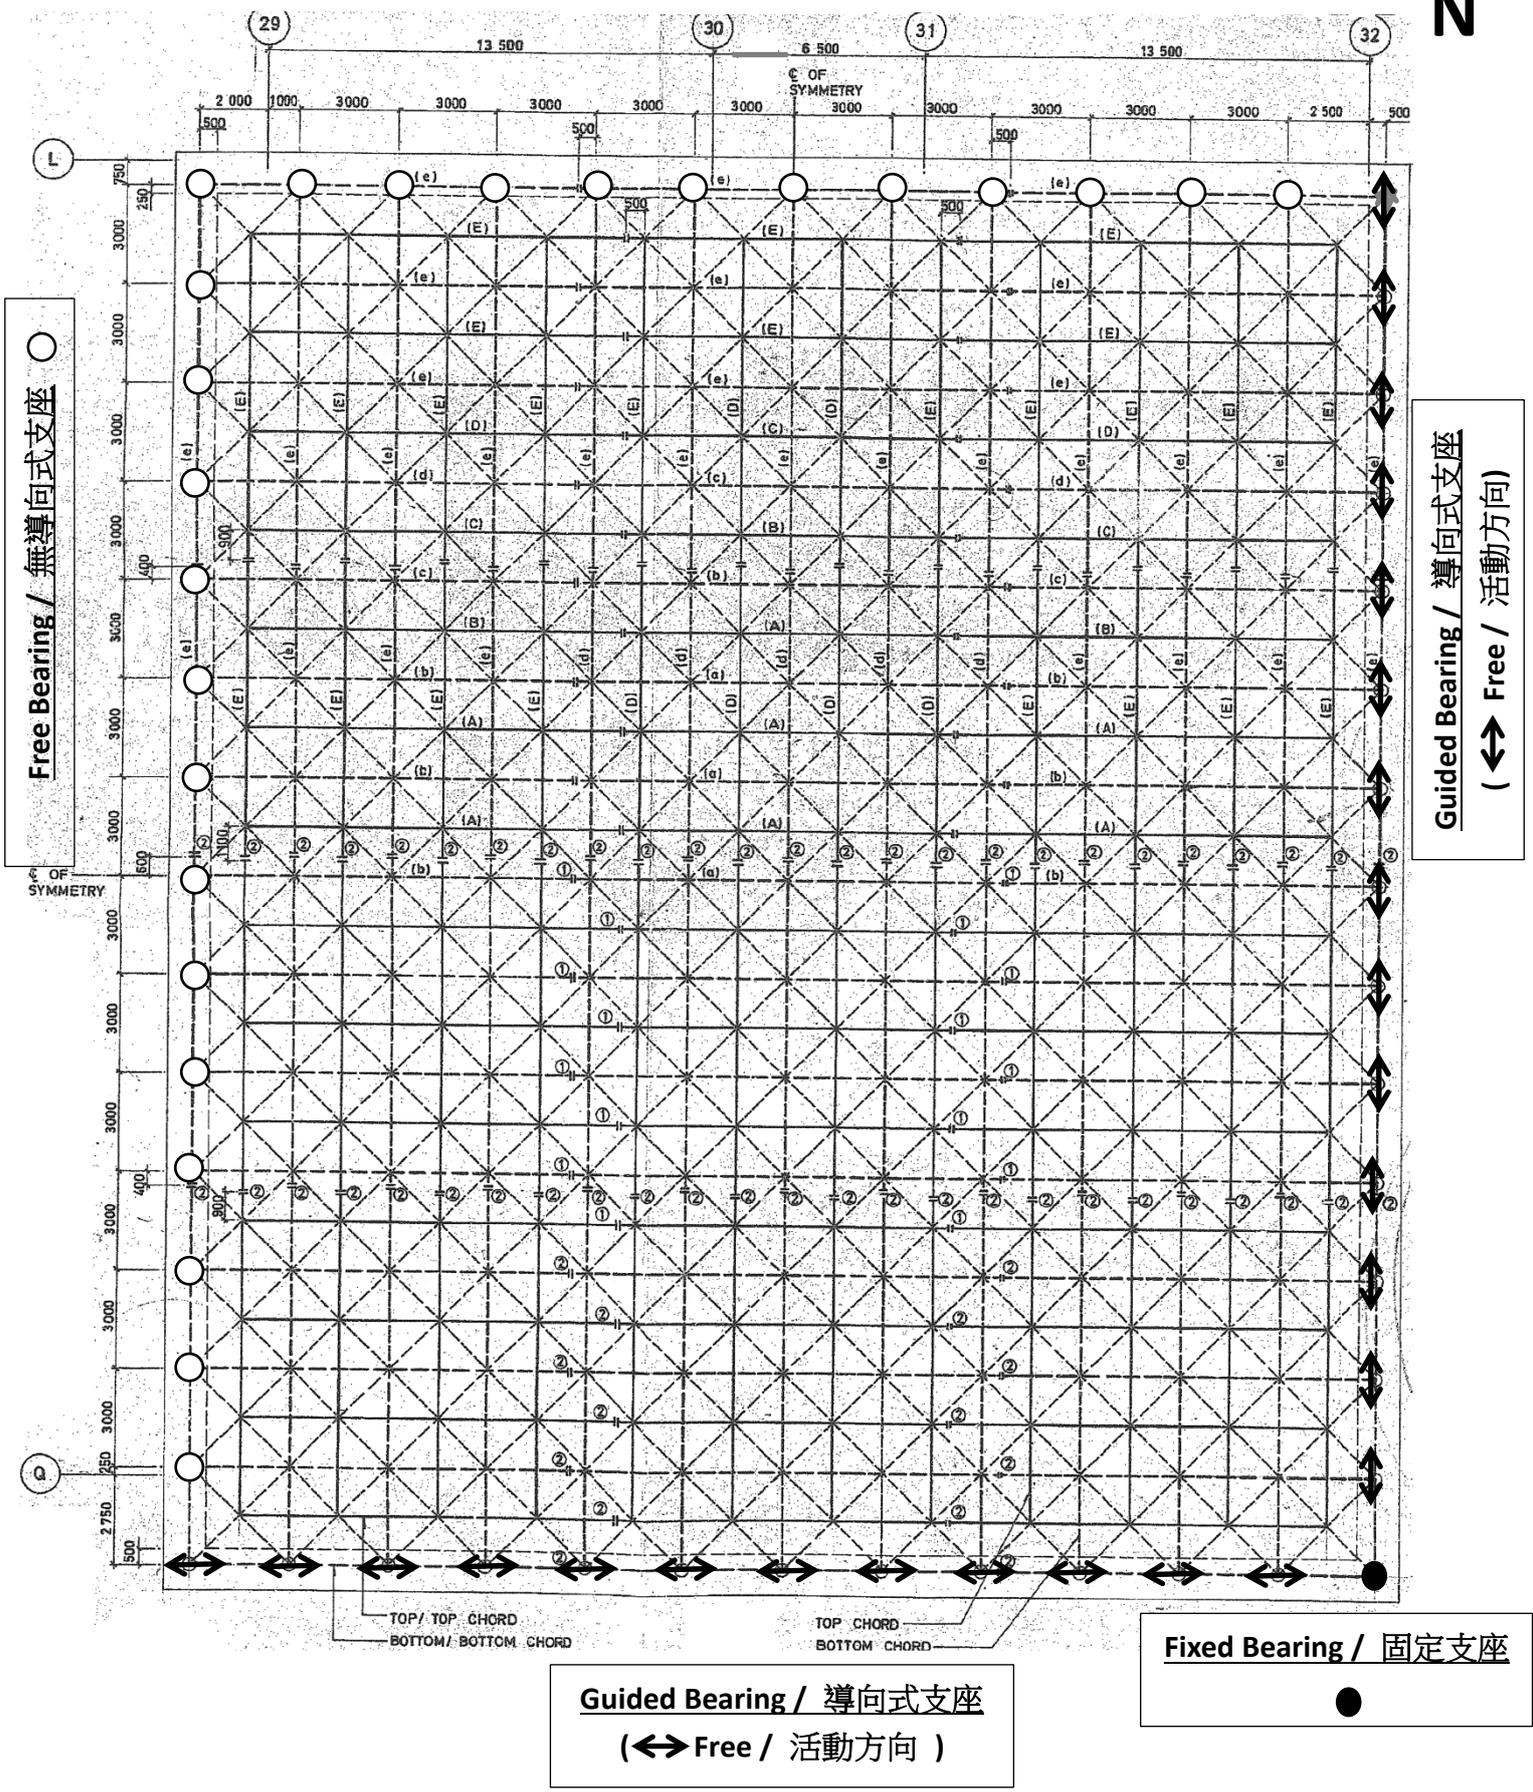
Annex 3 – General Structural Layout of the STS
附件 3 – 空間桁架裝置的總體結構布置圖

7.3 According to the Approved Plans, the STS was 42m long, 36m wide and 2.25m high. It was composed of hot rolled rectangular hollow steel sections as the chords and cold formed circular hollow steel sections as the webs, and supported on 4 sides by a series of bearings at about 3m intervals along the peripheral beams on the Main Roof. Based on the Approved Plans, the STS provided support for a 125mm thick R.C. slab (the Roof Slab) served as the decking of the Roof, 20mm thick screeding, two woodwool layers, building services and fittings. (*Annex 3 – General Structural Layout of the STS*)

13.3.1 According to the Approved Design, guided bearing supports were the supporting points where the STS were seated on the R.C. beams at the Main Roof. On-site inspection and samples collection after the incident revealed that for some guided bearing supports, dowel bars of larger diameter were used and their position was shifted, which led to the edge distance between the beam surface and dowel bars (commonly referred as *concrete cover*) less than the Approved Design. Nevertheless, according to the laboratory test results of the concrete samples collected on site after the incident, the ultimate shear resistance and allowable capacity were considered capable in resisting the required shear force acting upon the guided bearing supports under the original design loads. As a result, the discrepancies are not related to the structural performance of the STS.

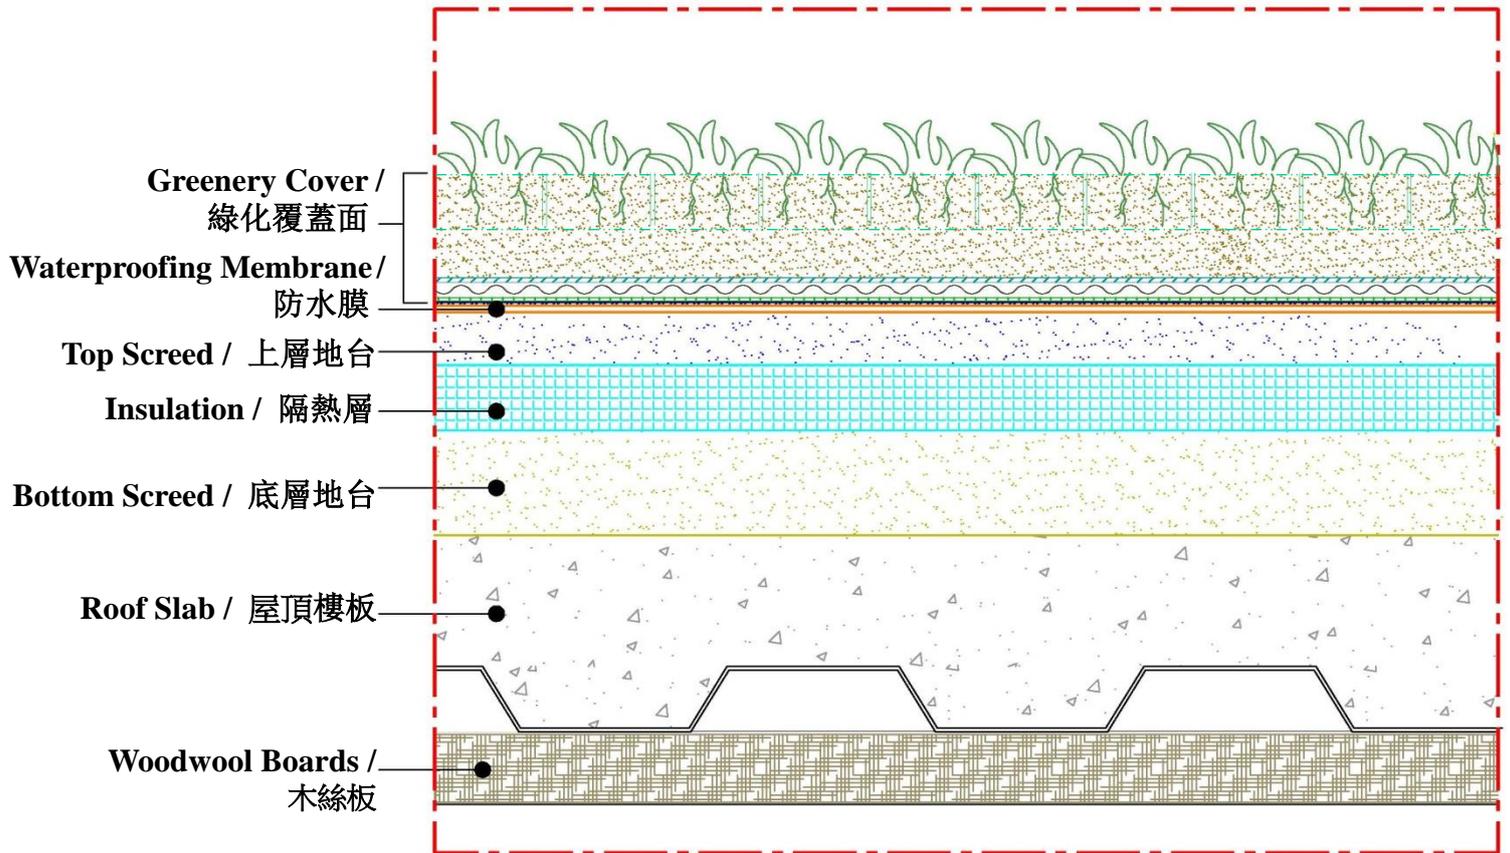
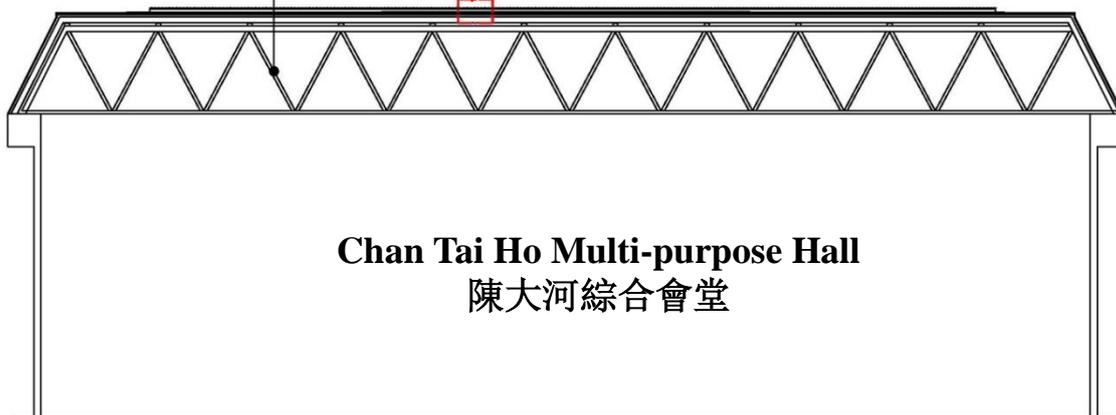
Annex 4 – Indicative Section of the Roof (Before Collapse)
附件 4 – 屋頂截面示意圖 (倒塌事件發生前)

9. As revealed from the surrounding circumstances and laboratory test results, the STS and the Roof Slab were generally in line with the Approved Design⁷ but the following discrepancies were identified and the loading imposed on the STS was beyond the extent anticipated or considered in the Approved Design (*Annex 4 – Indicative Section of the Roof (Before Collapse)*):

- (a) a layer of screeding (the Bottom Screed) thicker than the original design on the top of the Roof Slab, and an additional layer of screeding underneath the waterproofing membrane of the Roof (the Top Screed); and
- (b) the GC.

10.2 As revealed from the concrete core samples collected on site after the incident, there were two layers of screeding and one layer of foam-type insulation on top of the Roof Slab, which were different from the Approved Design. While the loading of this insulation layer (0.13 kPa) identified has no significant impact, the overall dead load imposed on the STS including the weight¹⁰ of the Roof Slab, Top Screed (0.88 kPa), and the Bottom Screed (1.45 kPa) on the STS increased to 5.75 kPa, which is about 35% more than the approved dead load of 4.25 kPa. The thickness of the Top Screed and the Bottom Screed measured up to about 64mm and 93mm respectively in contrast to the screeding of 20mm thick in the Approved Design.

12.1 The loading imposed on the STS including the weight of the Roof Slab, the Bottom Screed, the Top Screed and the GC was about 7 kPa when the GC was fully saturated, which is about 65% more than the approved dead load on the STS (i.e. 4.25 kPa) or over 40% more than the total designed dead load and live load on the STS (i.e. 5.0 kPa).
