PRELIMINARY REPORT
ON
THE COLLAPSE OF ROOF STRUCTURE OF
CHAN TAI HO MULTI-PURPOSE HALL OF
HU FA KUANG SPORTS CENTRE OF
CITY UNIVERSITY OF HONG KONG
TAT CHEE AVENUE, KOWLOON
ON 20 MAY 2016

Buildings Department

June 2016

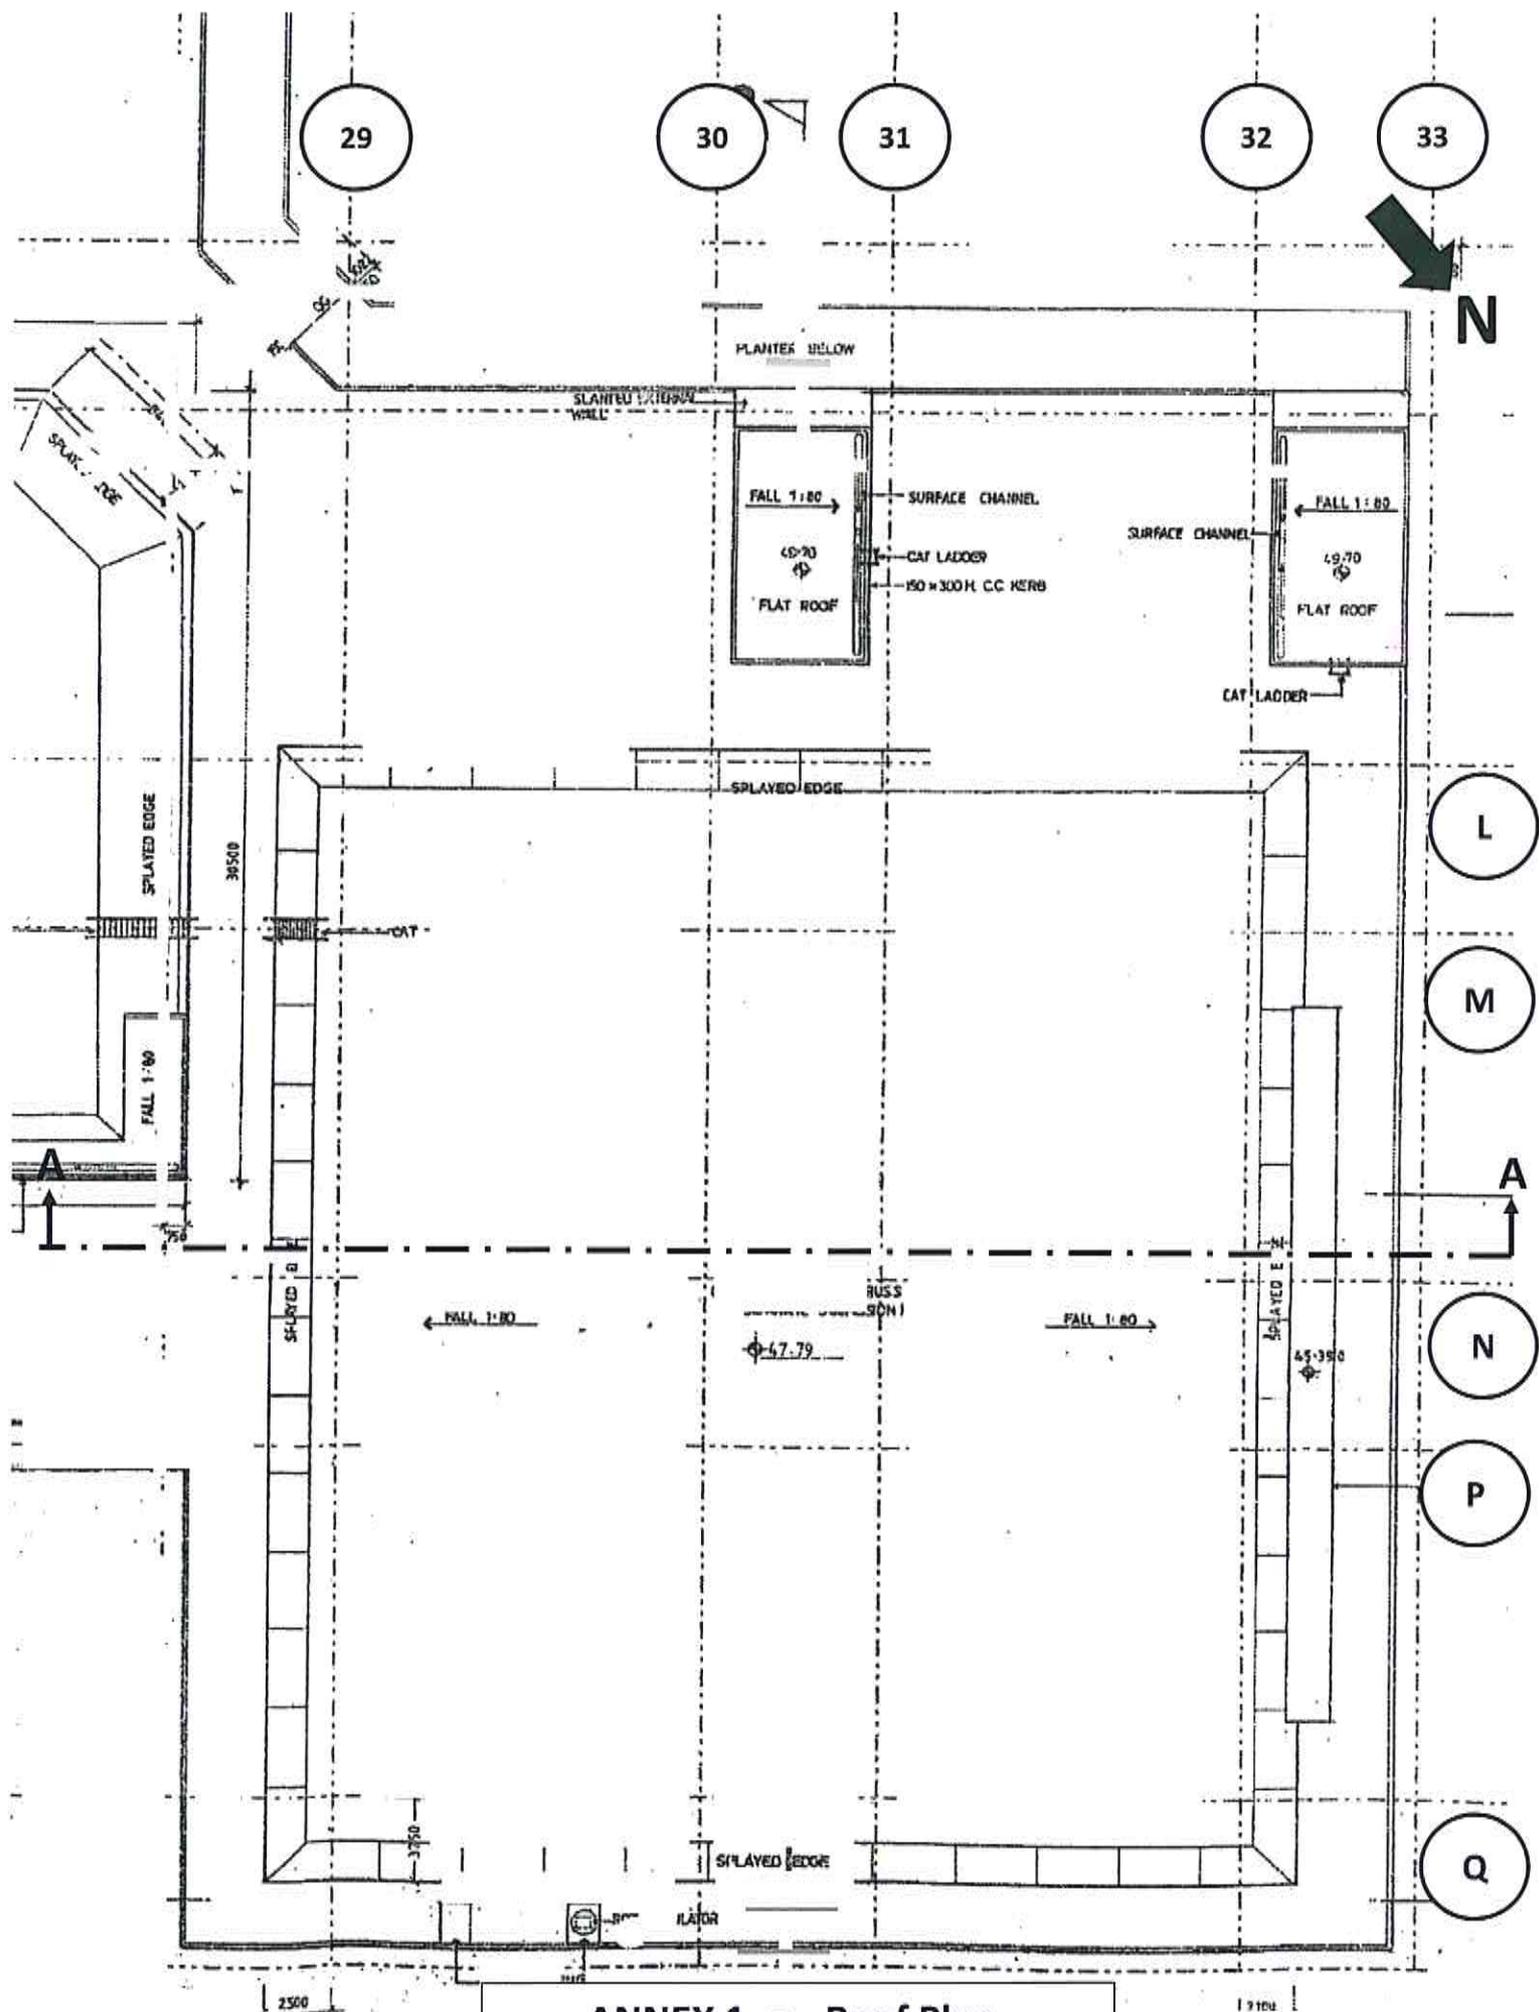
ANNEX 1 - Roof Plan

10. The Sports Hall is situated at Floor 05 of the Sports Centre with a clear headroom of about 10m (*Annex 1 - Roof Plan* and *Annex 2 - Section A-A*). The roof structure of the Sports Hall was a space truss system (STS) with its rooftop level at Floor 08 (the Roof). There is no record of submissions of alteration and addition works for the Roof after the issue of occupation permit.
