# Practice Guidebook for Adaptive Re-use of and Alteration and Addition Works to Heritage Buildings 2012

**Practice Guidebook**  
**on**  
**Compliance with**  
**Building Safety and Health Requirements**  
**under the Buildings Ordinance for**  
**Adaptive Re-use of and**  
**Alteration and Addition Works to**  
**Heritage Buildings**

**Buildings Department**  
**Hong Kong**

**(2021 Edition)**

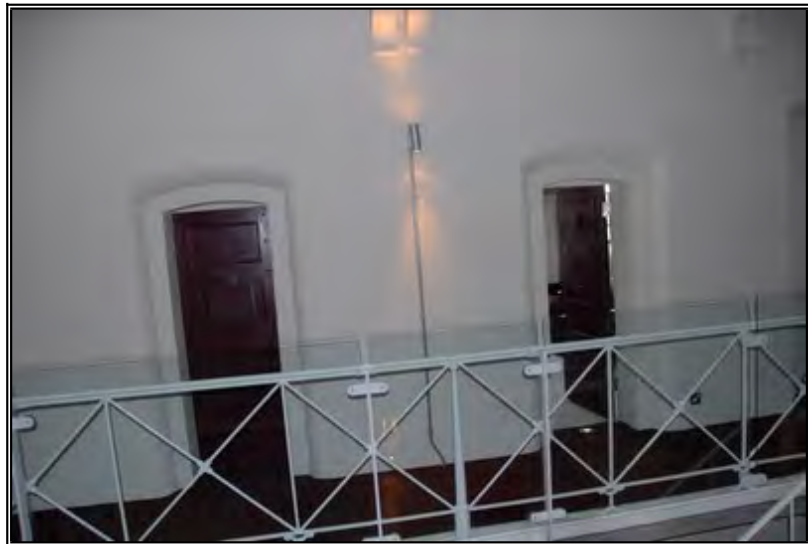
Photo 6 A glazed panel added behind the existing balustrade to meet the current safety requirement in Oxford Castle, UK

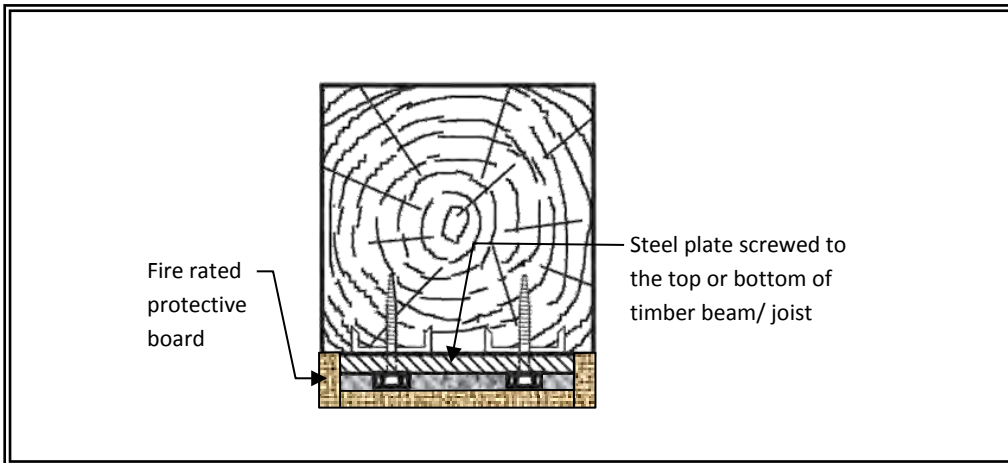
Figure 1 Steel plate for strengthening a timber beam/ joist (with composite action)

To increase the flexural strength of timber beams or joists against bending moment, it is possible to insert a steel plate at the bottom or the centre of the timber beam/ joist to form a composite section with the timber or constructing a new steel beam underneath the existing timber beam/ joist to increase its carrying capacity (as in Figure 1). The steel plate, which may form a composite section with the timber, must be fixed to the timber section with connectors at suitable spacing capable of transmitting the horizontal shear forces. The steel plate should be adequately protected to achieve the required fire resistance rating (FRR).

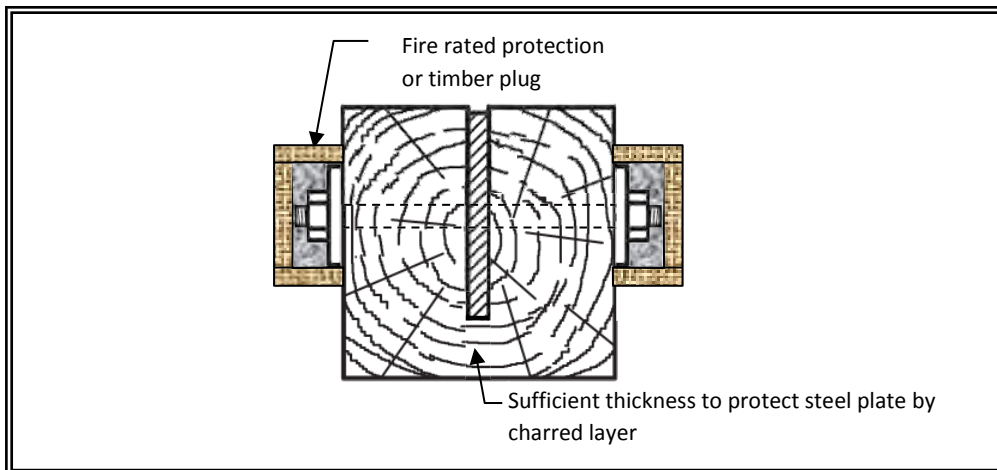
Figure 2 Steel strengthening plate in vertical sawn slot

It is also possible to add timber joists or steel plates bolted alongside the joists. Where the inserted steel plate is used (as in Figure 2), the plate and associated connections should be protected with timber plugs against fire in accordance with BS5268 Part 4.1.

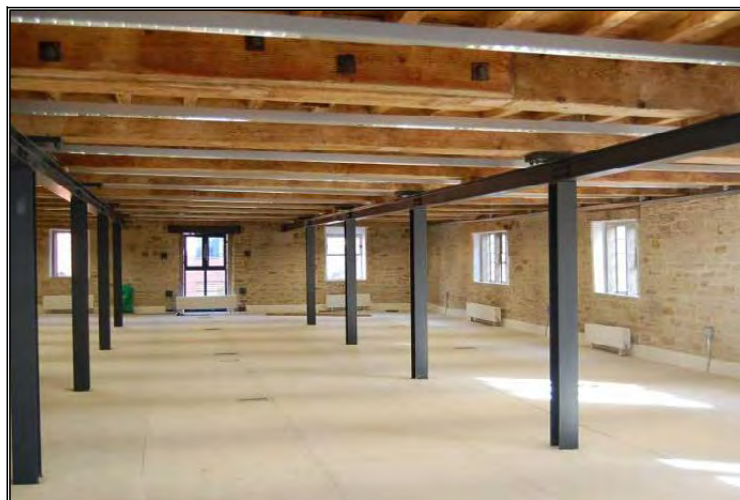
Photo 7 New beams and columns underneath the timber Joists

The deficiency of the load carrying capacity of floors or beams may be resolved by putting in additional supports in specified locations. Often, large rooms need to be sub-divided through re-planning by constructing new partitions. These partition walls can be designed as structural supports to reduce the floor span. It is also possible to put in additional columns and beams constructed of material that are distinguishable from the existing structure to reduce the stresses in the existing structures.

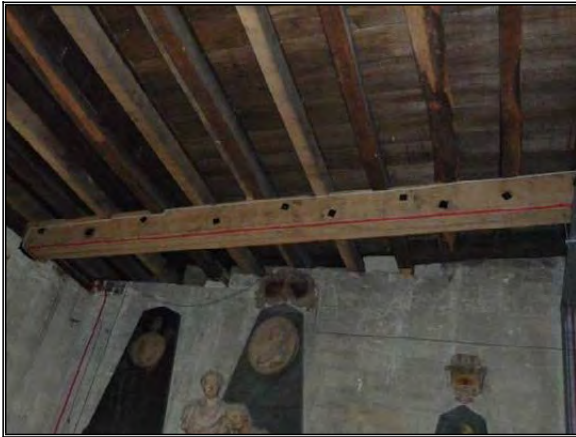
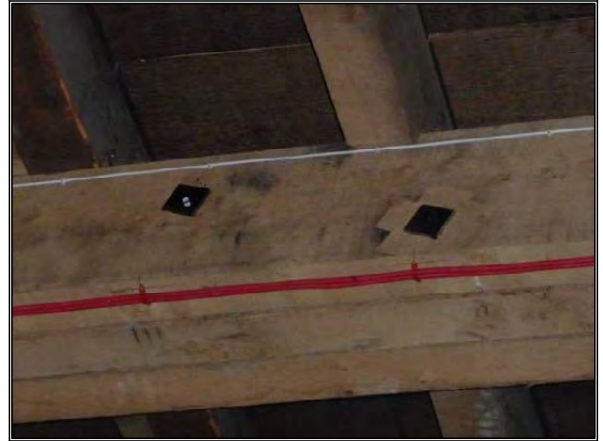
Photos 8 and 9 Three timber joists bolted together

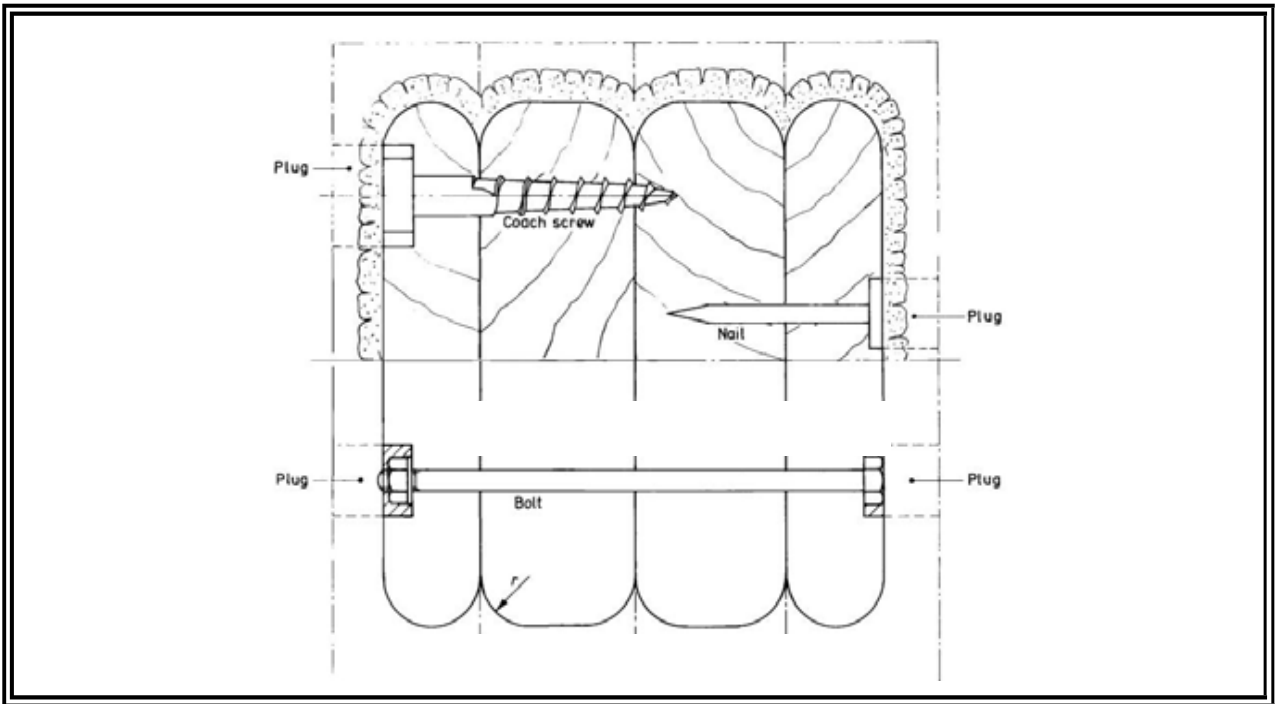
Figure 3 Charred timber section with steel connections to BS 5268 Part 4.1

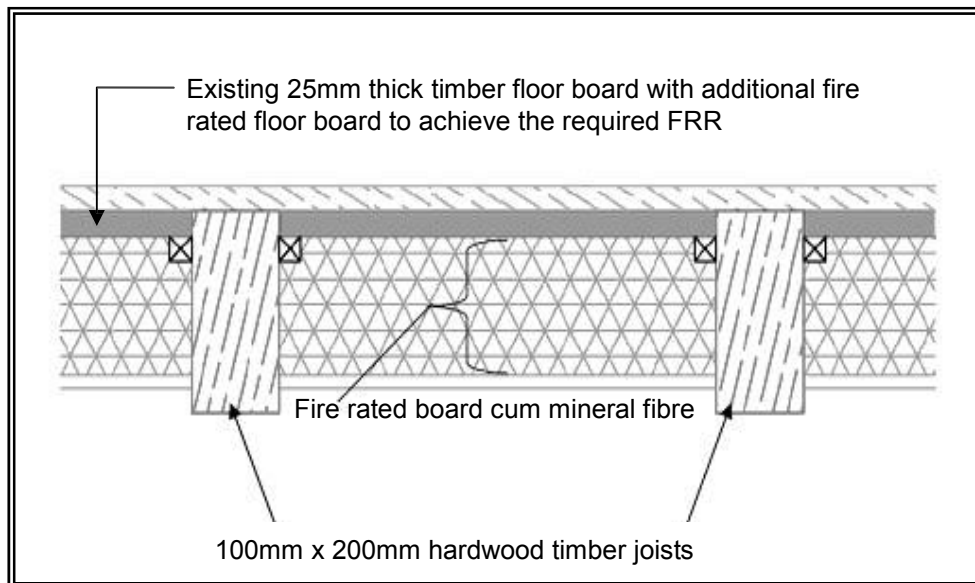
Figure 4 Additional fire rated protective board fixed at underside of floor board with additional fire rated board installed underneath the top timber planking

When the existing timber floor board is required to achieve certain FRR under the FS Code, additional fire rated floor board can be installed beneath the existing timber floor planking (Fig. 4 refers). If the top surface of the existing timber floor board is exposed to fire, the additional fire rated floor board installed underneath can still provide structural support to the imposed floor loads. Details of the upgraded timber floor should also be included in the Schedule of Building Materials and Products under PNAP APP-13 when applying for occupation permit or certifying completion of the respective A&A works.

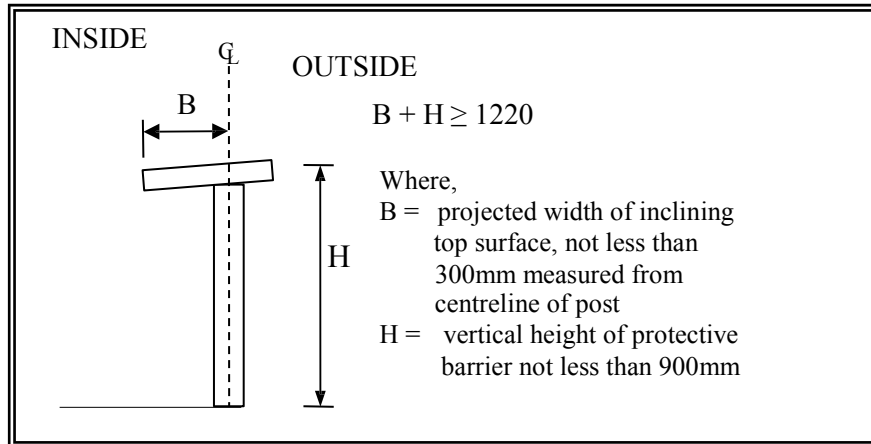
Figure 5 Relationship between the height of protective barrier (H) and minimum width of top surface (B)

- (i) the height of the protective barrier is not less than 900mm;
- (ii) the sum of the width of the top surface measured from centreline of the barrier being not less than 300mm and the height of protective barrier being not less than 900mm, is not less than 1220mm. Figure 5 refers;

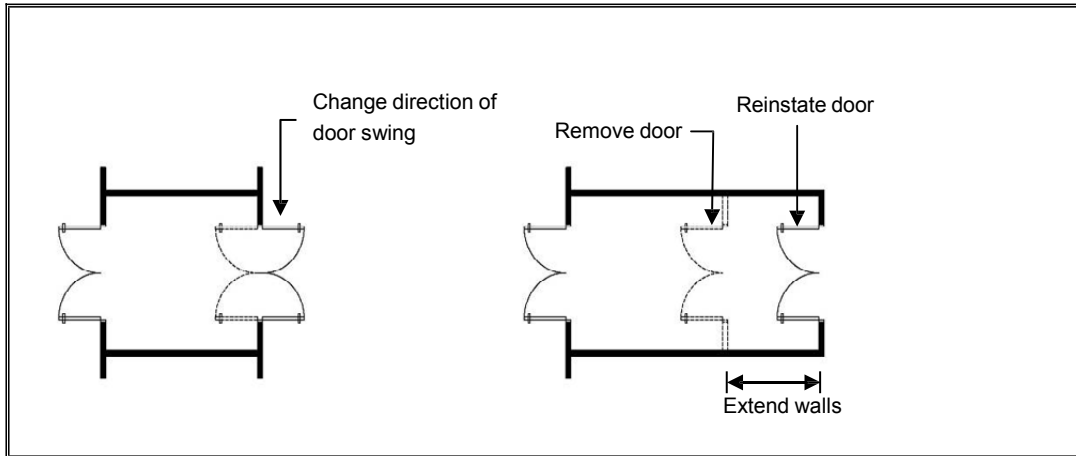
Figure 6 Change door swing direction

Figure 7 Lobby extension

It may be possible to either change the direction of door swing or to replace the door hinges by those allowing double action such that the full length of the lobby being not less than 1200mm can be allowed for manoeuvring wheelchairs (Figure 6 refers). If the latter one is to be adopted, a check mechanism shall be provided to prevent the door swinging beyond the closed position and a transparent vision-panel with a bottom edge not more than 1000mm and the top edge not less than 1500mm above the finished floor level shall be provided.

Alternatively, where there is enough space, it may also be possible to extend the walls of the lobby to achieve the minimum length requirement subject to the AMO's agreement. Figure 7 refers.

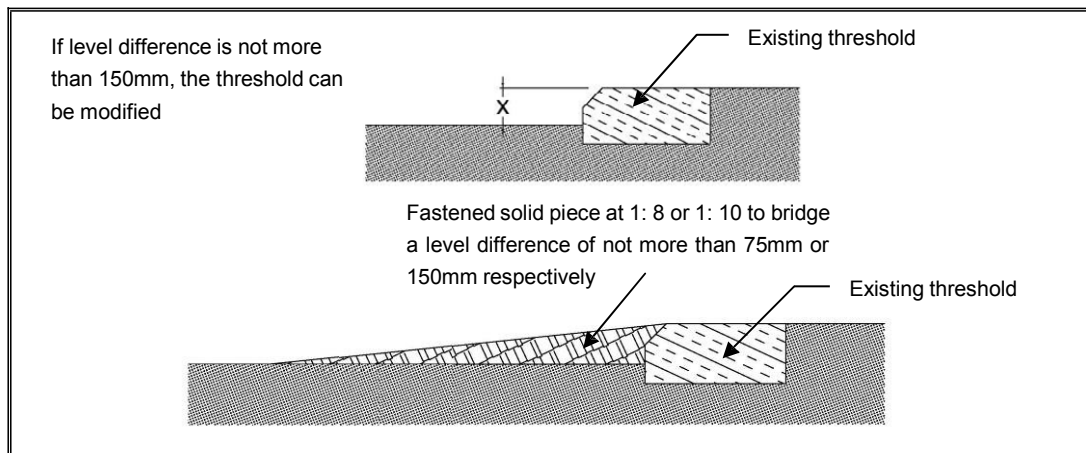
Figure 8 Installation of solid piece

It may be possible to fasten a wedge-shaped solid piece having gradient of not less than 1:8 or 1:10 to bridge a level difference of not more than 75mm or 150mm respectively if its maximum length is not more than 600mm and 1500mm respectively. Figure 8 refers.

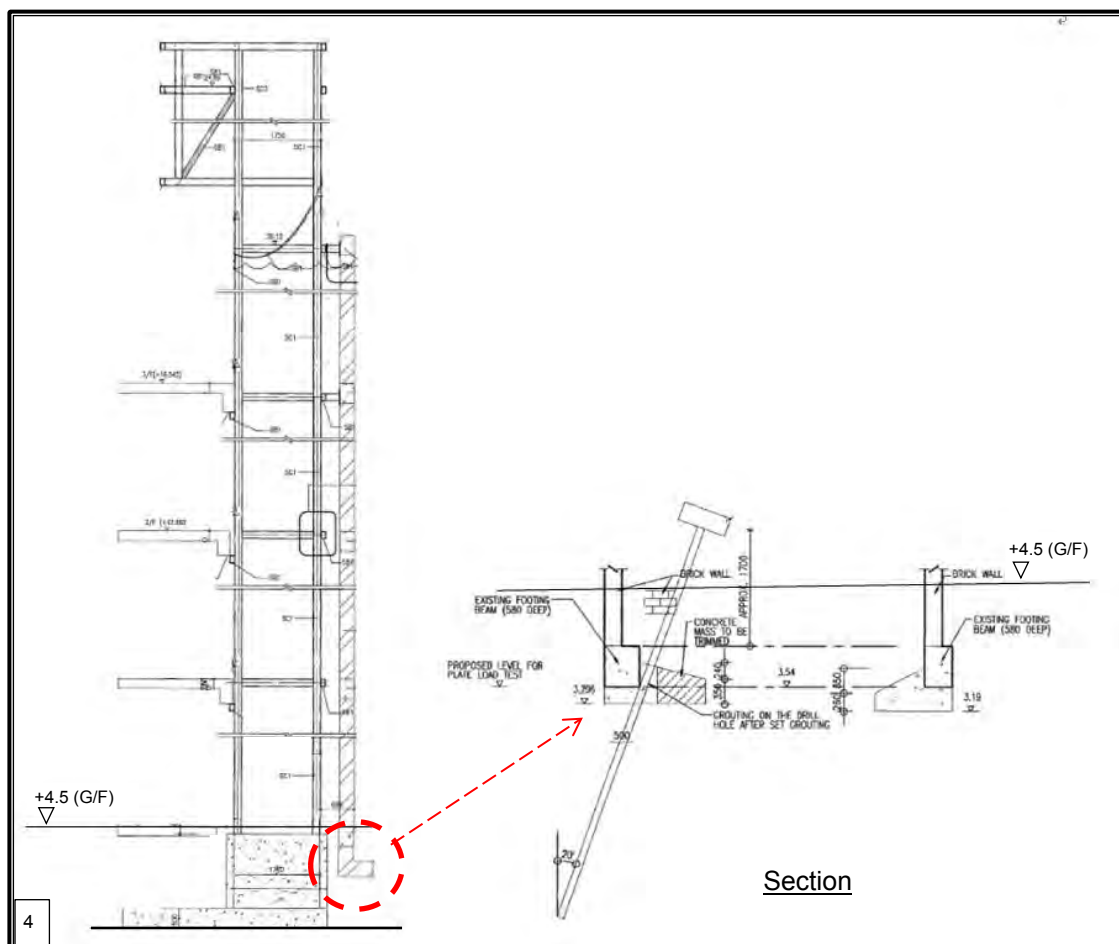
New steel structure, footing for accessible lift and ground improvement works by injecting cement grout into ground soil underneath existing footing

To accommodate a new accessible lift, a structurally independent new steel frame has been constructed on a new spread footing within the existing building. To allow space for the new footing, a portion of the existing footing has been trimmed and modified. Ground improvement underneath the affected footing has also been carried out locally to enhance the bearing capacity.

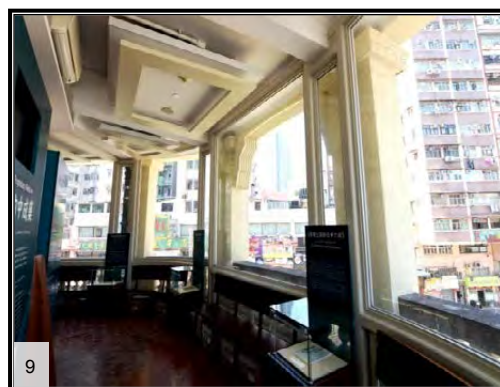
Enclosed verandah with new glass walls

Considering the need to convert the verandahs into consultation rooms, patient waiting areas and pharmacy, the verandahs are enclosed with full height tempered glass walls. Apart from preventing the danger of falling to meet the statutory requirements, the tempered glass panels provide weather protection, traffic noise barrier and air quality control serving the functional needs of the new rooms.

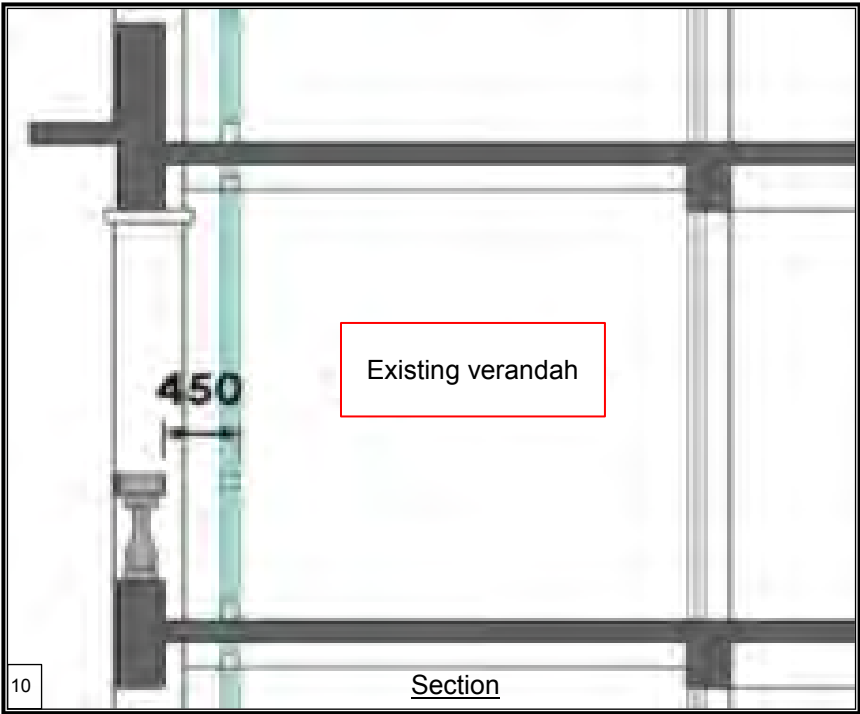
Setting out of tempered glass wall and existing balustrade

The new glass walls have been set back from the balustrade to avoid intruding the preserved facade. The new structural frames and mullions of the glass walls are positioned behind the existing columns to minimise visual impact on the elevations. The existing configuration and features of the verandahs are thus retained with minimal intervention.

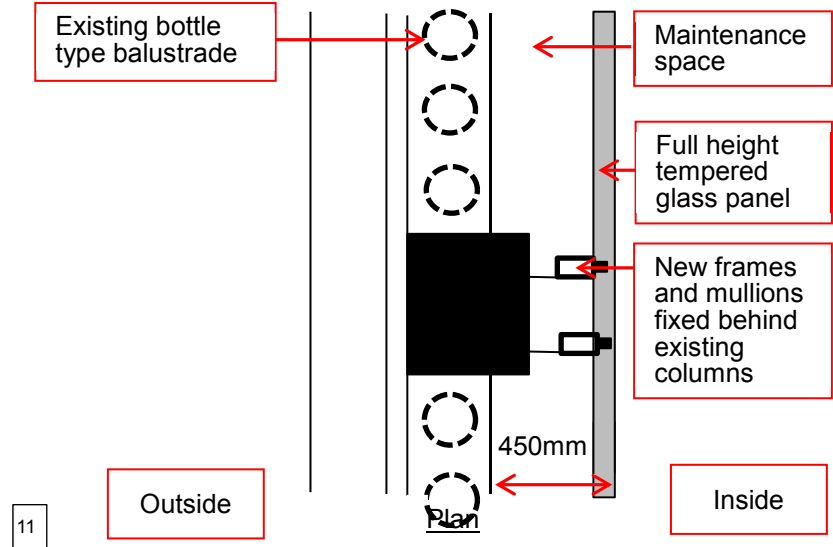
Typical layout of new glass walls and existing balustrade

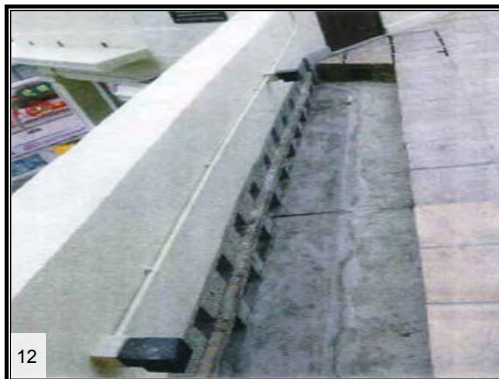
Canton tiles with insulation layer removed along the parapet walls

Part of the canton tile deck with insulation layer of about 200mm high adjoining the parapet walls on roof are removed to lower the adjoining floor level. Potted plants are placed along the parapet walls as a management measure to prevent the users from getting close to the parapet walls.

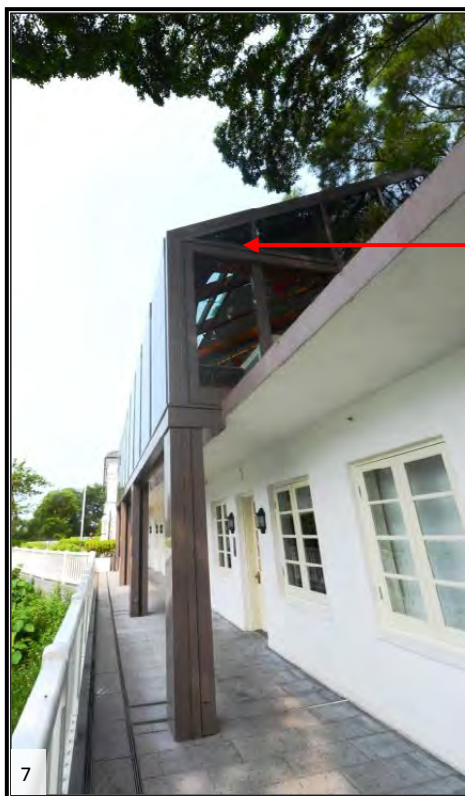
To provide a new roof for the restaurant but without inducing further additional loads on the existing structure, a structurally independent metal pitched roof and new pad footings were constructed.

Independent structure of the new roof for the restaurant

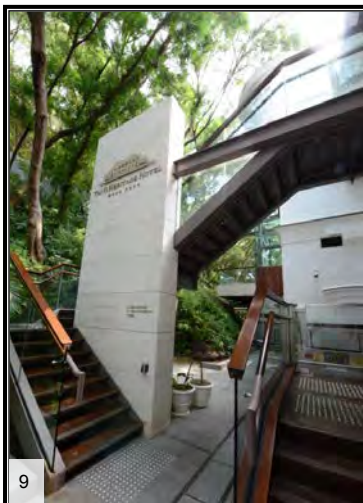
New staircase to the Main Building

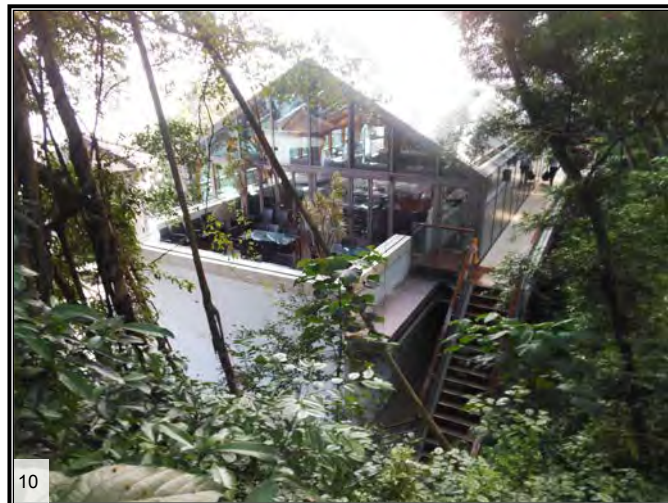
New staircase to the Annex

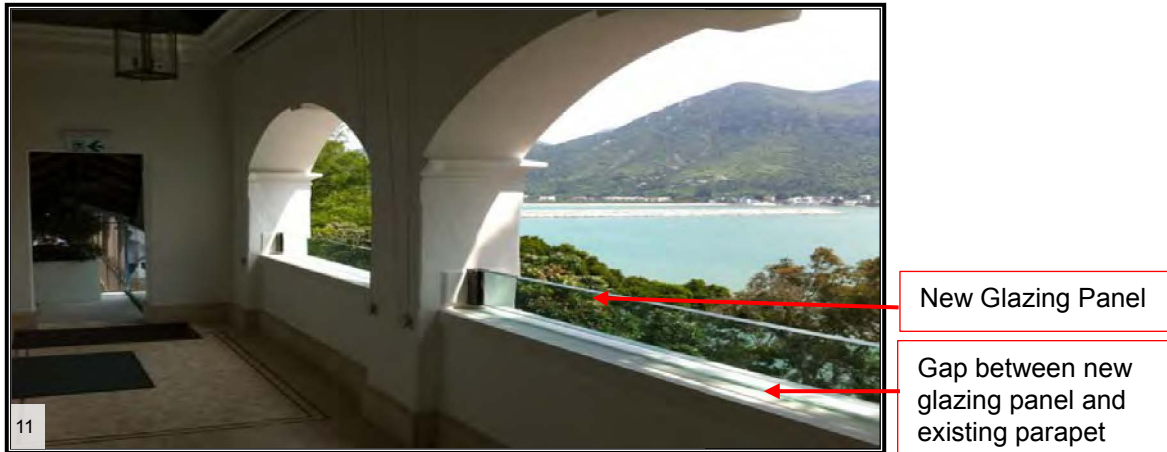
For the parapet walls on 1/F of the Main Building, a small gap is reserved between the new glazing panels and the existing parapet walls so that the panels can be removed without damaging the existing parapet walls in future. The glazing panels are supported by the nearby columns.

Additional glazing panels to add height to the existing parapet walls in the Main Building

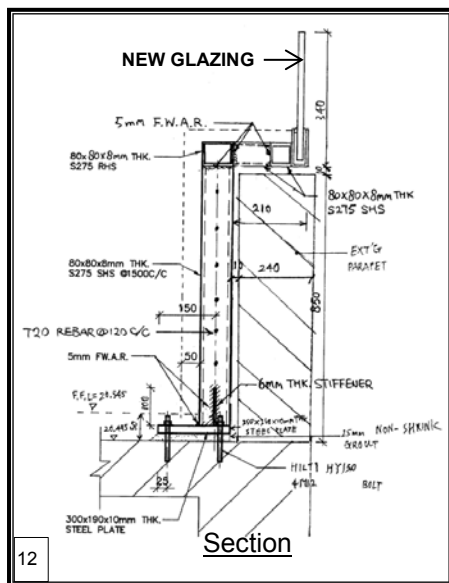
Similarly for the parapet walls at the Annex, the new glazing panels are fixed by independent steel frame mounted on the structural floor.

Fixing detail of steel frame for additional glazing panel at Annex

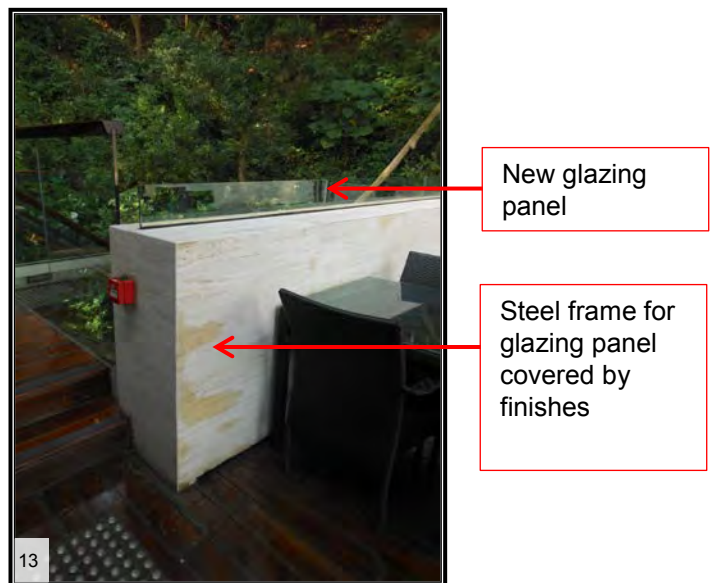
Additional glazing panel at Annex

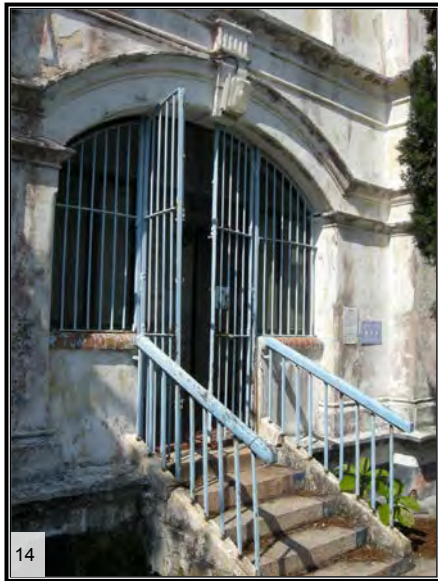
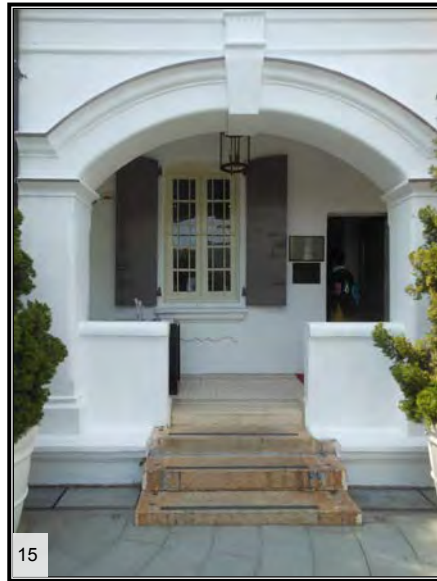
The existing parapet walls on G/F of the Main Building are also of insufficient height for serving as protective barriers<sup>5</sup>. The ground level of the adjoining open garden is raised so that protective barriers are not required at the verandahs.

Before levelling

After levelling

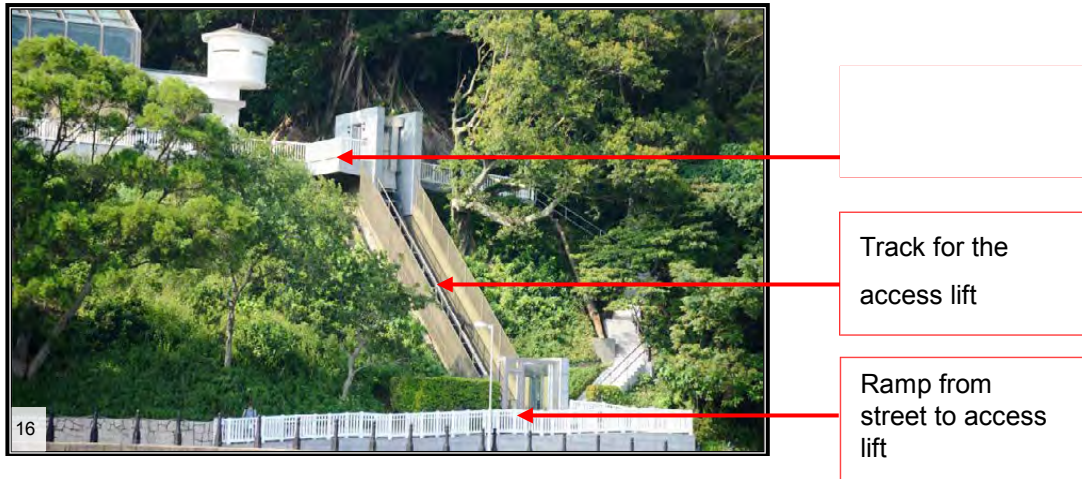
An inclined lift respecting the existing slope profile is added to provide access for persons with a disability (PwD) from Shek Tsai Po Street to the entrance level of the compound.

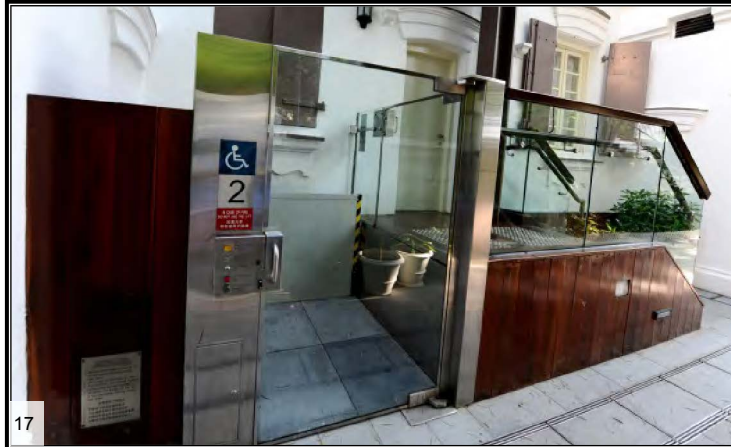
To overcome the level differences, two vertical lifting platforms are added. One is at the rear of the Main Building to provide access to the Reception and Interpretation centre (Photo 17). Another one is installed on G/F of the Main Building to provide access to 1/F (Photo 18).

Vertical lifting platform to the Main Building

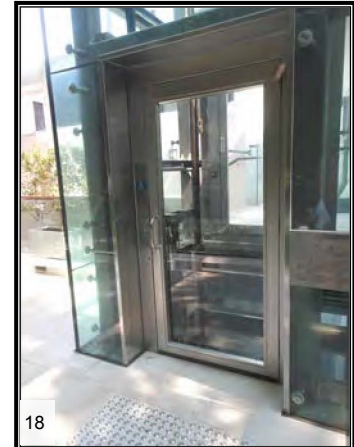
Vertical lifting platform to 1/F

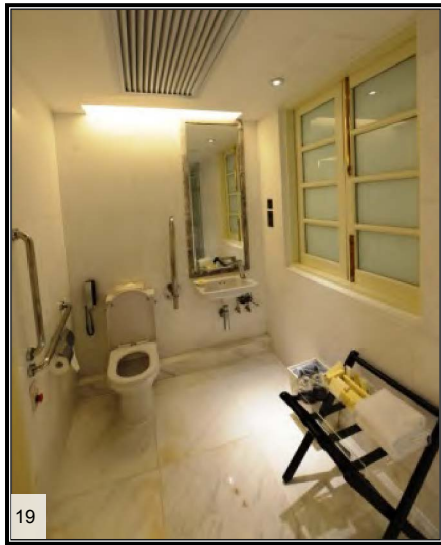
Accessible toilet

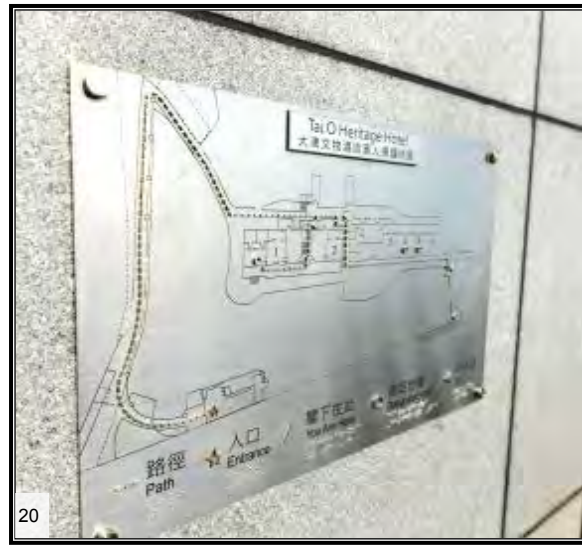
Braille and tactile floor map

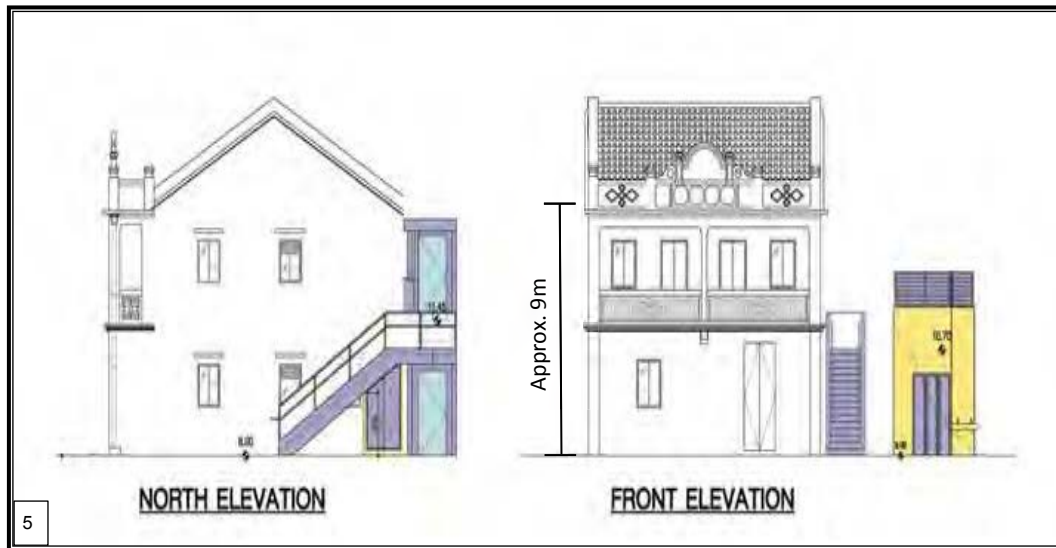
Elevations (new structures shown in colour)

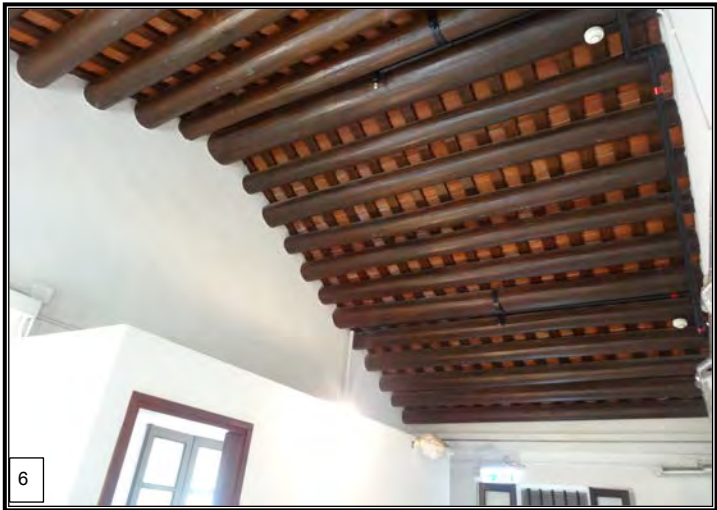
The original timber pitched roof was replaced by metal roof supported by metal truss around 1998. A new pitched roof has been reconstructed with timber purlins and battens as well as clay pan-&-roll roof tiles to restore the original design. Concealed bolts have been used to secure the roof tiles to meet the current requirements<sup>1</sup>.

6  
Reconstructed timber roof

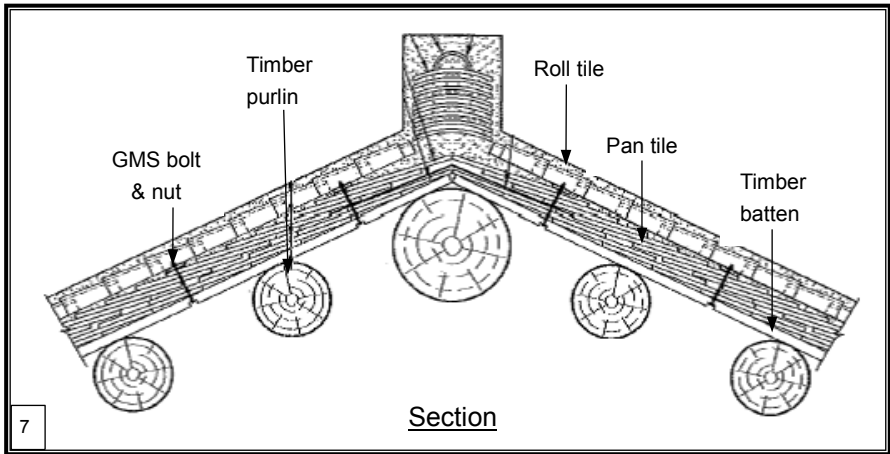
7  
Detail of new timber roof

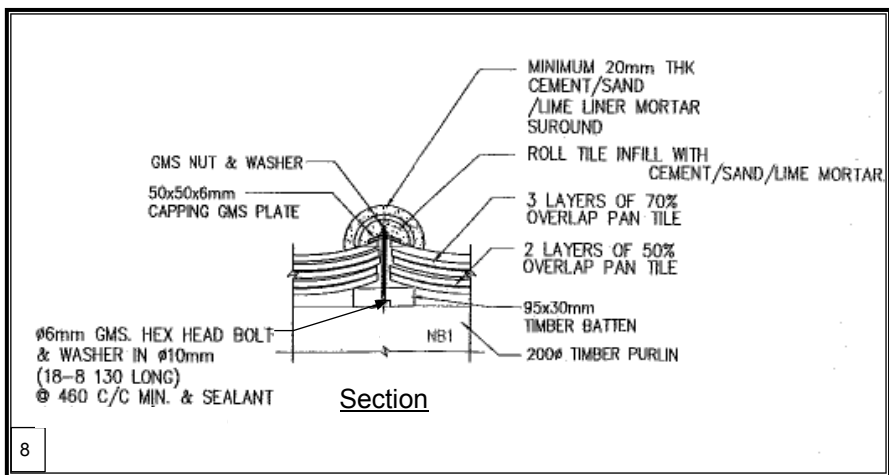
<sup>1</sup> Wind loadings are assessed in accordance with Code of Practice on Wind Effects in Hong Kong 2004.

8  
Fixing details of tiles

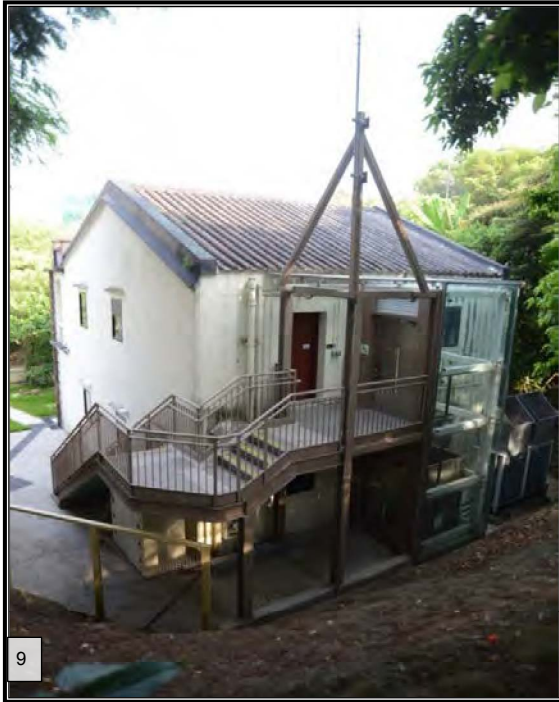
- (ii) The existing external concrete staircase is replaced by a new metal staircase of 1200mm wide
- (iii) The existing openings of the building within 6m of the new open staircase are protected by new fire-rated door or dampers with adequate FRR

A new external metal staircase added at the side and rear elevations

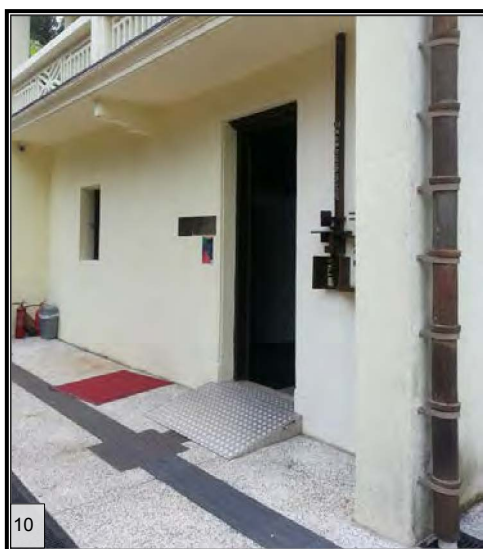
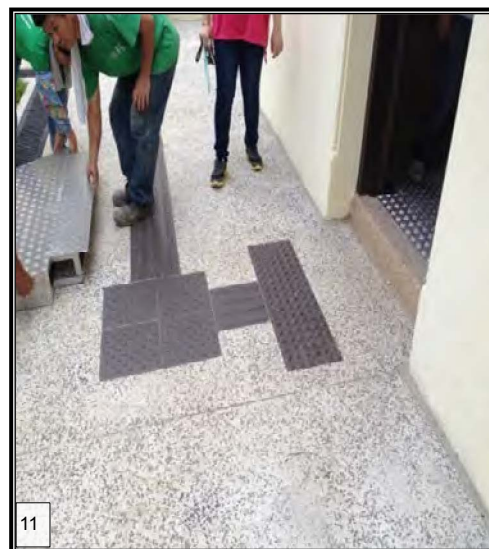
Apart from providing tactile warning strips near the threshold, a barrier free access management plan has been adopted to enhance the barrier free access including the operation of a standby movable ramp and provision of trained staff during operation hours of FYSH to assist persons with a disability to enter or leave the building.

Tactile warning strips and movable ramp at G/F entrance

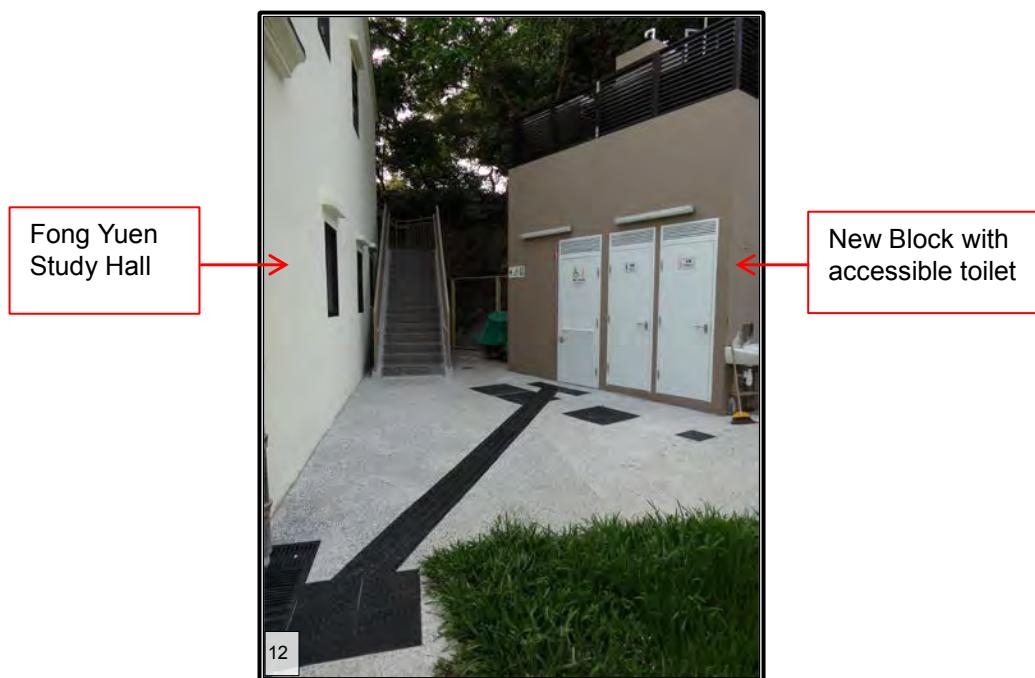
FYSH has very restricted space, provision of new accessible toilets within the building<sup>9</sup> is not feasible. An accessible toilet and other ancillary building services is provided in a new block adjacent to FYSH.

Provision of accessible toilet

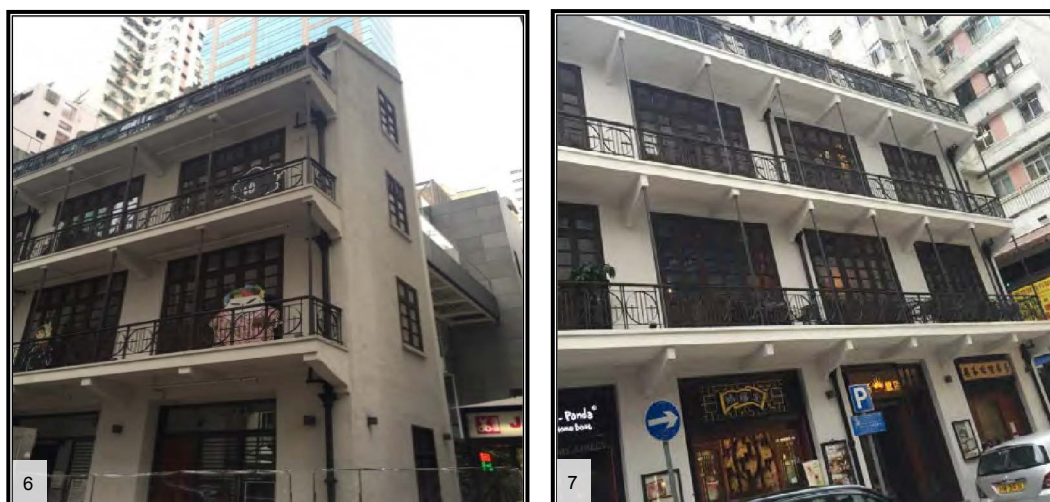
The existing cantilevered balconies project over the two streets. Due to their unsatisfactory structural conditions, the balconies had to be reconstructed replicating the original profile. They are permitted to project over the adjoining streets through exemptions under the Buildings Ordinance but are accountable for gross floor area calculation under the Building (Planning) Regulations<sup>2</sup>.

Reconstructed balconies facing Burrows Street and Mallory Street

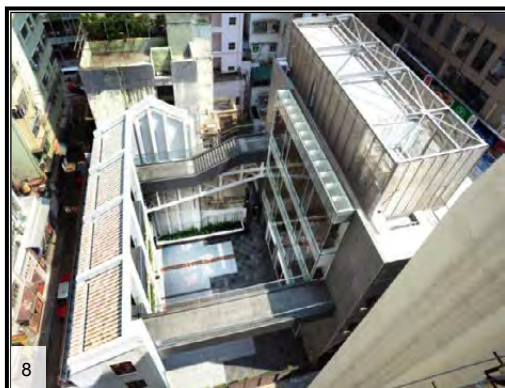
These two trusses also serve as connecting footbridges offering vistas to the public open space in the central court.

Aerial photo showing the trusses connecting the New Annex and the existing facade

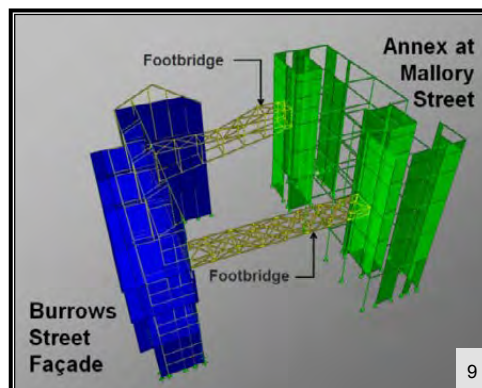
Three-dimensional structural model showing arrangement of the structural system

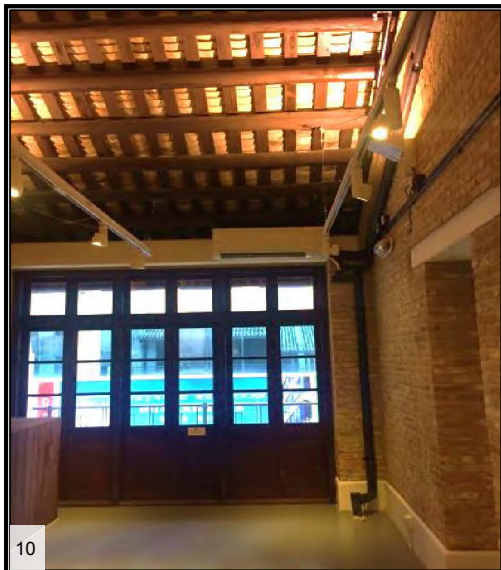
The Chinese-style tiled and timber roof

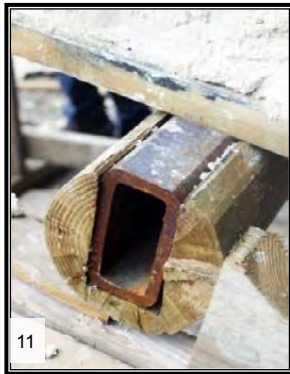
New steel members have been integrated with the restored timber purlins and heatproof materials; and new steel fixings were embedded in traditional Chinese double-layer pan-and-roll tiling construction to meet the current requirements on structural safety<sup>3</sup>. The original distinctive outlook of the timber pitched roof which is one of the CDE can therefore be retained.

11  
New steel members embedded in timber purlin

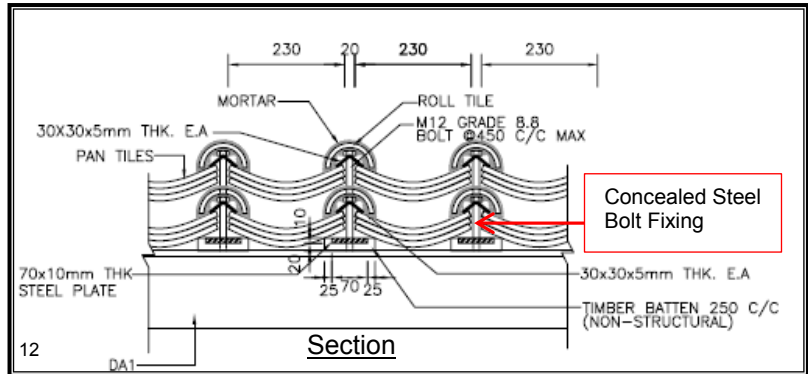
<sup>3</sup> Wind loadings are assessed in accordance with Code of Practice on Wind Effects in Hong Kong 2004.

12  
Fixing details of double-layer pan-and-roll tiles

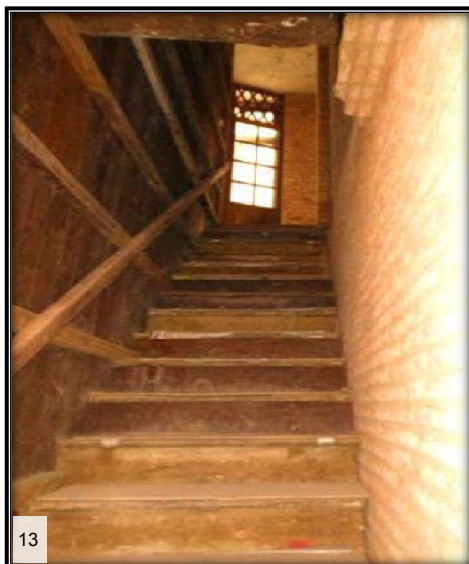
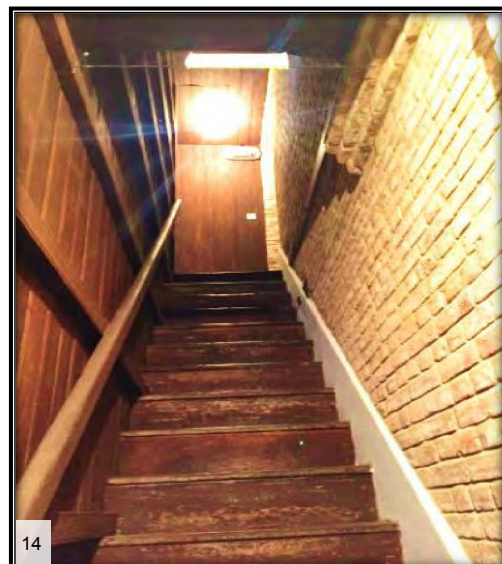
New steel structures have been erected to stabilise the staircase structure which have been covered by the original timber planks and components of the staircase. Similarly, new structural decks have been installed above the preserved structural frame of the timber floor and the original timber planking was re-installed above the new steel frame. In the process of preservation, current standards on structural safety<sup>4</sup> have not been compromised.

13  
Before revitalisation

14  
After revitalisation

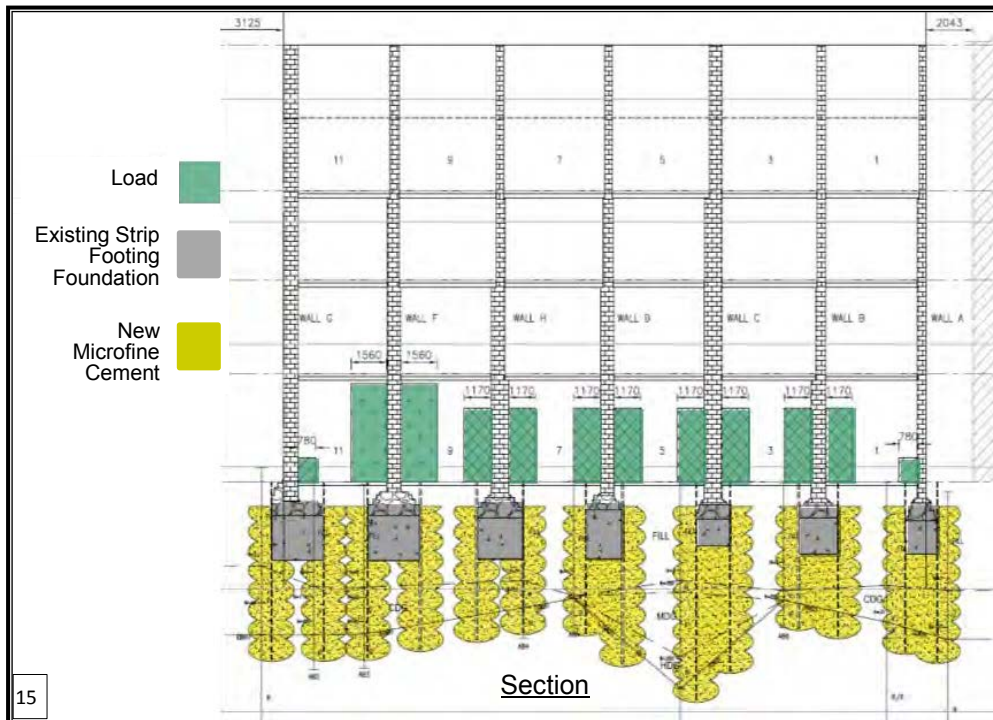
To cater for the additional imposed loads due to the changes in use from residential to commercial or exhibition, microfine cement (particle size  $<20\mu\text{m}$ ) has been injected by pressure into the soil underneath the existing footings for strengthening to increase the load bearing capacity.

Strengthening of foundation by pressure grouting

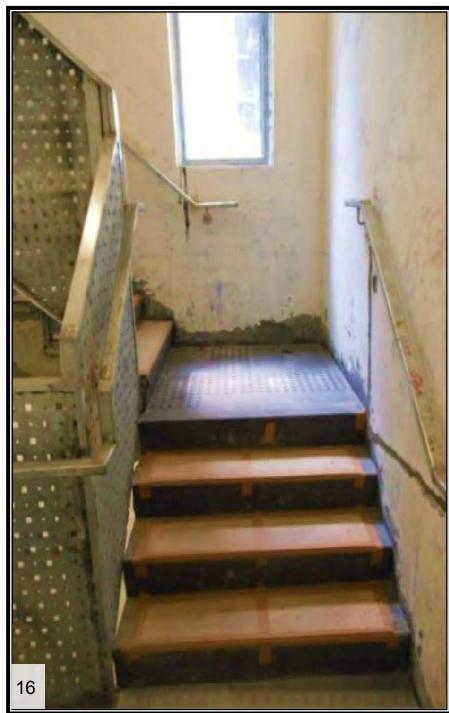
The new additional staircase

<sup>5</sup> For the subject building, a required escape staircase shall be of a minimum width of 1050mm in accordance with Building (Planning) Regulation (B(P)R) 41 and Code of Practice for Fire Safety in Buildings 2011 (FS Code).

<sup>6</sup> Floors and escape staircases shall be constructed of non-combustible materials with adequate fire resistance rating in accordance with B(C)R 90 and the FS Code.

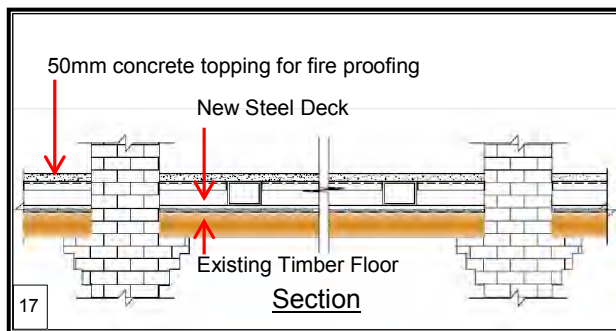
Typical floor system

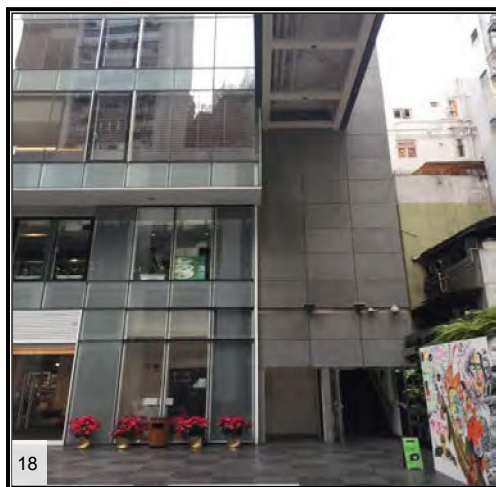
A fireman's lift has been added at the new Annex Block to meet the current safety standards as well as to enhance the vertical mobility of Persons with a Disability (PwD) and servicing.

The new Annex Block

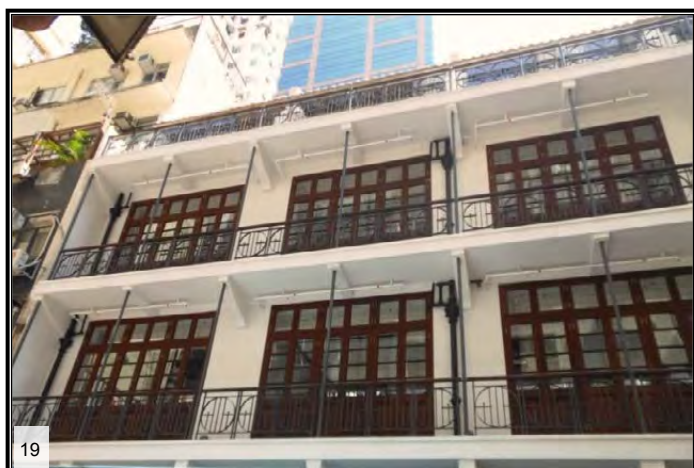
Considering the iron railings are the key CDE of the front façade facing streets, new railings replicating to their original appearance are installed.

Existing railings are inaccessible and retained for visual enjoyment
