# Practice Guidebook for Adaptive Re-use of and Alteration and Addition Works to Heritage Buildings 2012

**Practice Guidebook**  
**on**  
**Compliance with**  
**Building Safety and Health Requirements**  
**under the Buildings Ordinance for**  
**Adaptive Re-use of and**  
**Alteration and Addition Works to**  
**Heritage Buildings**

**Buildings Department**  
**Hong Kong**

**(2021 Edition)**

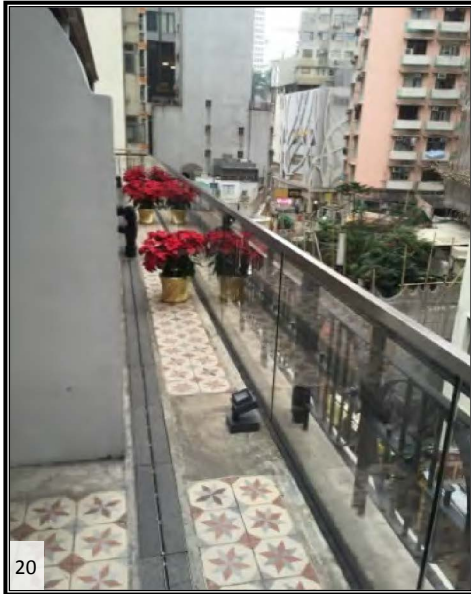
For the accessible balconies, secondary barriers made of clear tempered glass panels of 1100mm are installed behind the railings for meeting statutory requirements<sup>7</sup>. Original state of the railings in other balconies has been retained for visual enjoyment only from a distance, to prevent the risk of falling.

New glass balustrade added behind the existing railing at accessible balconies

<sup>7</sup> Protective barriers shall be at a height above the higher of the adjacent levels of not less than 1100mm; and constructed as to prohibit the passage of articles more than 100mm in their smallest dimension in accordance with B(C)R 8.

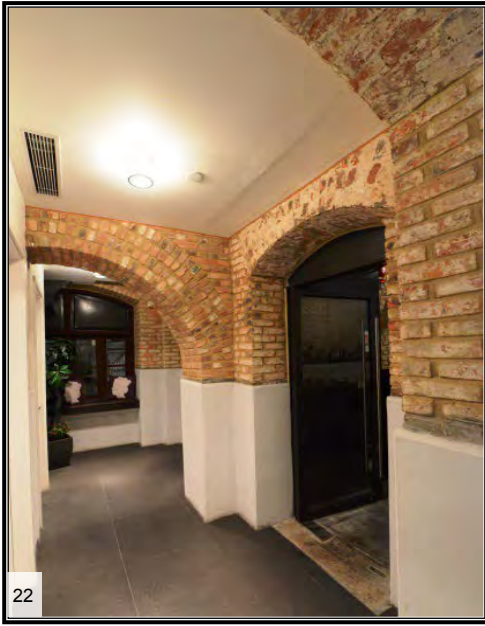
Existing brick arched doorways 800mm - 825mm wide are inadequate to serve as passageway required under DMBFA for PwD<sup>8</sup>. Alternative access routes are provided in less conspicuous locations so that prestigious doorways in prominent locations can be preserved.

Preserved prestigious doorways

<sup>8</sup> Passageway shall have a clear width of not less than 1050mm in accordance with the Design Manual: Barrier Free Access 2008 (DMBFA).

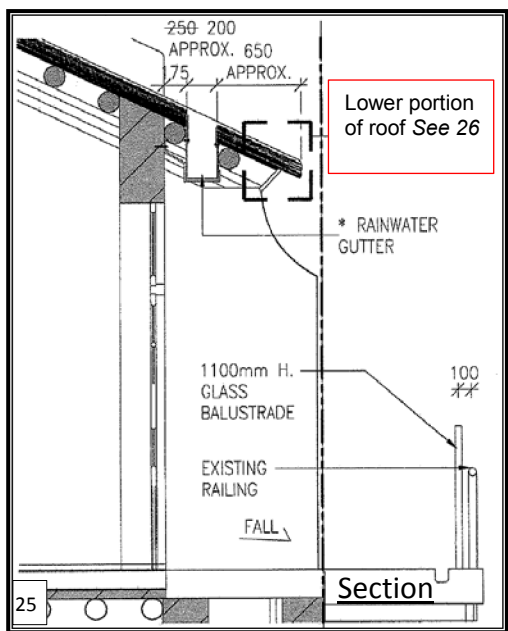
As the conventional method of installing gutter along the eaves to meet current requirement<sup>10</sup> would impair the traditional appearance of the Chinese-style pitched roof, gutters have been installed at a 650mm setback. Exemption from relevant statutory requirements has been granted permitting rain on lower portion to discharge directly to the floor of the balcony and then to the surface water channels.

The glass balustrade and rain water gutter

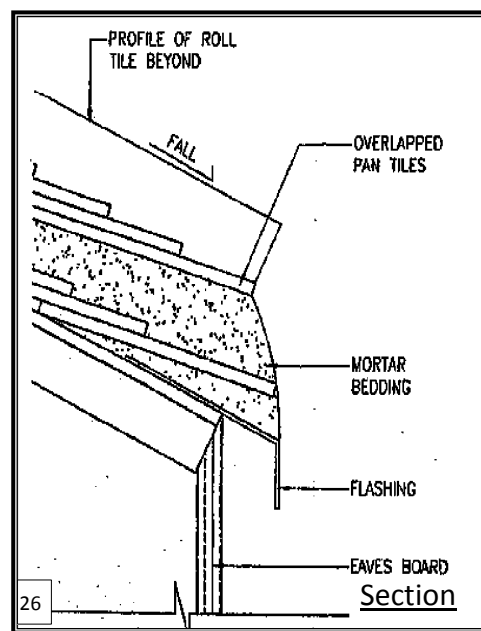
The eave facing Burrows Street

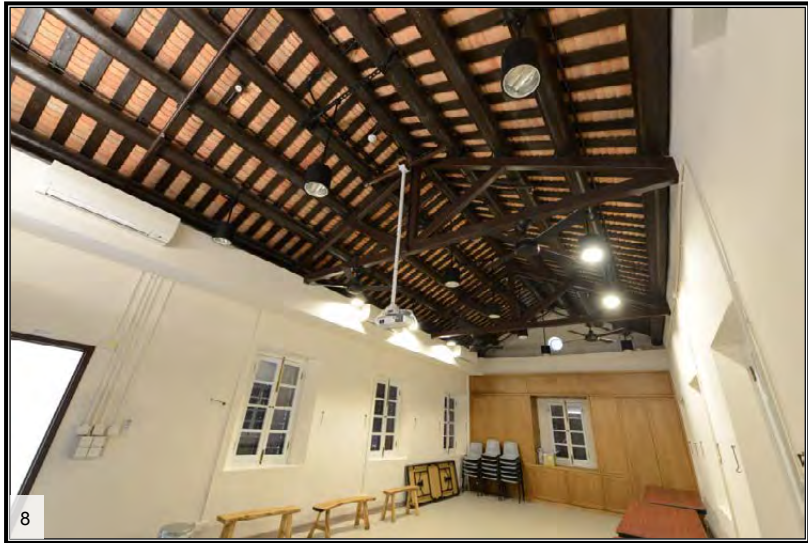
8

In the Main Building, the original timber pitched roofs are partially replaced by steel purlins and battens. After obtaining approval and consent under the Buildings Ordinance (BO), the relevant portions are reconstructed with timber purlins, timber battens and double-layer clay pan-&-roll roof tiles to restore the original design. To meet current requirements on structural safety<sup>1</sup>, concealed metal bolts are introduced to fix the roof tiles in positions against wind uplifting.

New timber roof for the multi-function room in the Main Building

<sup>1</sup> Wind loadings are assessed in accordance with Code of Practice on Wind Effects in Hong Kong 2004.

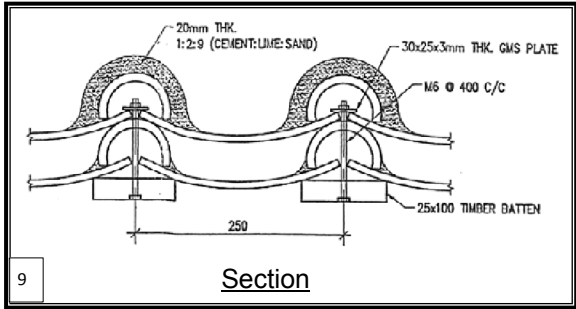
9

Section

Fixing details of roof tile

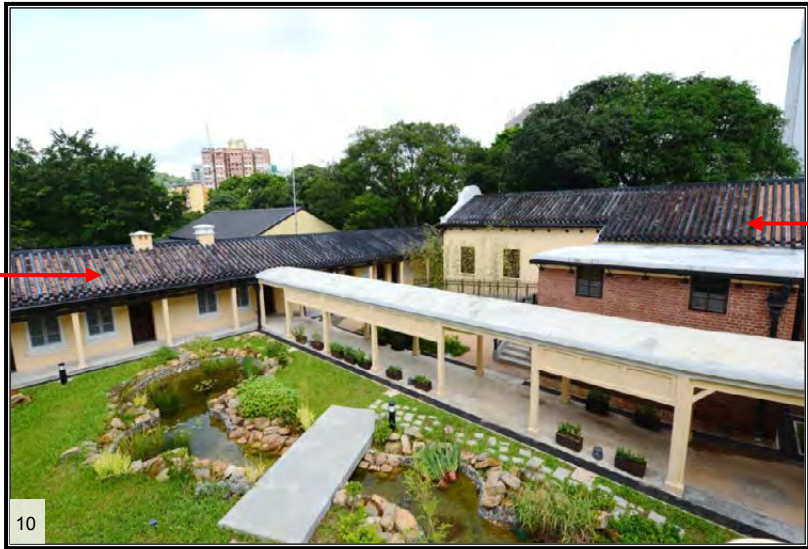
The existing timber roofs of the Ancillary Staff Quarters Block and the steel roof of the Canteen Block are repaired following the simplified requirements under the Minor Works Control System (MWCS).

The existing timber roof repaired under MWCS

The re-constructed timber roof approved under the BO

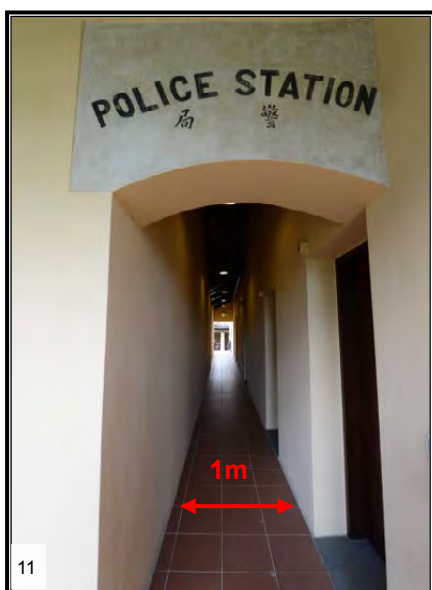
The existing corridor adjacent to the 3 guestrooms in the Main Building, being a required exit route, is only 1m wide and cannot meet the current requirements<sup>2</sup>.

Existing corridor adjacent to the guestrooms

Noting that the total occupant capacity of the guestrooms is only 6 persons, a secondary escape route for the guestrooms is available, the subject building is only 1 storey high, the importance to keep the original design and that the corridor is one of the Character-Defining Elements (CDE), the slight deficiency in the width of this corridor is accepted as not compromising fire safety standards.

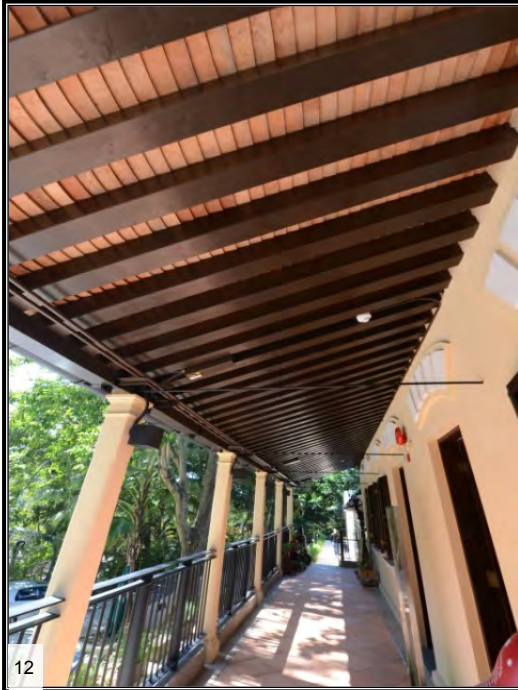
The purlins and battens of the reconstructed timber roof are protected with fire retardant paint to achieve the required Class 1 surface spread of flame tested in accordance with the requirements of BS 476 Part 7, and covered with non-combustible clay tiles.

Existing timber purlins and battens are protected with fire retardant paint

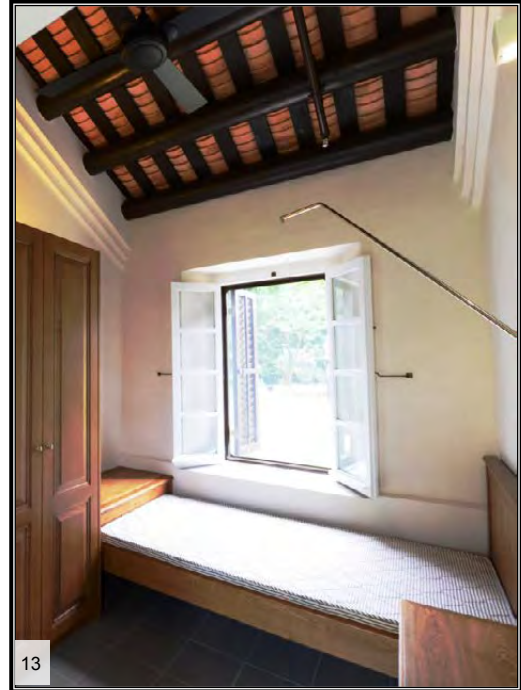
Reconstructed timber purlins and battens are protected with fire retardant paint

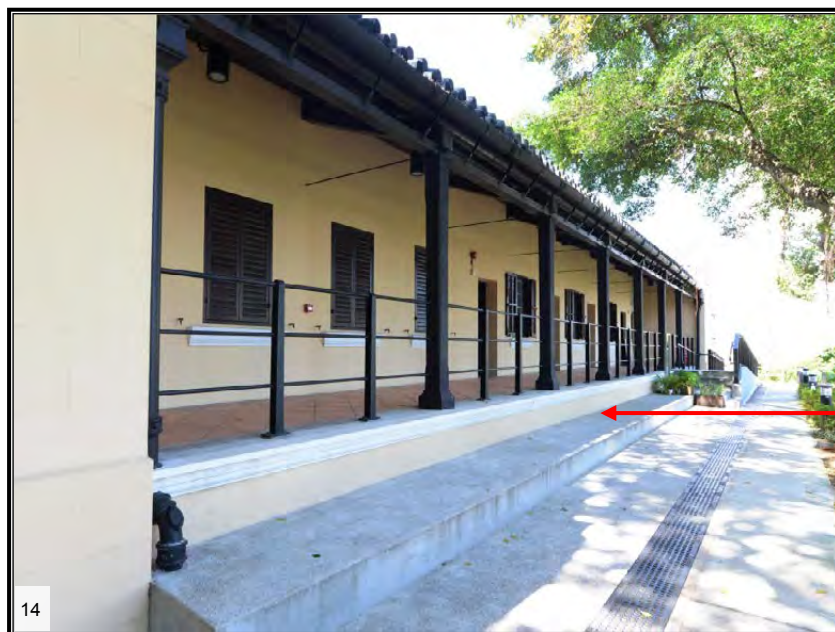
An intermediate platform is added to mitigate the level drop at the same time offering outdoor bench seating.

Intermediate platform added to mitigate level difference

A level difference of over 600mm is found between the verandahs of the Main Building and the adjoining passageway. However, the design of the original balustrade cannot meet the current requirements for protection against falling<sup>5</sup>.

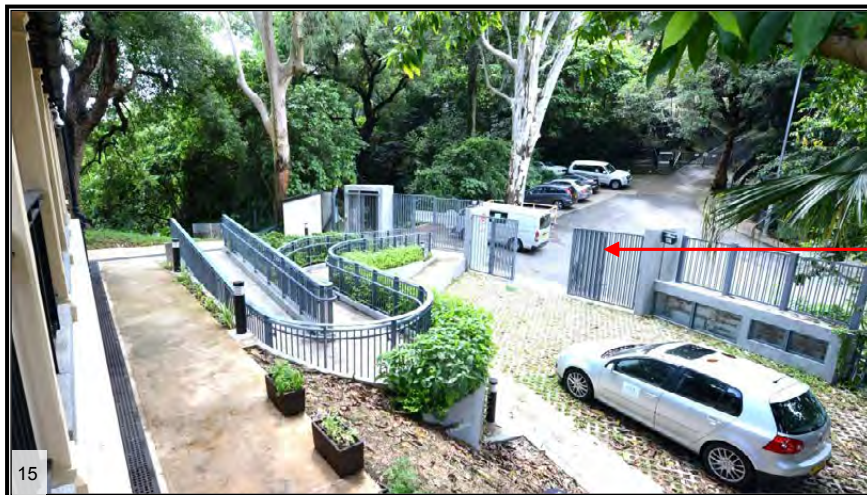
The compound is on elevated platforms about 2m higher than the adjoining street. In order to provide barrier free access, new ramps are added for connecting different platforms.

Barrier free access from the main gate

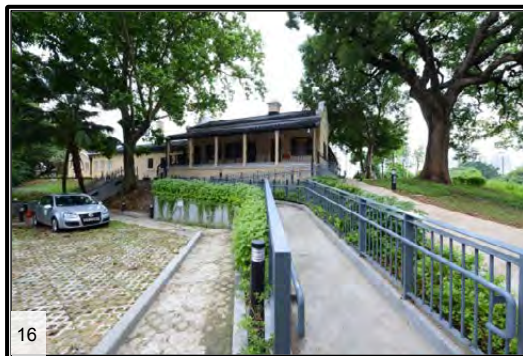
Initial access ramp to the compound

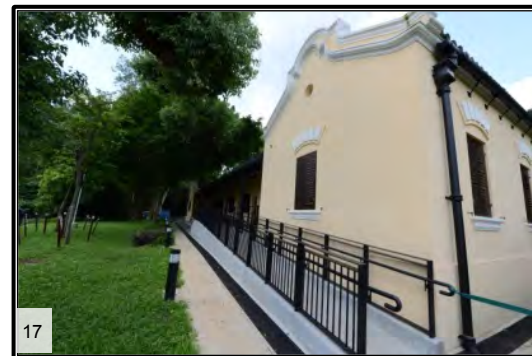
Ramp to the Main Building

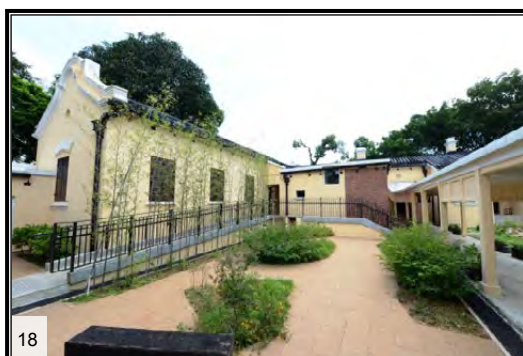
Ramp connecting the Main Building and courtyard

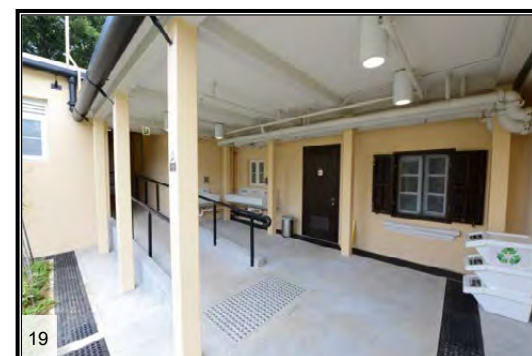
Ramp connecting the Main Building and guestrooms

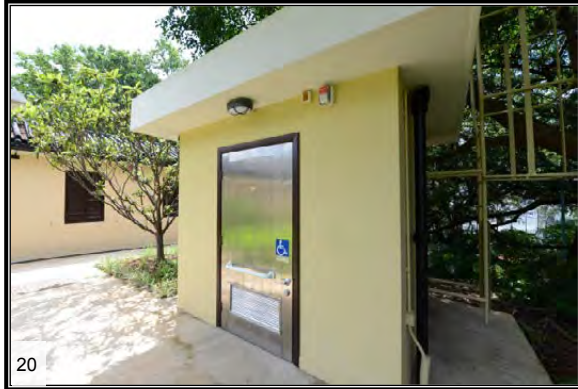
An existing store is converted into an accessible toilet.

New accessible toilet

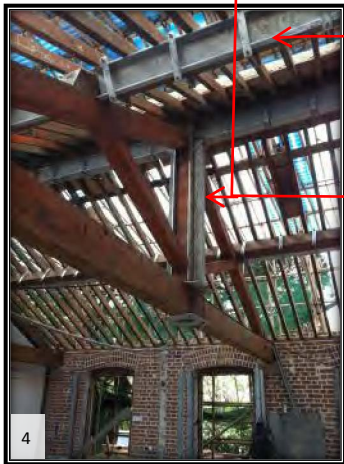
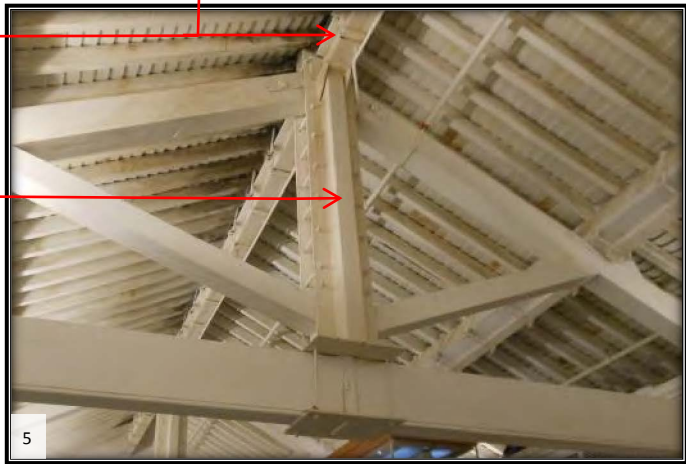
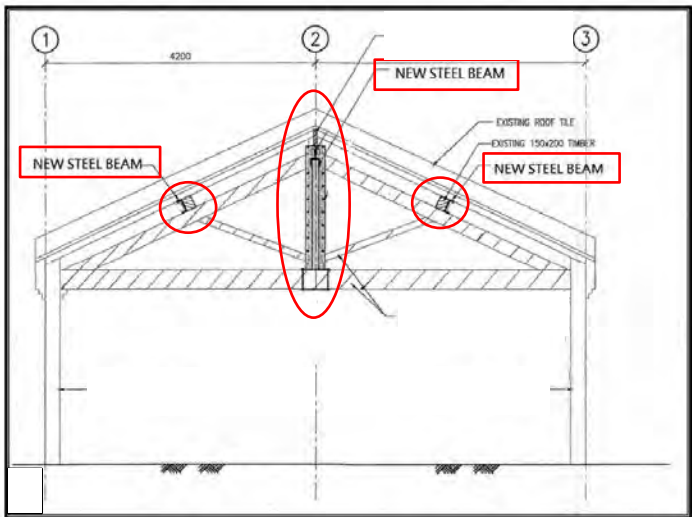
“Sandwich” strengthening by through bolts

New steel beam

Photo and section showing strengthening to the structural elements and connection joints of roofs of buildings in the Low Zone (Source: P&T Architects and Engineers Ltd.)

Location	Pitched Roofs		1/F Floor slabs	
	Original	Additional	Original	Additional
Low Zone (1-storey)	Timber trusses and purlins	<b>Repair and Enhancement Works</b> Localised strengthening by adding steel beams and plates to existing timber structural members	N/A	N/A
Middle Zone (2-storey)	Timber / steel truss and purlins	<b>Repair and Enhancement Works</b> Adding horizontal steel bracings to existing trusses	Reinforced concrete slabs	<b>A&amp;A Works</b> Existing deteriorated timber joists are replaced by new steel beams
High Zone (2-storey)	Steel trusses and purlins	<b>A&amp;A Works</b> Existing steel roof sheets and purlins are replaced by new steel corrugated sheets and steel purlins	Reinforced concrete slabs	<b>Repair and Enhancement Works</b> Adding steel beams to existing floor slabs

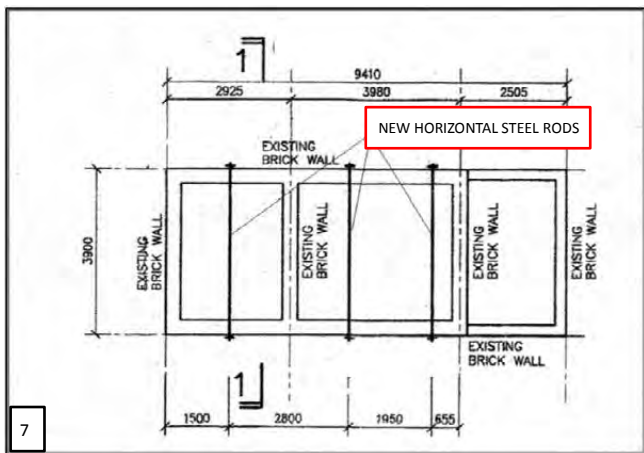
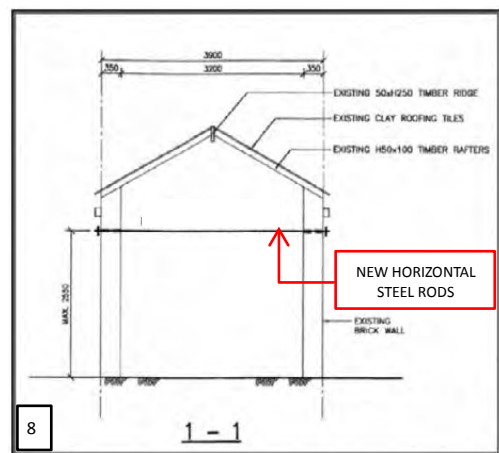
Plan and section showing strengthening works by horizontal steel rods in buildings at the Low Zone

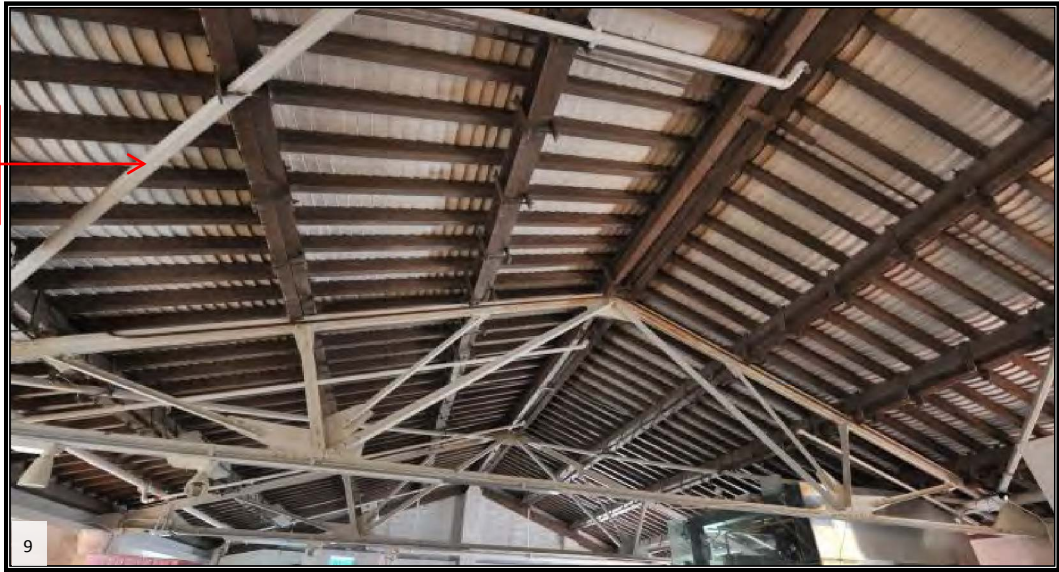
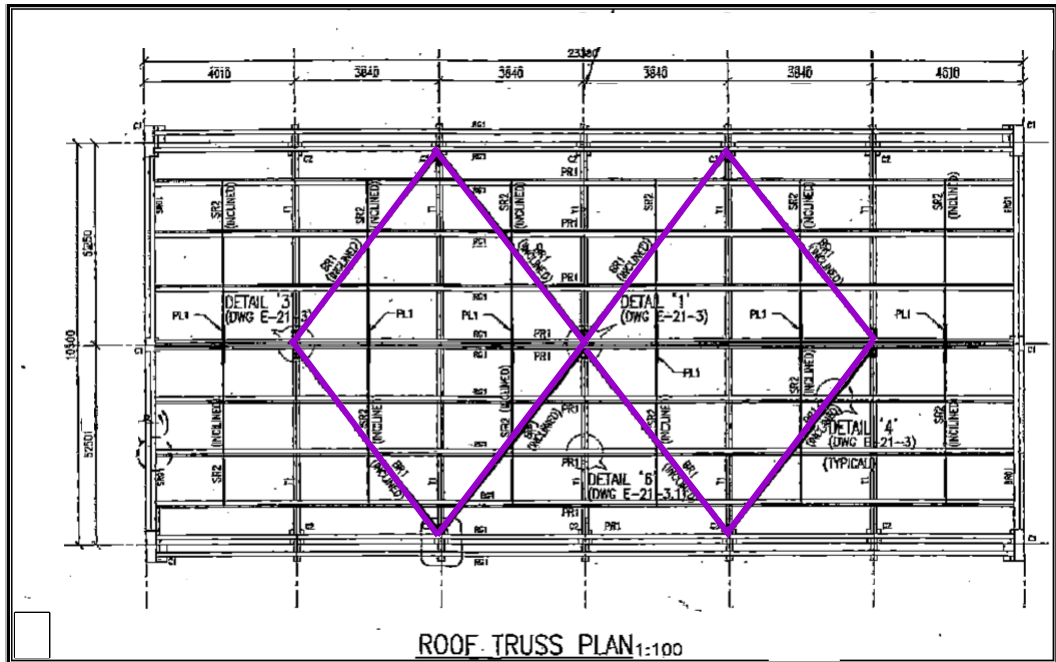
Additional steel bracing

— Diagrammatic indication of additional steel bracings

Additional steel bracings for roofs of existing buildings in the Middle Zone

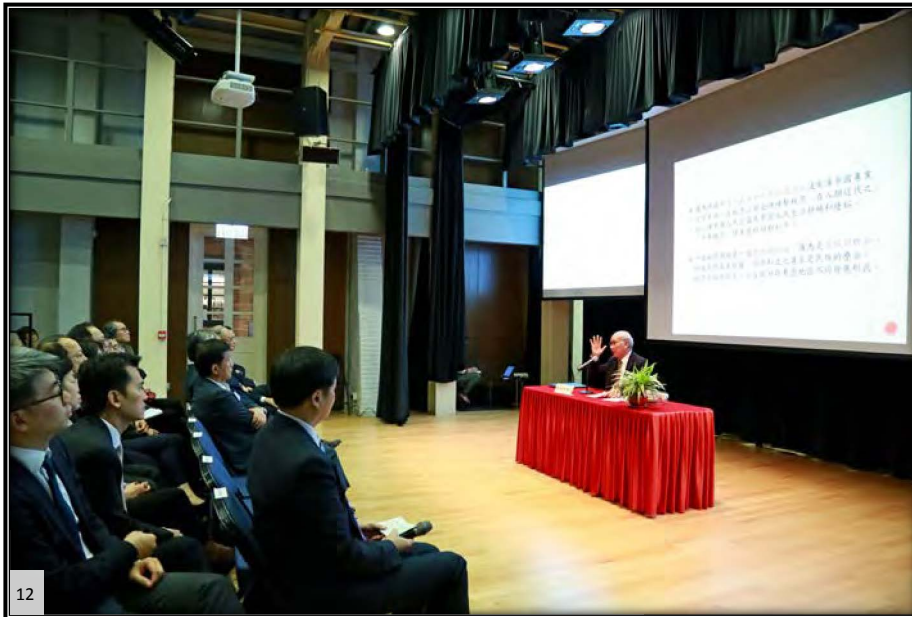
To strike a balance between maintaining architectural authenticity of the buildings and creating spacious environment for functional needs, headroom of one of the buildings in the Middle Zone is doubled by removing the first floor slab and the associated columns.

First floor slab removed to form a multi-function room with high headroom  
(Source: P&T Architects and Engineers Ltd.)

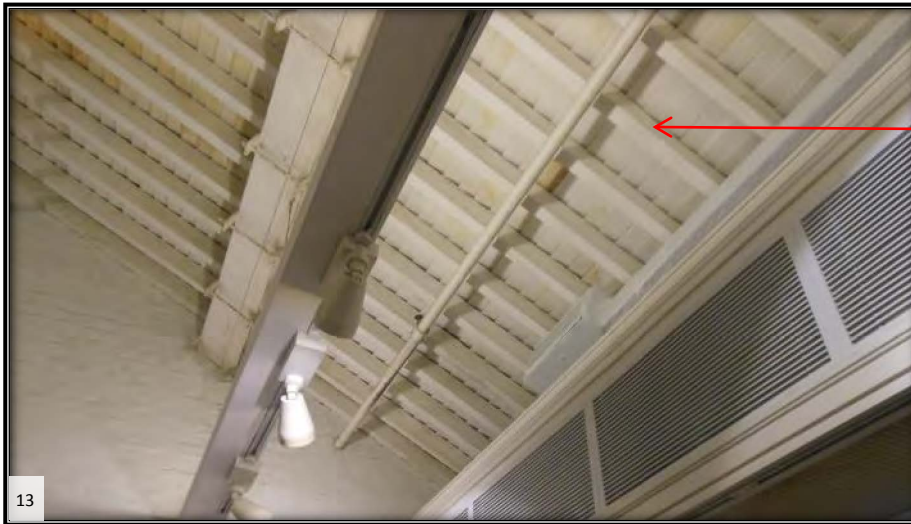
Timber pitched roof protected with fire retardant paint

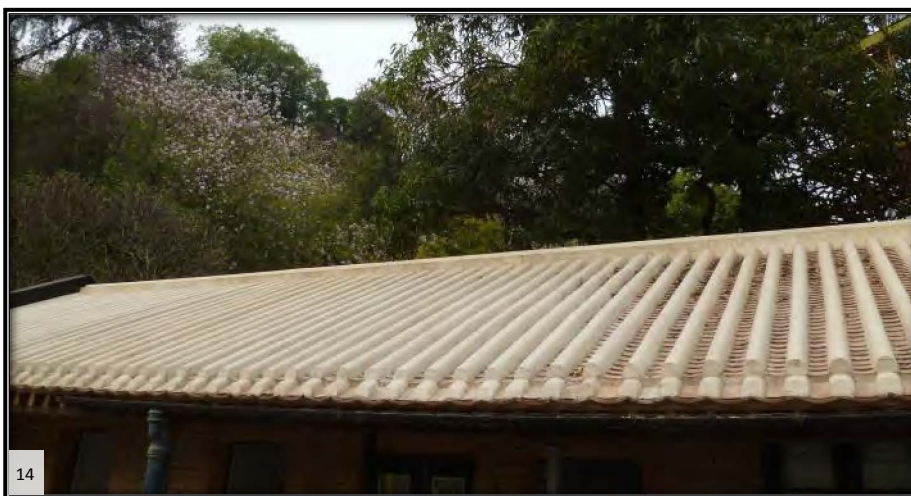
Timber pitched roof covered with non-combustible clay tiles

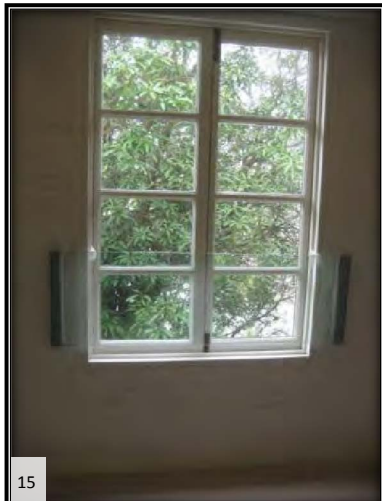
Fixed glazing panels are added to serve the function of protective barriers.

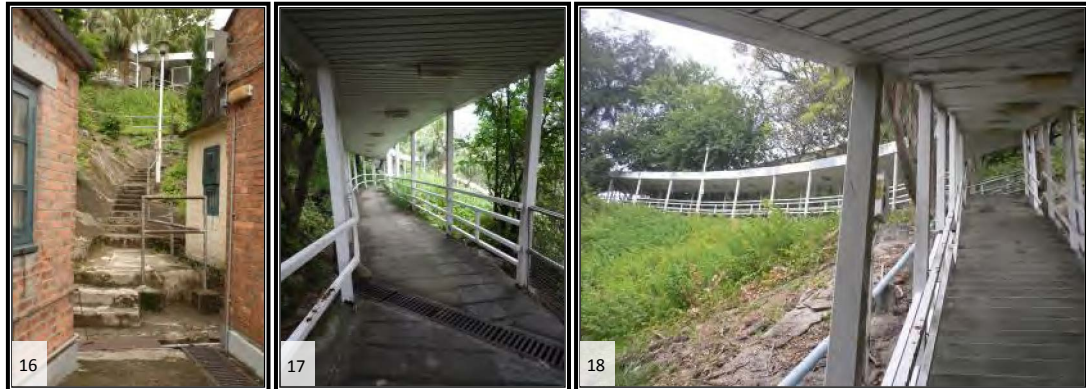
Photos taken before revitalization

(Left) The Low and Middle Zones are linked by flight of steps

The level difference from the Low to Middle and from the Middle to High Zones is about 9m and 23m respectively. The Middle Zone is accessible from the Low Zone by accessible ramps, a lift and a link bridge, but there is no barrier free access provided between the High Zone to the other Zones.

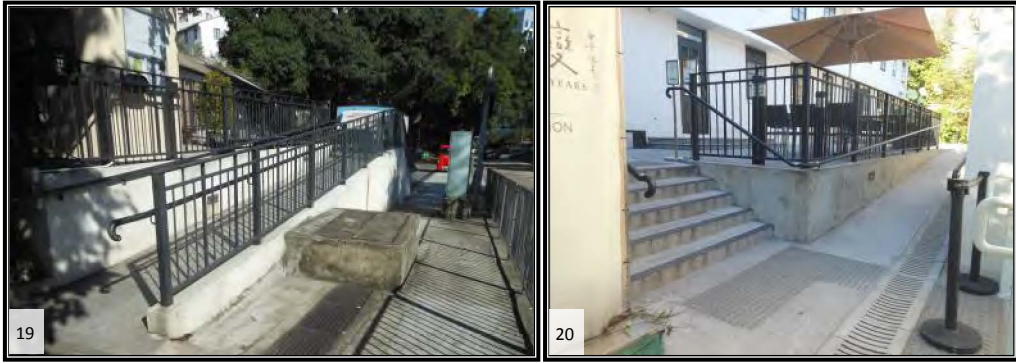
New Accessible ramps at the entrance and other locations within the site

The connection between the Low and Middle Zones is enhanced by a new accessible route comprising lifts and link bridges. New lifts, lifting platforms and ramps are also added in various locations over the vast compound to enhance accessibility.

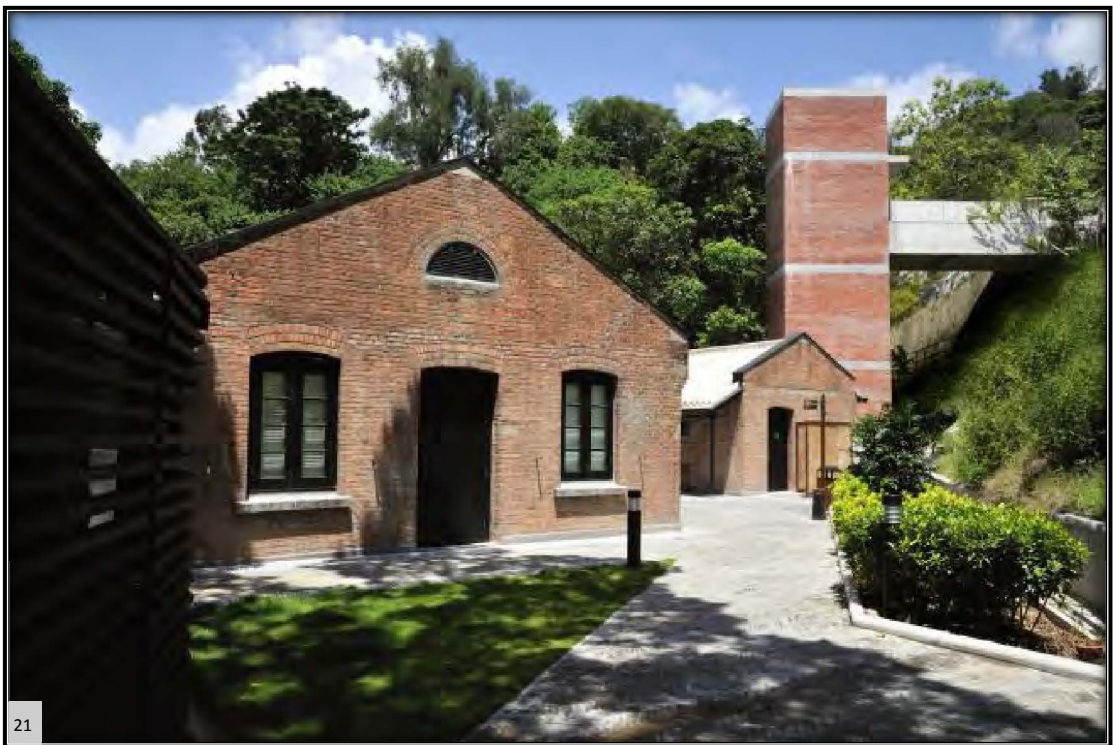
New accessible lift and link bridge connecting the Low and Middle Zones  
(Source: P&T Architects and Engineers Ltd.)

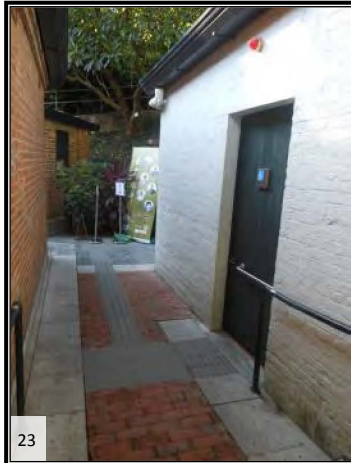
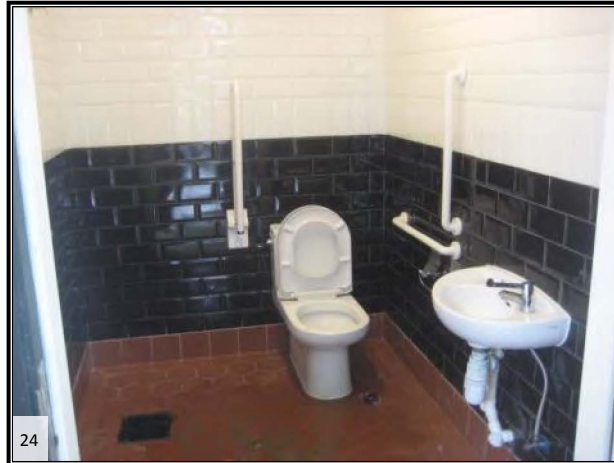
Accessible toilets, tactile guide paths, tactile warning strips, etc are provided. At least two out of the eighty-nine nos. of hostel rooms are designed as accessible rooms.

Other barrier free facilities, such as tactile guide path and accessible toilet

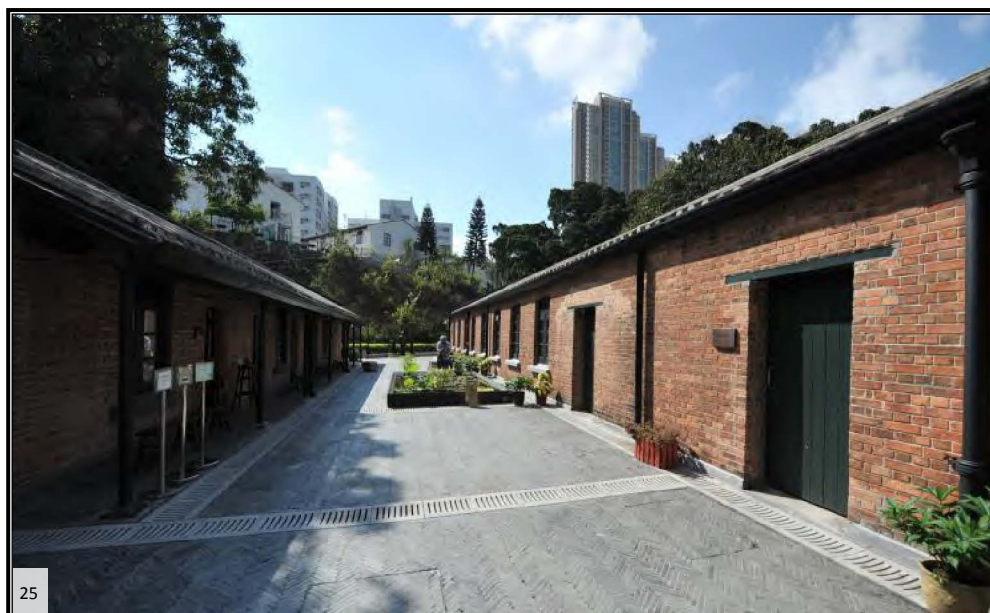
Level difference between the external and the internal areas of exhibition halls, multi-function rooms and cafeteria are eliminated. New surface water channels are provided at the courtyards to prevent influx of surface water to the buildings.

New surface water channels added at the courtyard

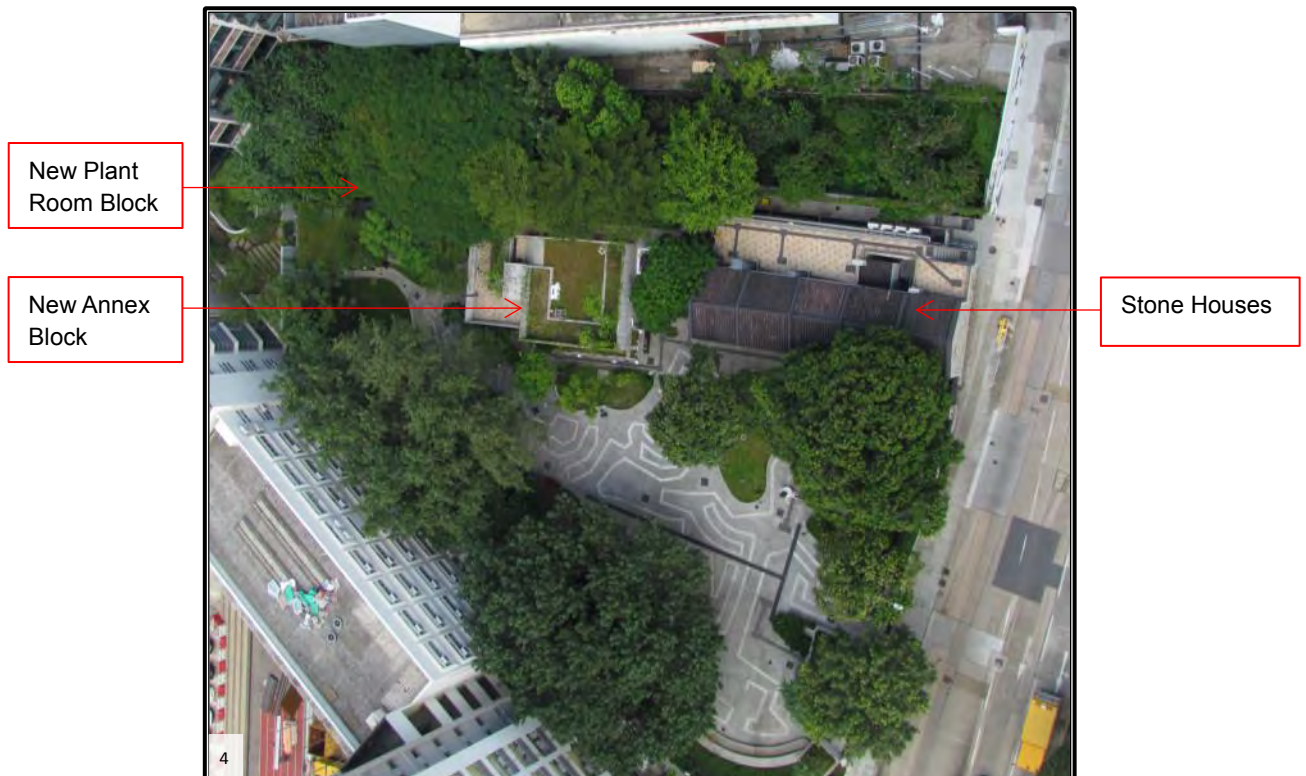
Stone Houses, New Annex Block and Plant Room

Two new single-storey blocks for use as a multi-function room and plant rooms were built to share the extensive area of the courtyard with the existing buildings.

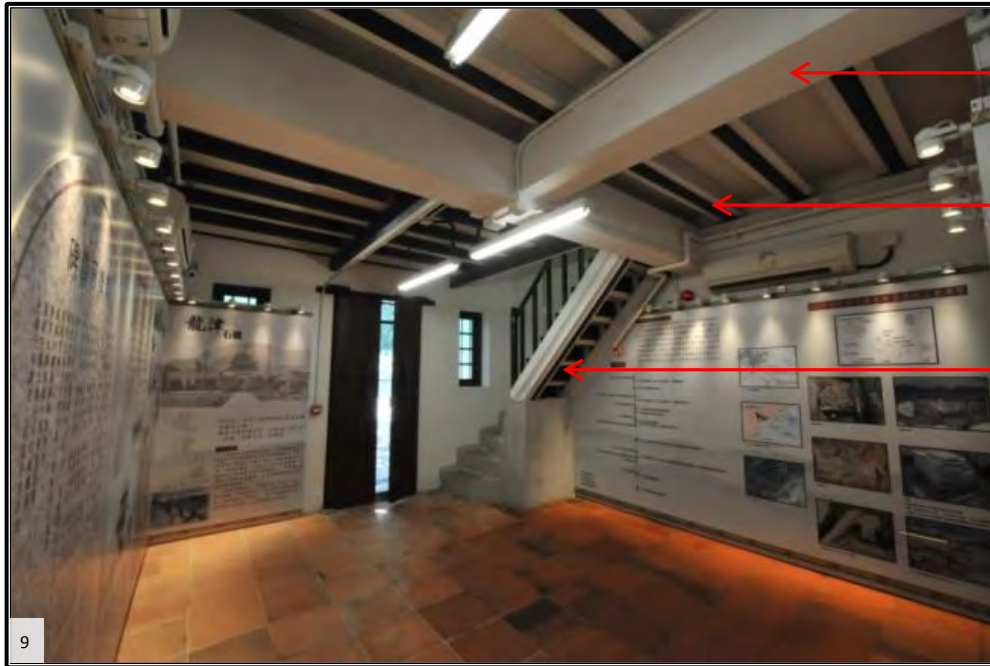
Existing RC beams supporting timber floor & staircase

New steel beams at the sides of existing timber joist

The timber floors and staircases of the remaining four units are replaced with new steel decks, beams, frames and columns supported by new reinforced concrete raft footings. Some original timber planks and floor tiles are salvaged and relayed on the new structures as floor finishes.

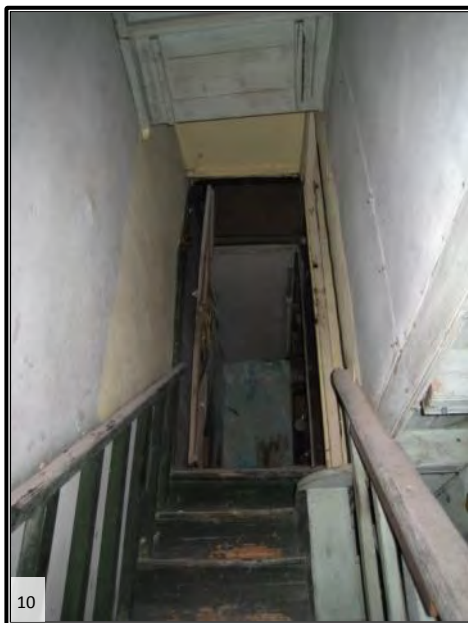
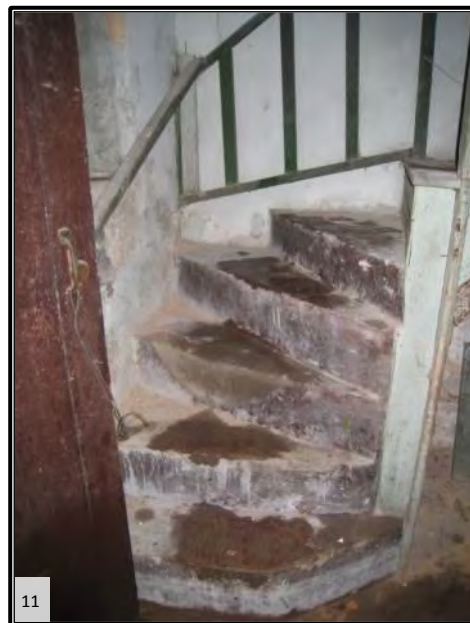
Existing timber staircase with solid winders at the bottom before revitalisation

The existing timber stairs connecting G/F and 1/F are 725mm wide, with risers 200mm high, treads 200mm deep and solid winders at the bottom and no enclosure walls. Their construction and fire resistance rating (FRR) are inadequate in meeting the current fire safety requirements<sup>2</sup>.

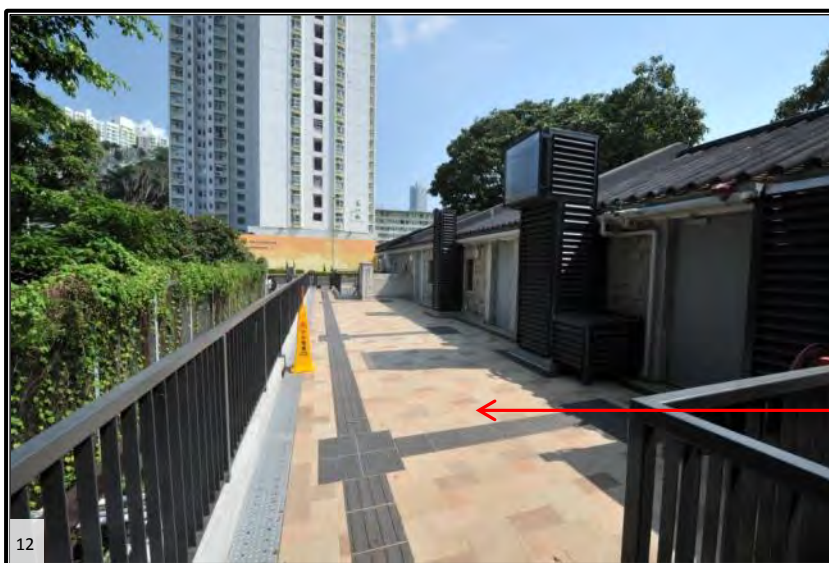
New metal deck

New metal deck at the rear

Two new code-compliant open staircases connecting the 1/F of the 5 houses via a structurally independent deck are constructed at the back to serve as the MOE, without intervening the main facade which carries higher heritage value. The new metal deck with new footings is structurally separated from the existing masonry structures. No additional loading from the new metal deck is transferred to the existing masonry walls. The original internal timber staircases are repaired and retained for circulation only.

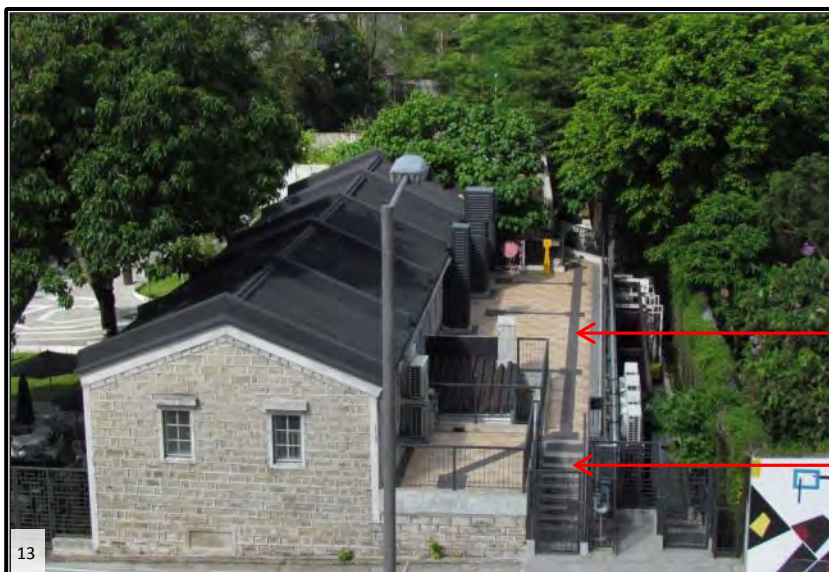
New metal deck

One of the new open staircases serving 1/F of Stone Houses

New metal deck connecting to open staircases

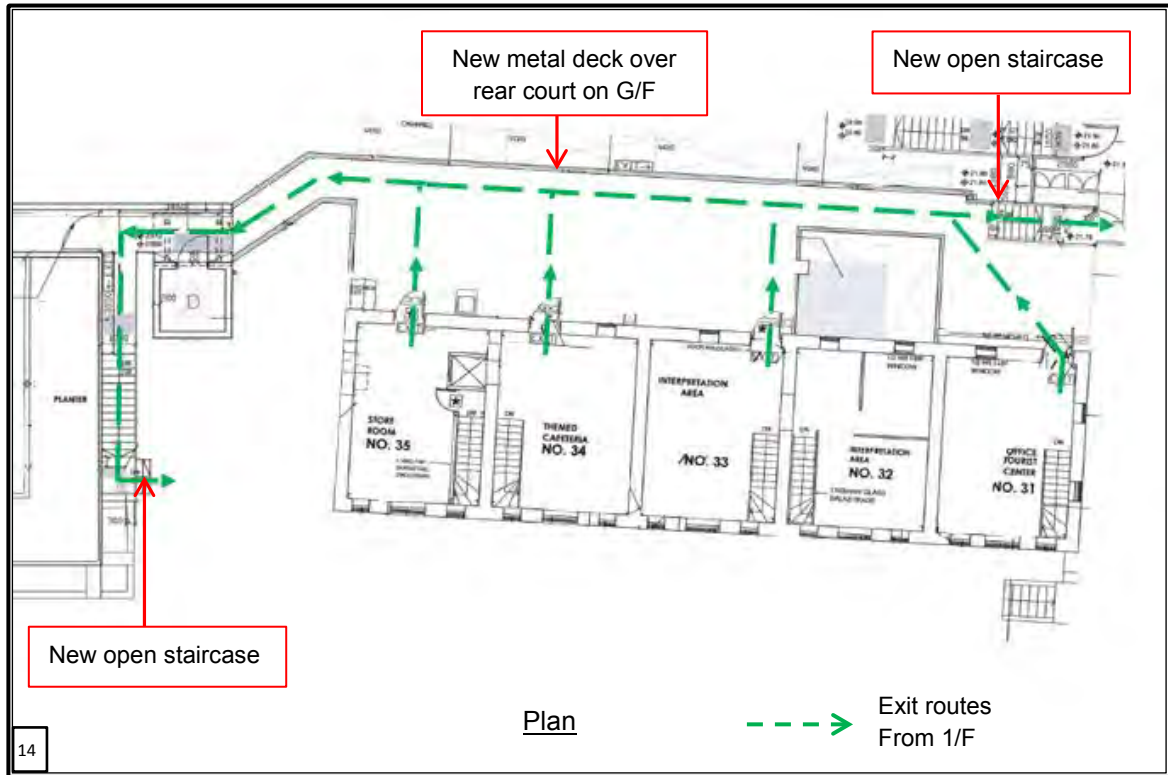
MOE Routing on 1/F

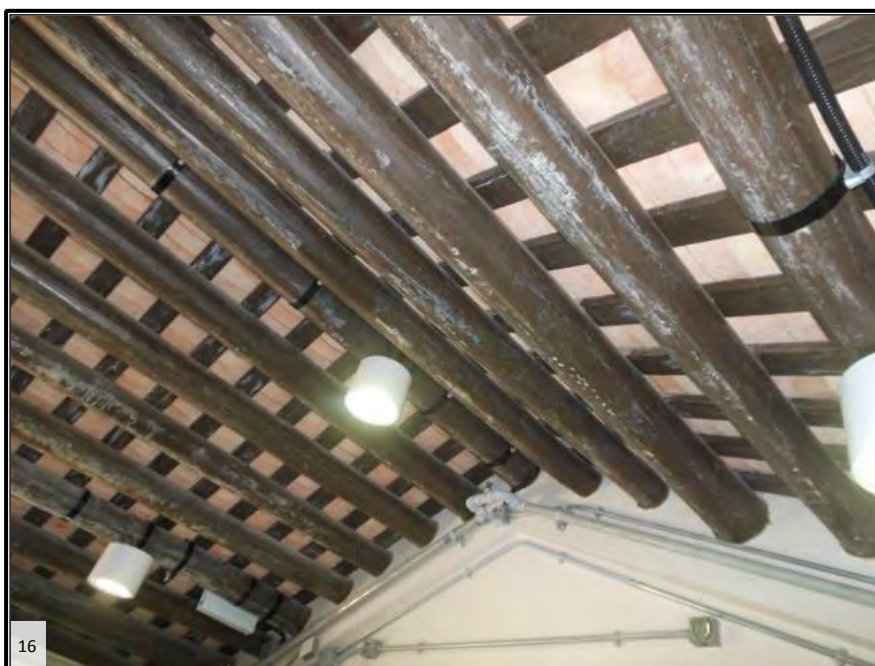
Existing timber pitch roof are retained for appreciation but timber elements are painted with fire retardant paint

All timber elements of the roof are repaired and protected with fire retardant paint to meet the Class 1 standard on surface spread of flame tested in accordance with the requirements of BS 476 Part 7, and then covered with the original non-combustible clay tiles.

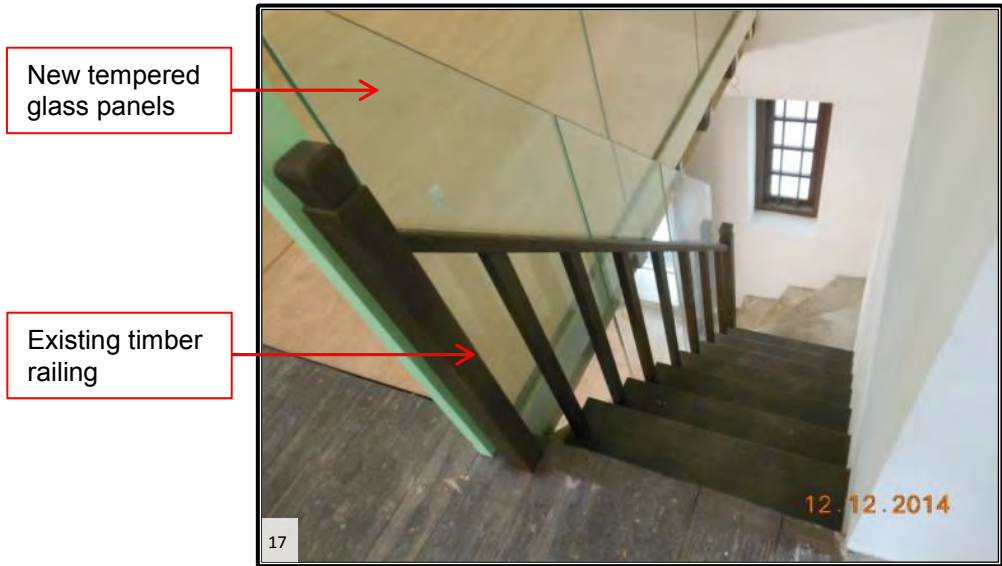
New tempered glass panels

Existing timber railing

<sup>4</sup> Protective barriers shall be at a height above the higher of the adjacent levels of not less than 1100mm; and constructed as to prohibit the passage of articles more than 100mm in their smallest dimension in accordance with B(C)R 8.

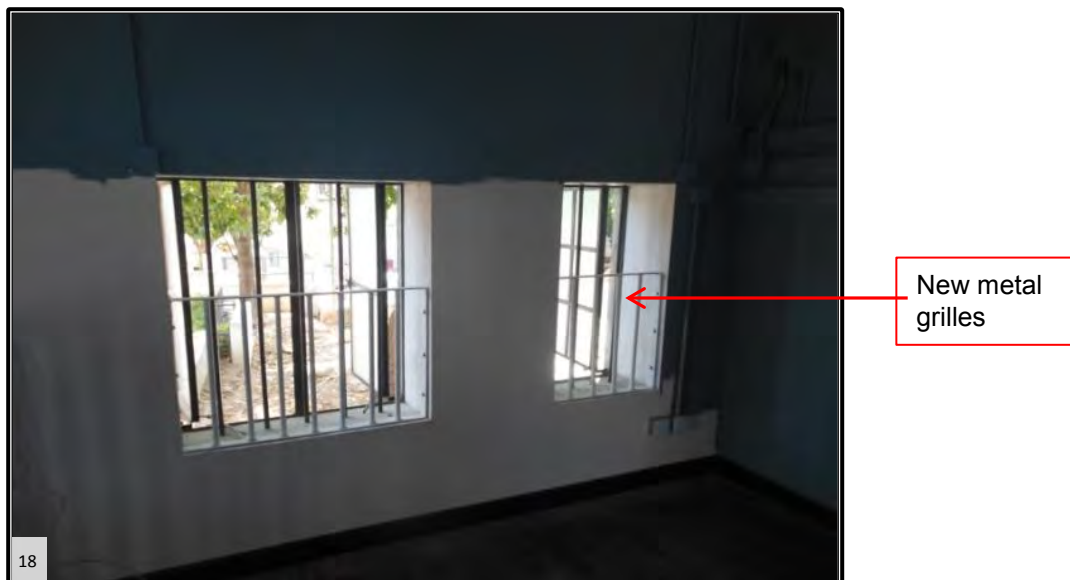
New metal grilles added at the existing window openings

To avoid making irreversible changes to the components of the original timber framed windows which are CDE, the protection against the danger of falling is achieved by adding new metal grilles on the walls behind the windows.

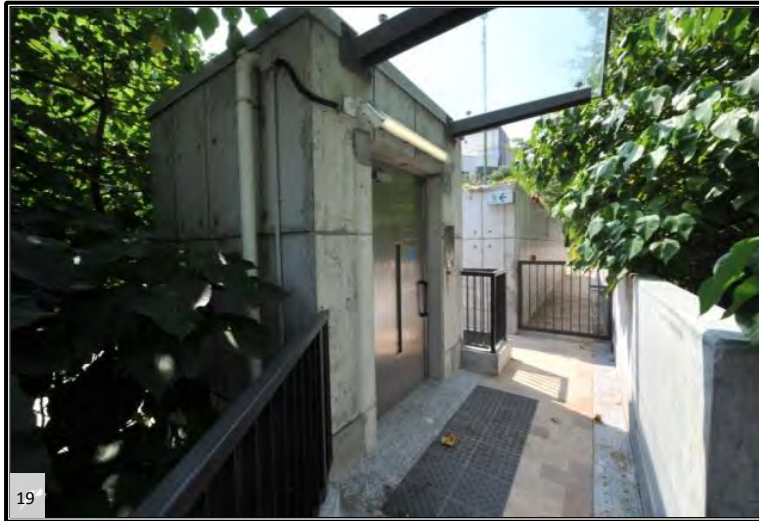
19

A new vertical lifting platform is installed between SH and the New Annex Block to provide access to 1/F of SH through the new metal deck at the back.

New lifting platform, 1/F

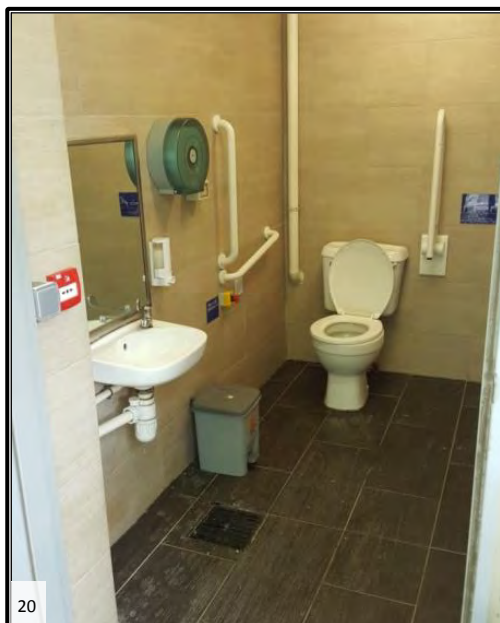
20

An accessible toilet and other ancillary facilities are provided in the New Annex Block next to SH.

New accessible toilet, New Annex Block

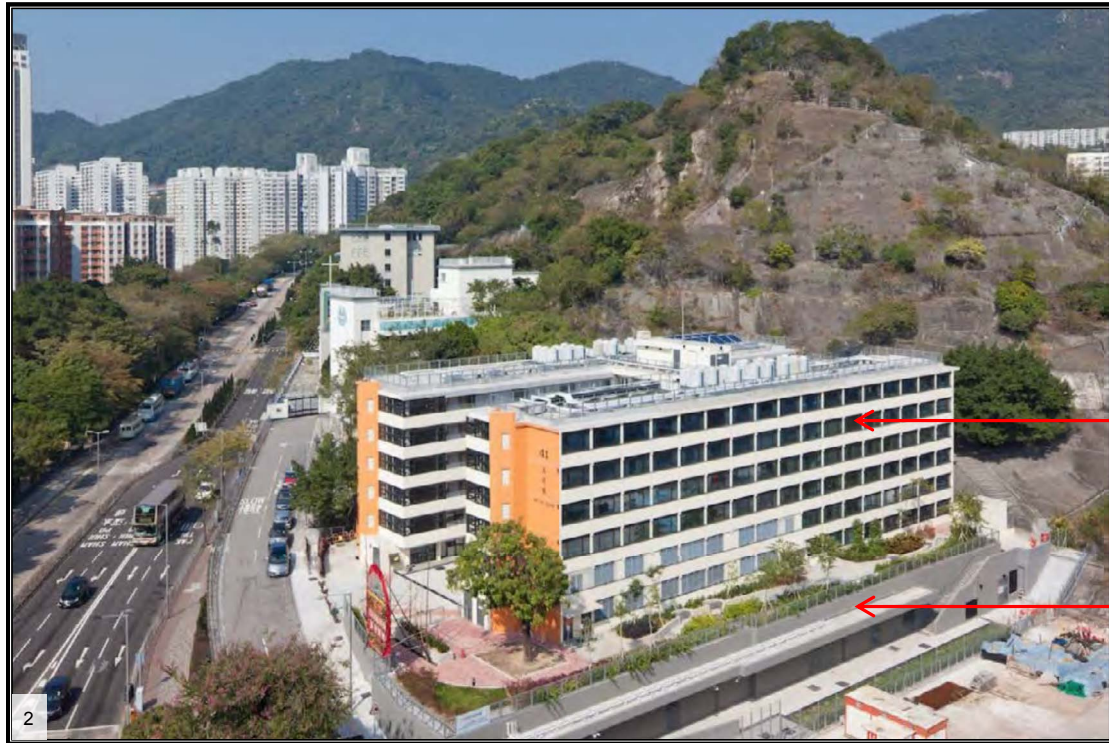
New 1-storey plant room on LG/F

Revitalised Mei Ho House over new plant rooms on LG/F (Source: AD+RG)
