# Practice Guidebook for Adaptive Re-use of and Alteration and Addition Works to Heritage Buildings 2012

**Practice Guidebook**  
**on**  
**Compliance with**  
**Building Safety and Health Requirements**  
**under the Buildings Ordinance for**  
**Adaptive Re-use of and**  
**Alteration and Addition Works to**  
**Heritage Buildings**

**Buildings Department**  
**Hong Kong**

**(2021 Edition)**

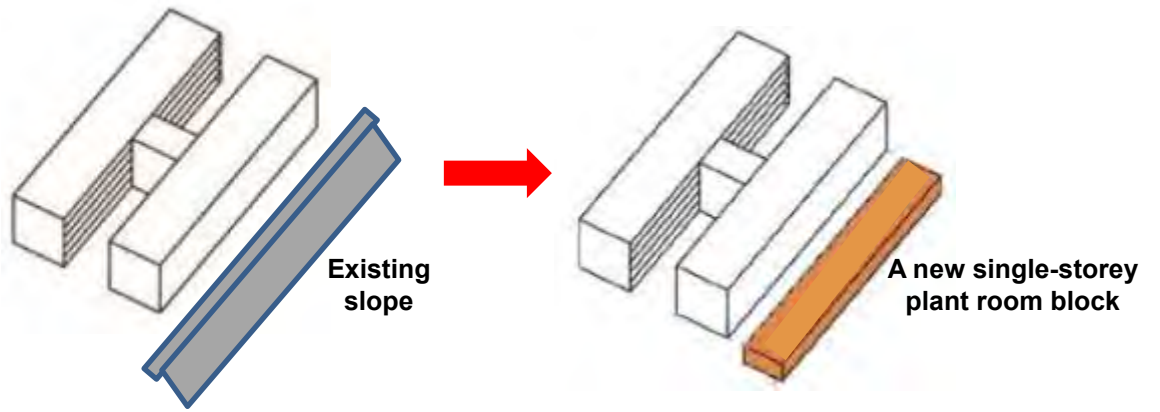
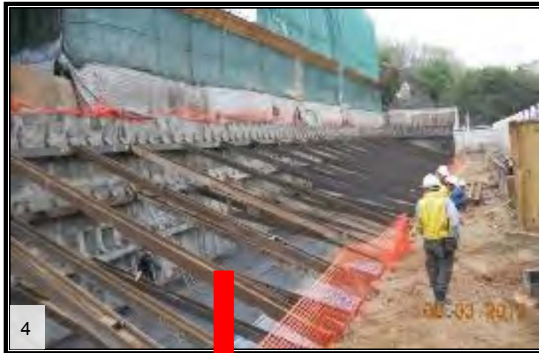
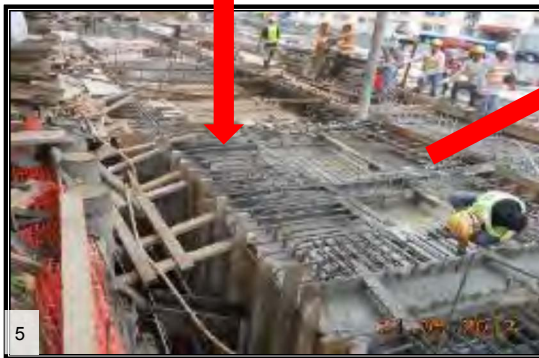
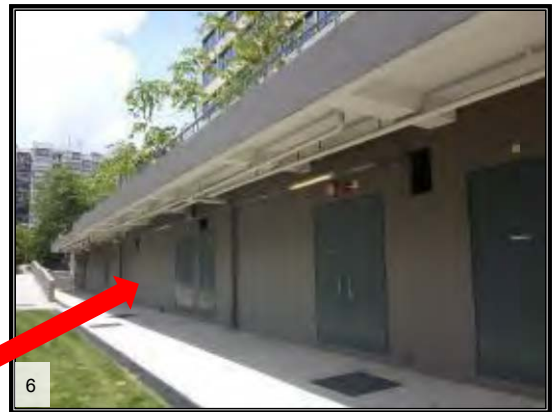
Removal of the existing slope to make room for new plant rooms  
 (Source: Hong Kong Youth Hostels Association)

A new single-storey block replacing the slope at the bottom of MHH, viz the Lower Ground Floor (LG/F), is created for housing fire service/ fire sprinkler water tanks and mechanical plant rooms. Roof of the single-storey block (i.e. G/F) is finished as a landscaped area.

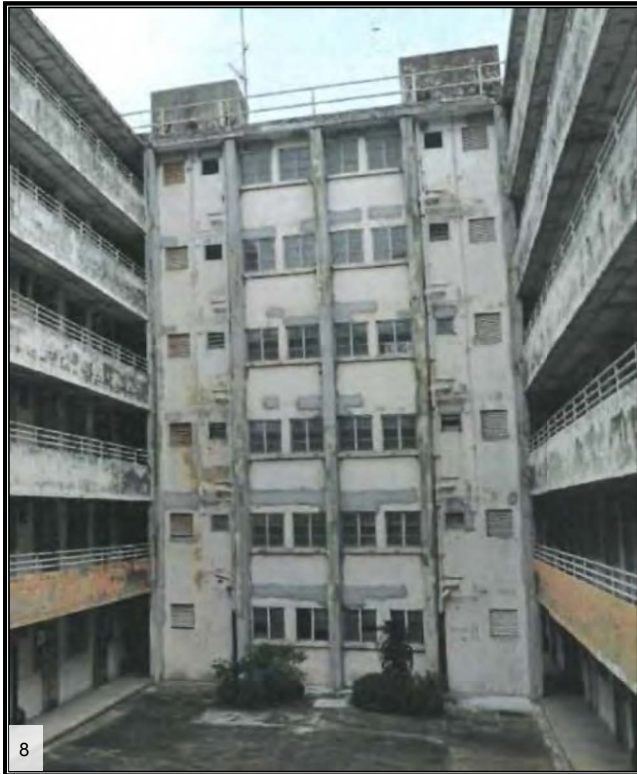
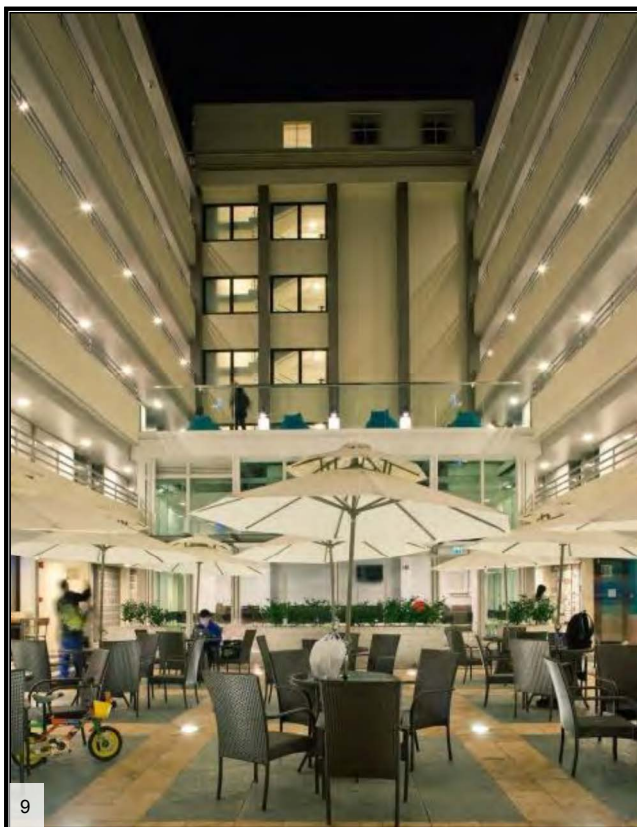
The central block before and after the revitalisation  
(Source: Hong Kong Youth Hostels Association UNESCO Report (Top); AD+RG (Bottom))

In addition, the central block is rebuilt with new lifts and required staircases to meet the latest statutory requirements.

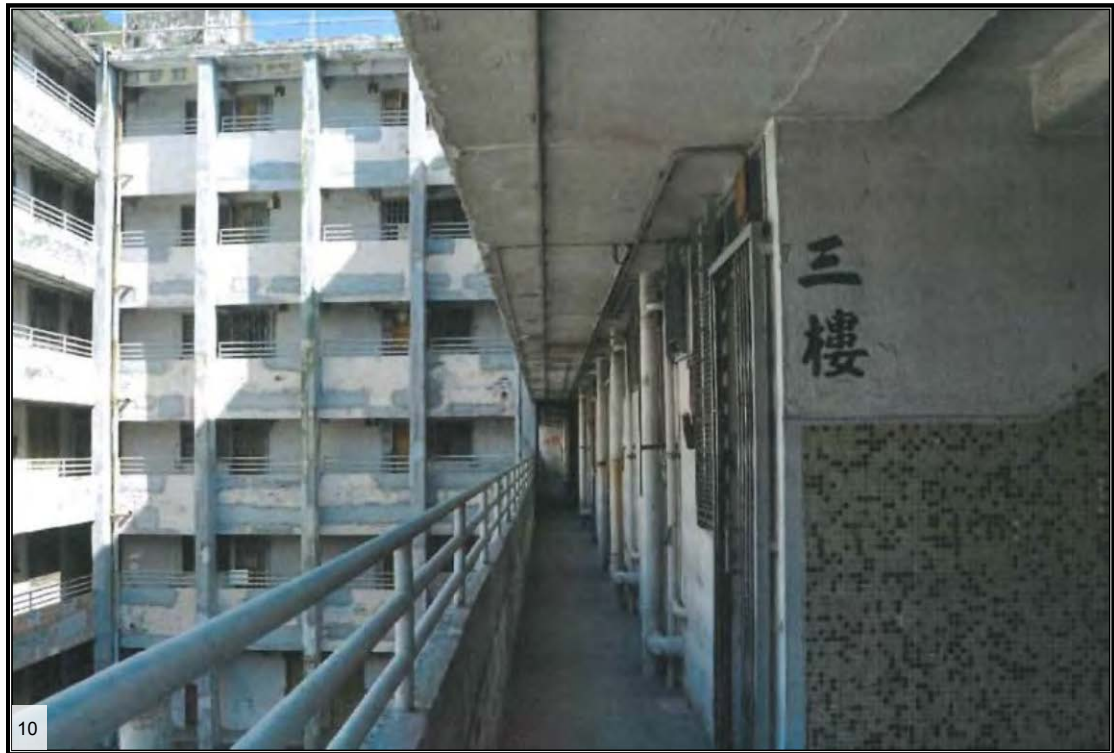
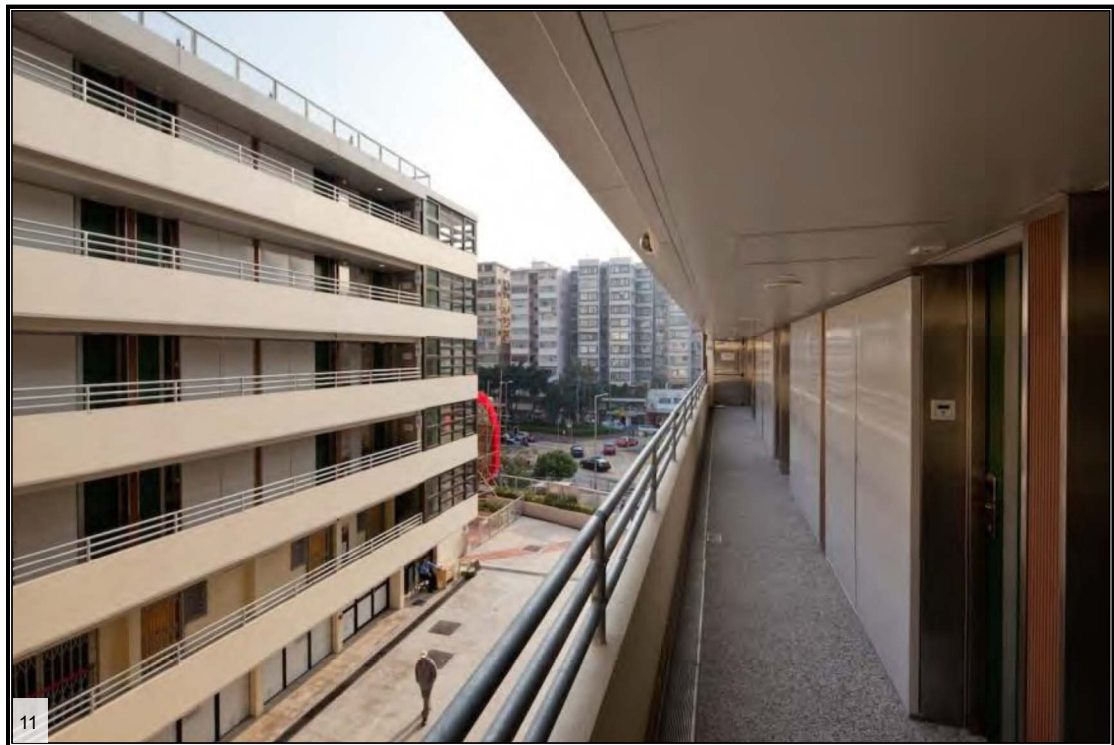
The corridor before and after the revitalisation  
(Source: Hong Kong Youth Hostels Association UNESCO Report (Top); AD+RG (Bottom))

The existing corridors facing the courtyards were cantilevered slab structures. They were in poor condition and their structural capacity was inadequate to meet the loading requirements for the adaptive re-use. Moreover, sufficient spaces along the corridors were also required to accommodate the building services for the hostel.

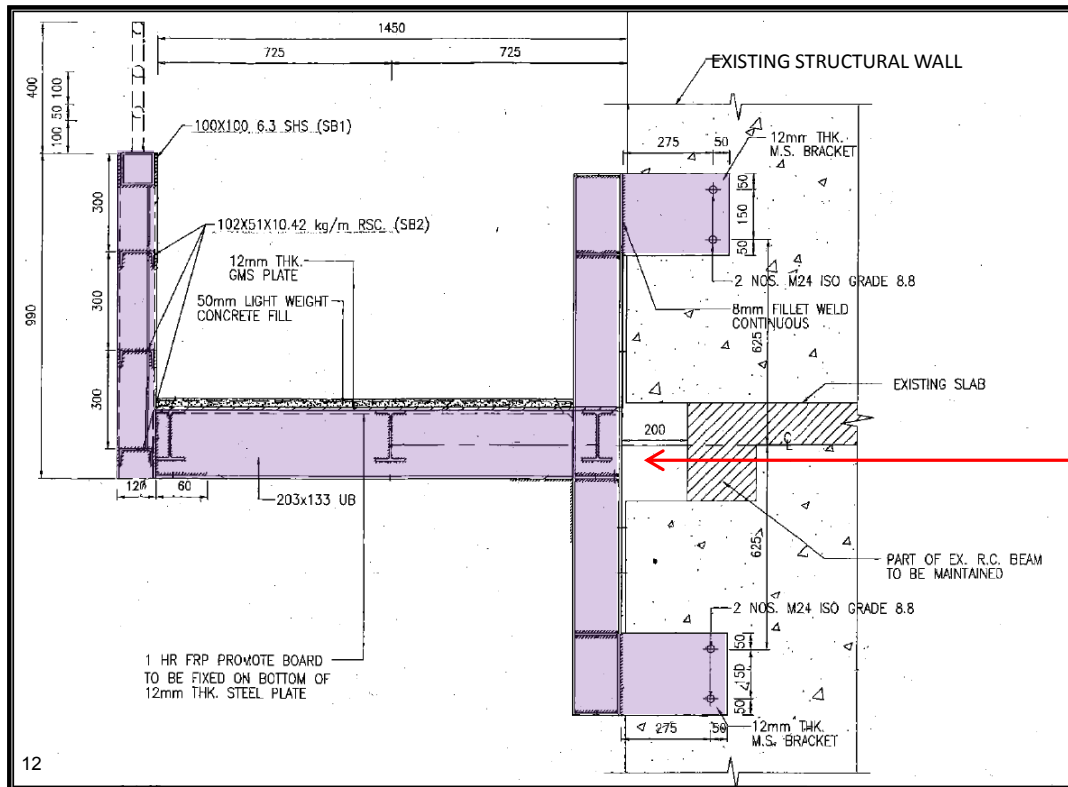
Section showing the new structural steel deck (in purple) fixed to the structural wall

In view of the drawback of the abovementioned traditional strengthening methods, the existing corridor slabs on each floor are demolished and replaced with structural steel decks with supporting beams cantilevered from the end of the existing structural walls of the building. After the revitalisation, a 1100mm wide corridor is provided as MOE for both wings. The adoption of relatively light-weight steel for the reconstruction of the corridors also has relieved the loading capacity limited by the existing structural walls. Such alteration works also have facilitated partial removal of the existing concrete floor beams so that a 200mm gap is left between the newly constructed corridors and the remaining floor beams for installation of building services. With this design, staff can access the building services from the corridors for maintenance purpose without the need of entering the hostel rooms.

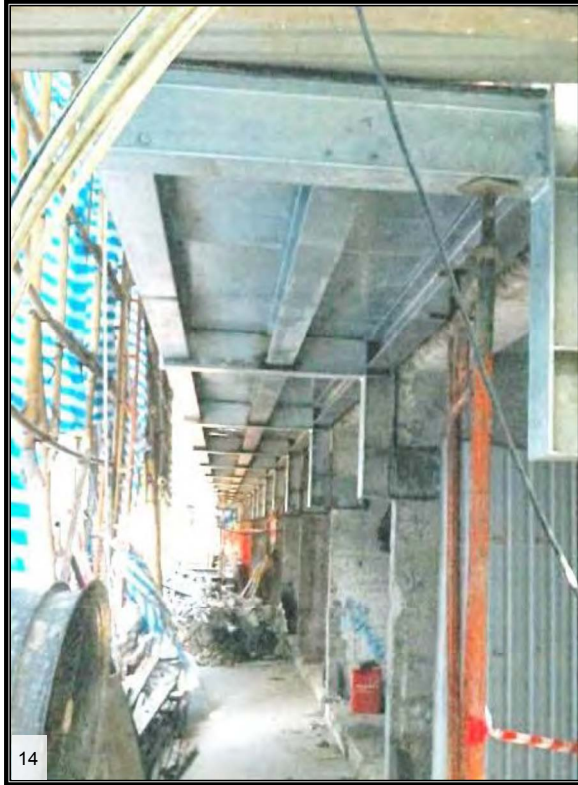
Corridor slabs were demolished and replaced by new structural steel decks  
(Source: Hong Kong Youth Hostels Association UNESCO Report)

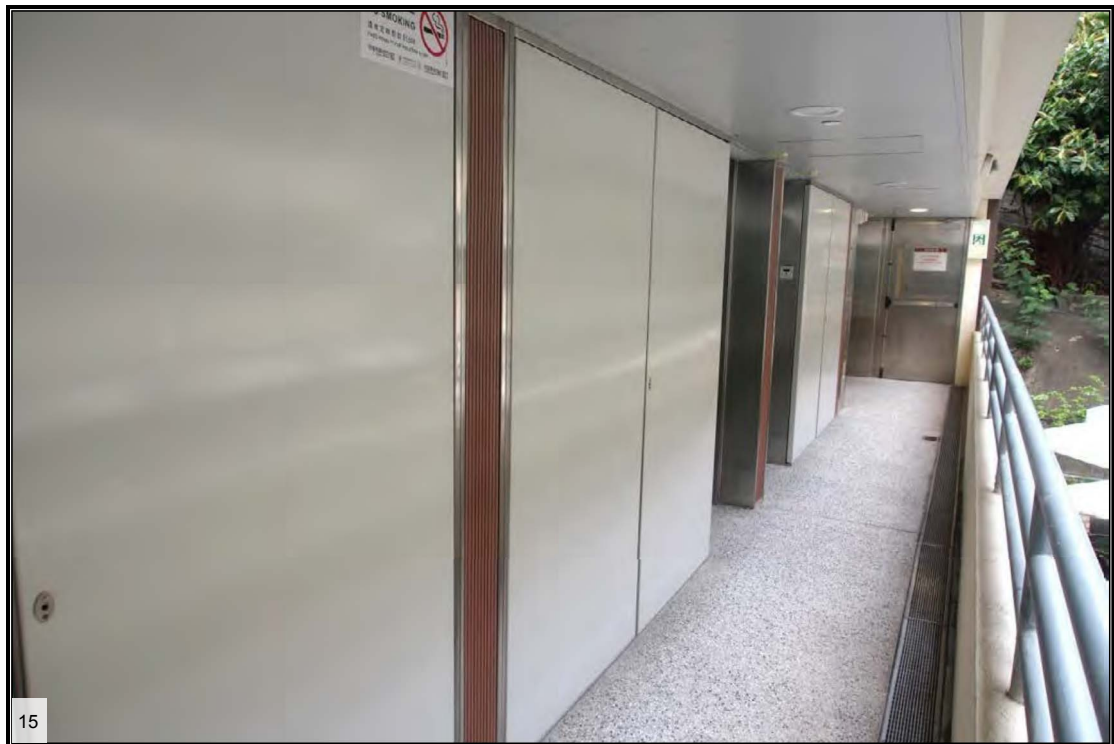
Access panels of pipe ducts facing the corridor

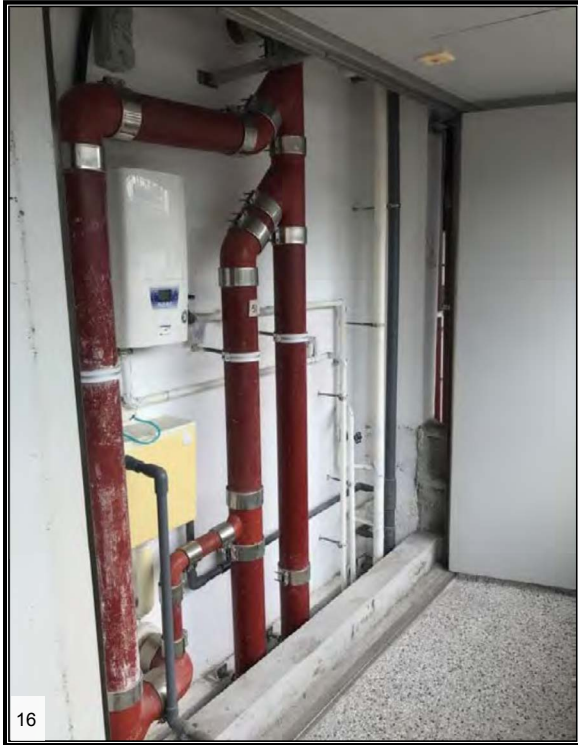
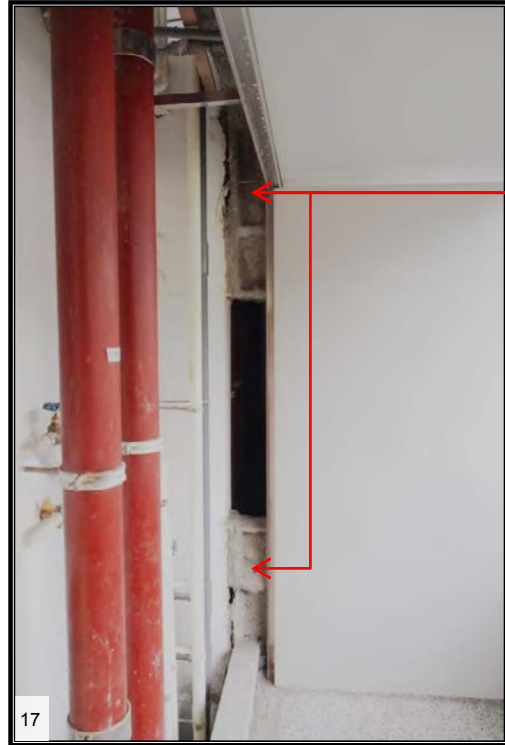
Vertical members of new steel deck

Access panels of pipe ducts facing the corridor

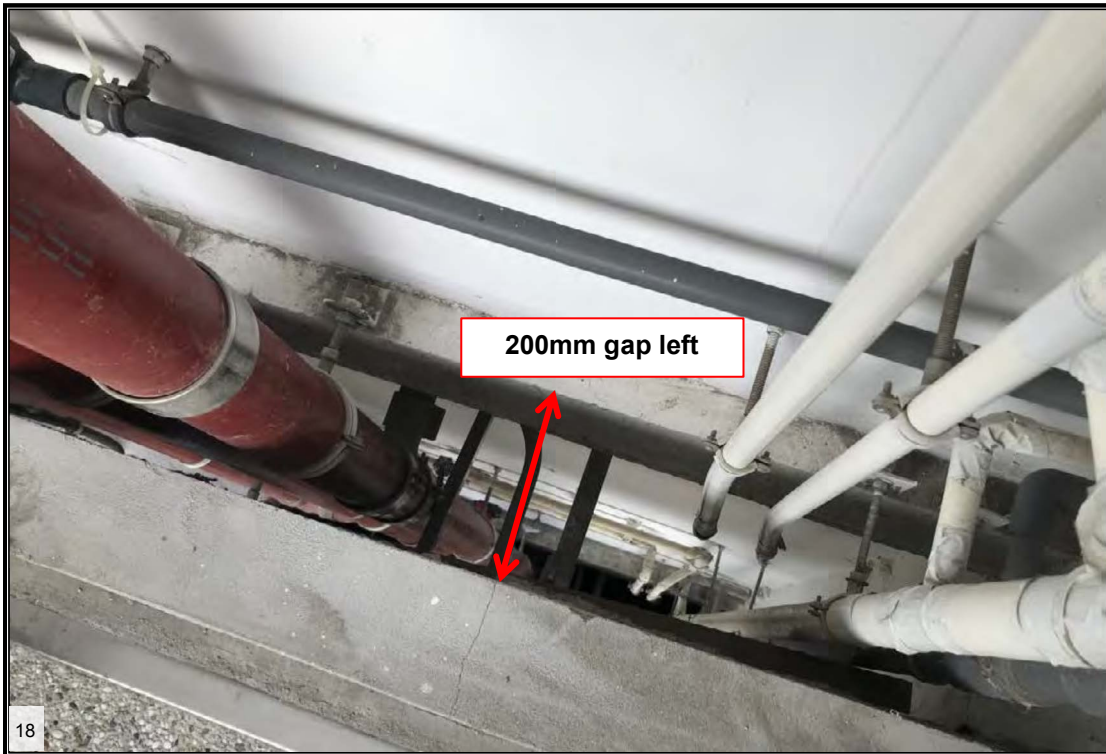
200mm gap was left after partial removal of the existing floor beams

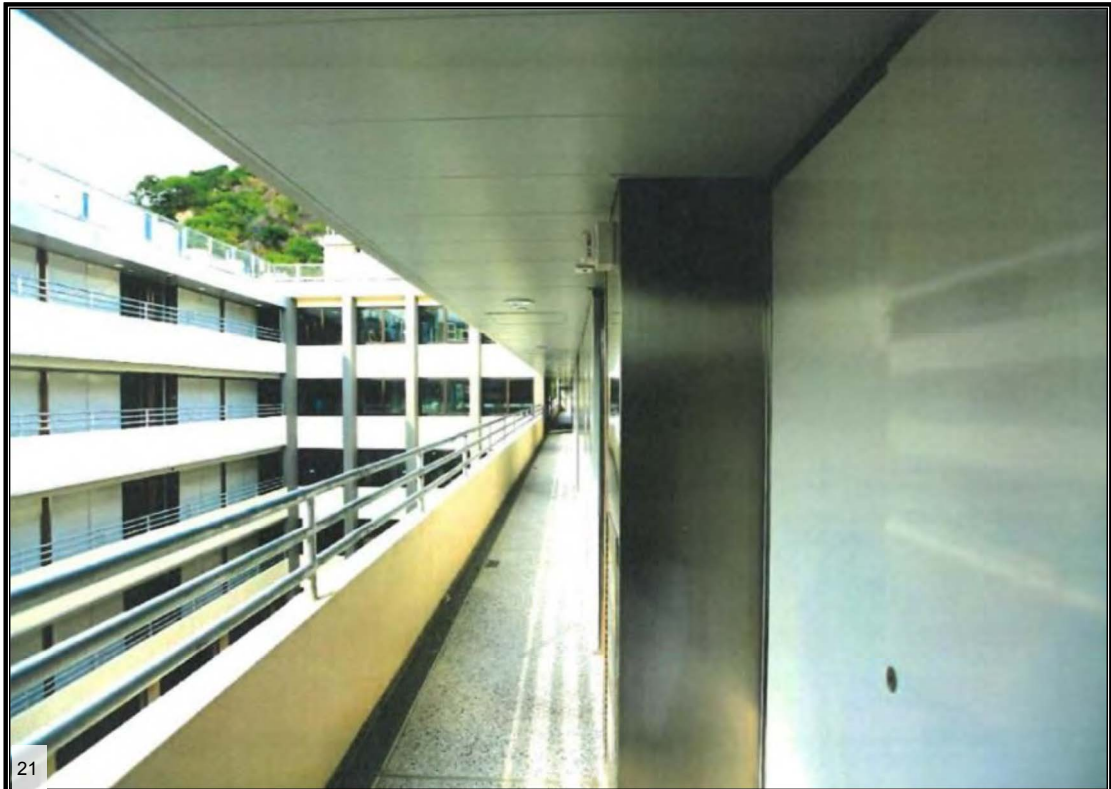
Parapet is rebuilt along corridors (Source: AD+RG)

New parapets along corridors emulating the original parapets and complying with the current statutory requirements in all aspects are rebuilt during the reconstruction of the new cantilevered corridor slabs as mentioned in section (b) above.

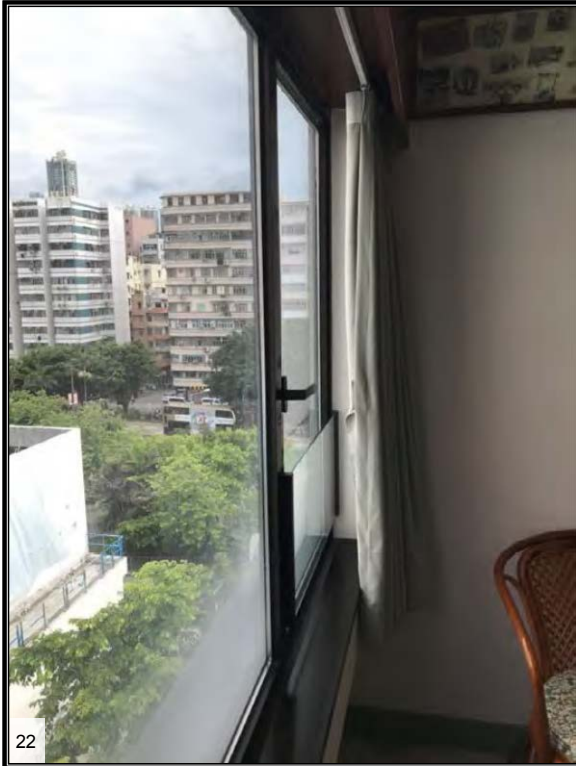
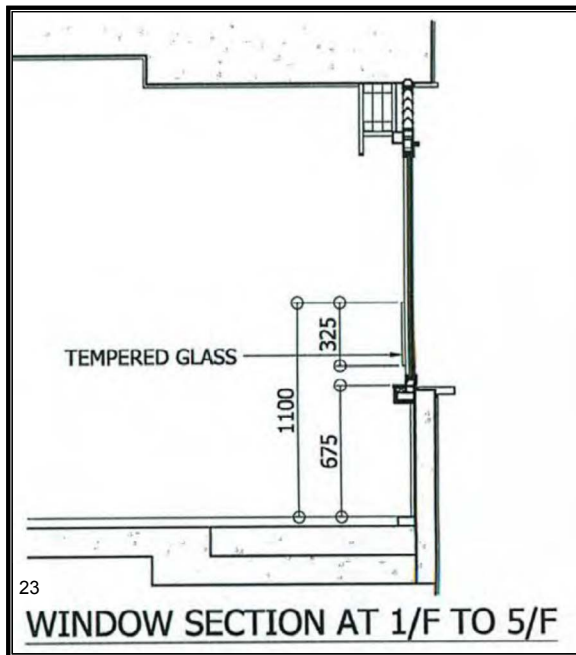
Tempered glass panel is installed above the existing parapet as protective barrier

New openable or fixed aluminium windows are installed on the existing parapets in previous domestic flats, which are not extended vertically in order to avoid too much disturbance to the external walls of MHH. Secondary protective barriers made of tempered glass panels are installed across new openable windows above existing low parapets to meet the current statutory dimensional requirement on protection against falling.

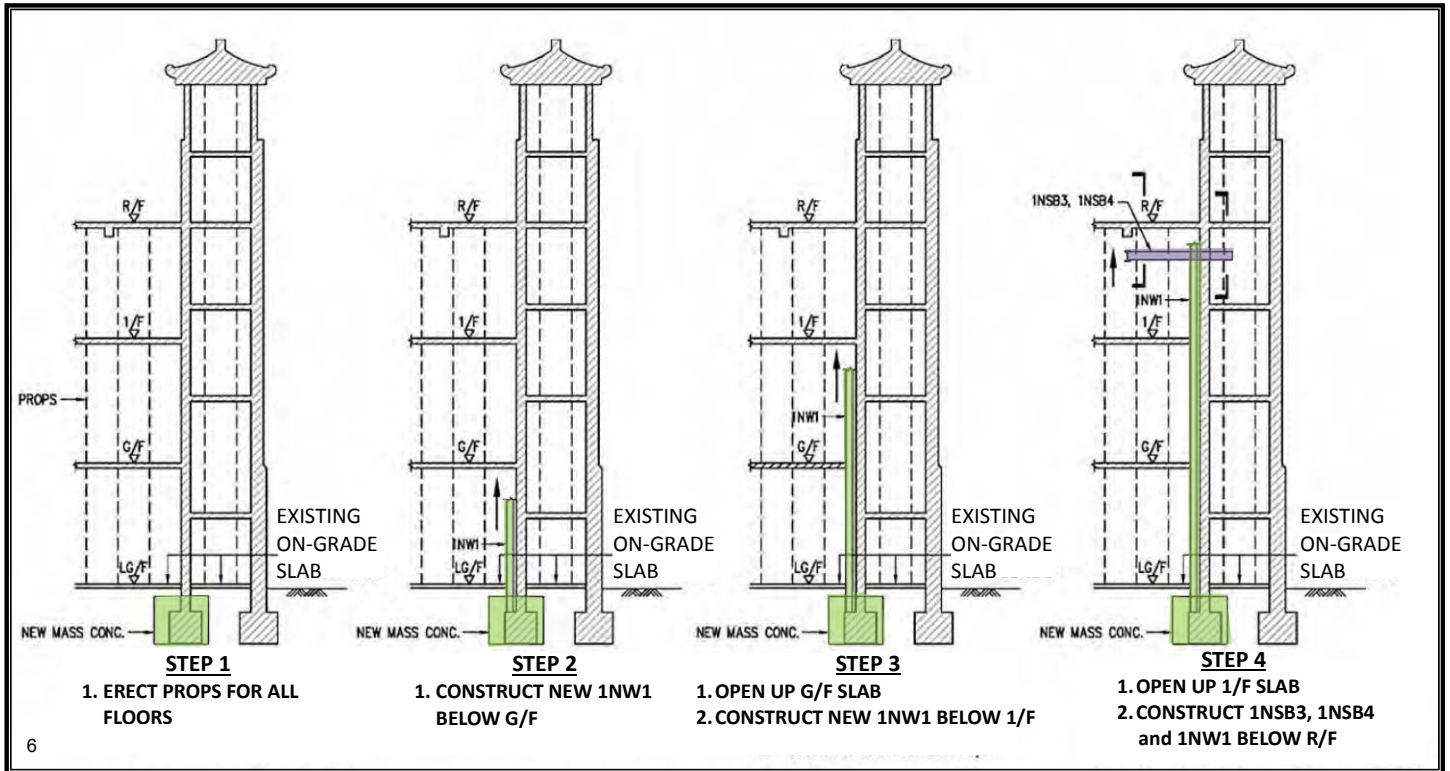
Sequence of rebuilding the exit staircase (ST-1) within the existing staircase tower

A new mass concrete has been added to strengthen the foundation of the existing staircase tower. Then, a new reinforced concrete wall is firstly erected outside one of the existing walls of the staircase tower to provide sufficient lateral and vertical stability of the structure of the staircase tower. After that, the existing staircase and the inner wall are demolished and re-built floor by floor with reinforced concrete stairs from top to bottom level together with partial steel works support at roof floor level to minimise the impact to the structure itself.

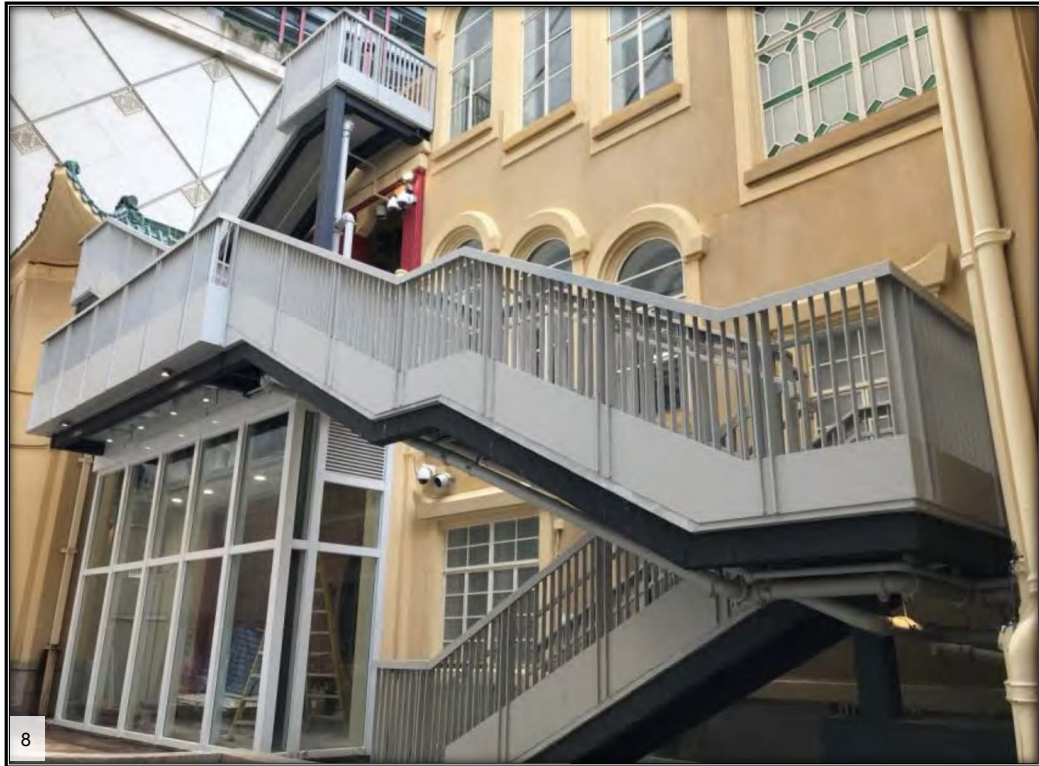
New open metal staircase (ST-4) added at the rear of HPM

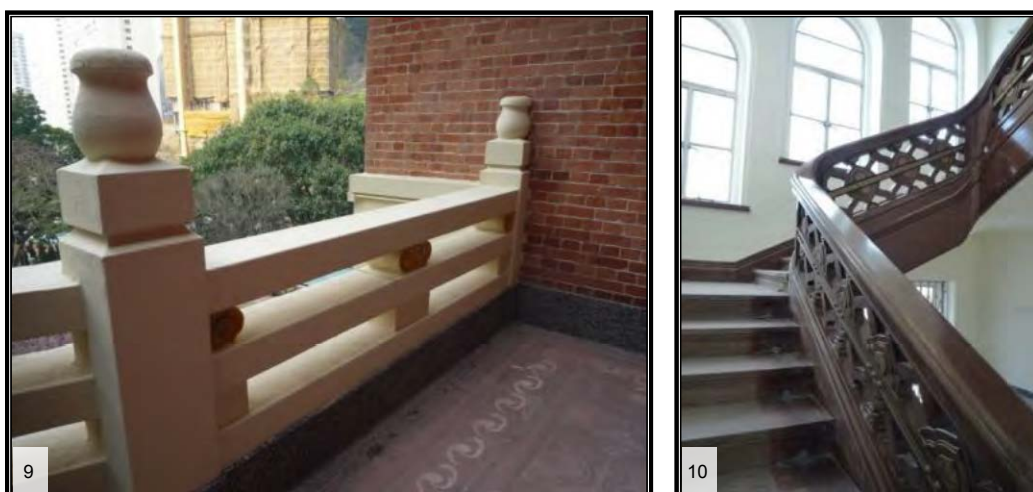
Existing parapets before revitalisation

The existing original parapets at various locations of less than 1.1m high and some even with gaps more than 100mm are not meeting the current standard<sup>5</sup>.

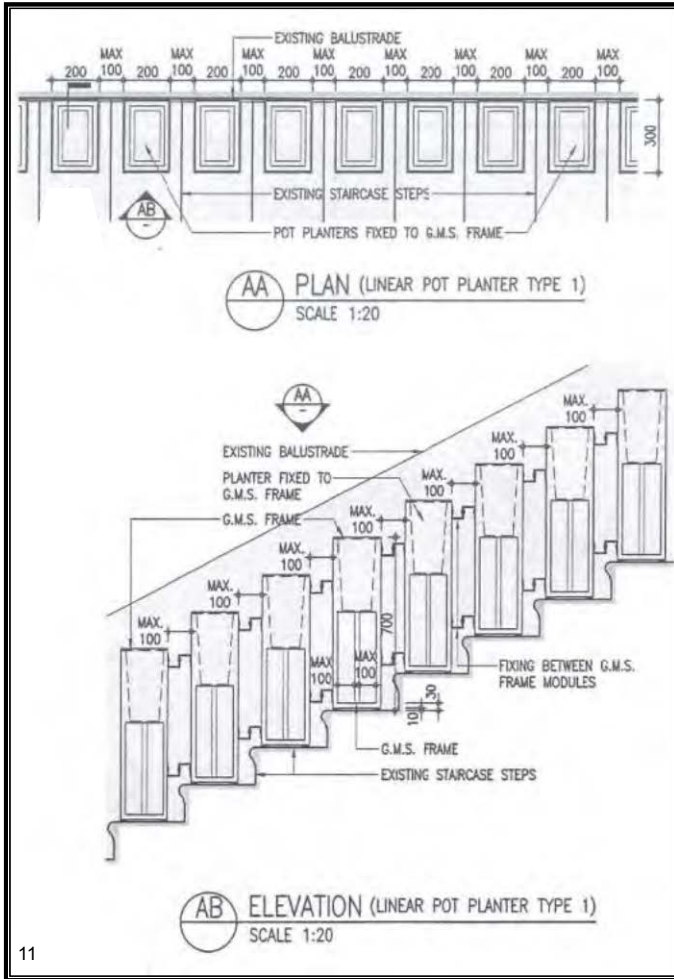
Plan and elevation showing Type 1 pot planters

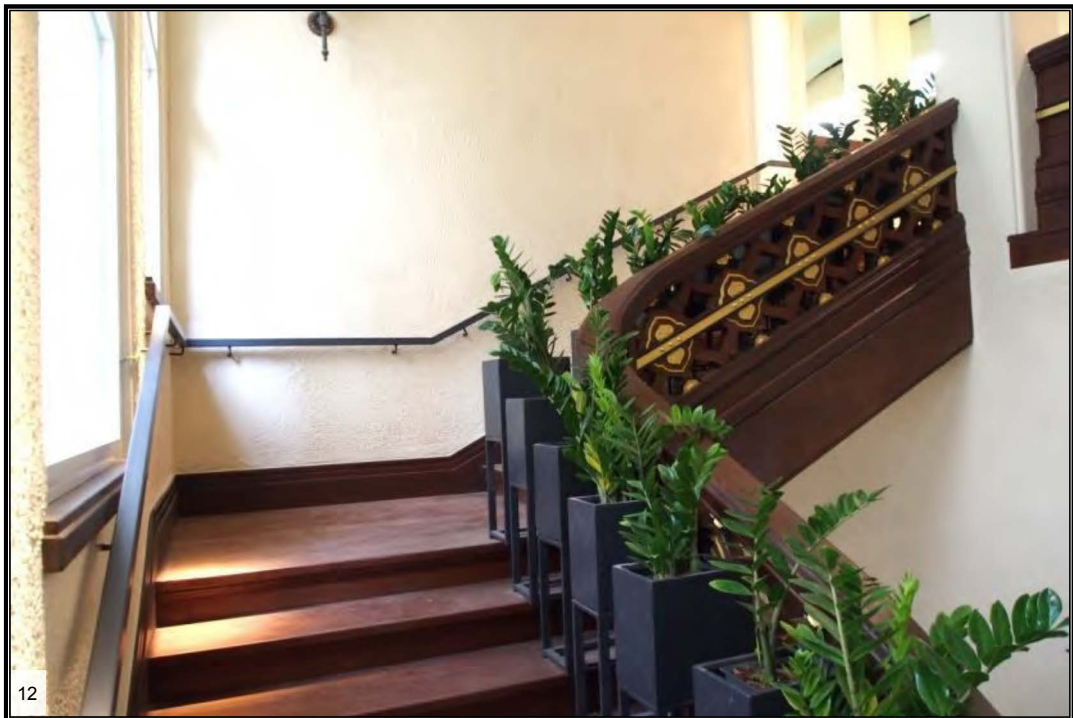
Type 1 pot planters along the circulation staircase (ST-3) (Source: Design 2 (HK) Limited)

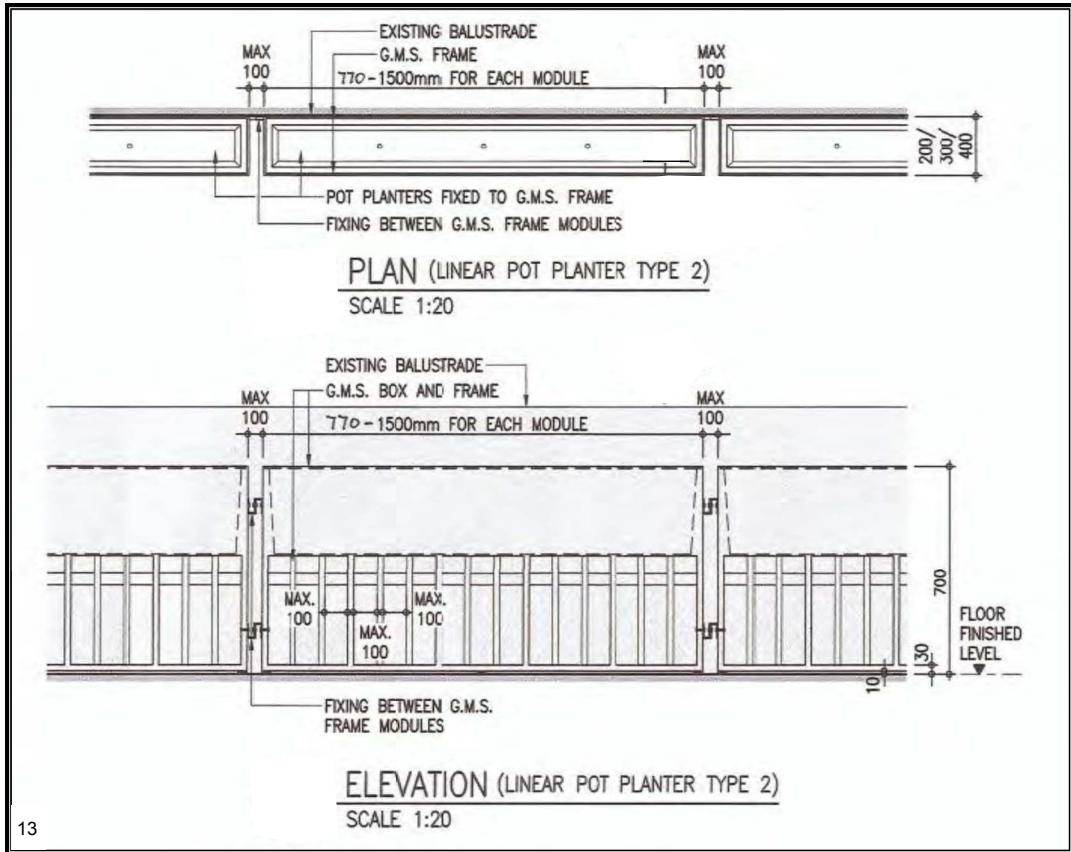
Plan and elevation showing Type 2 pot planters

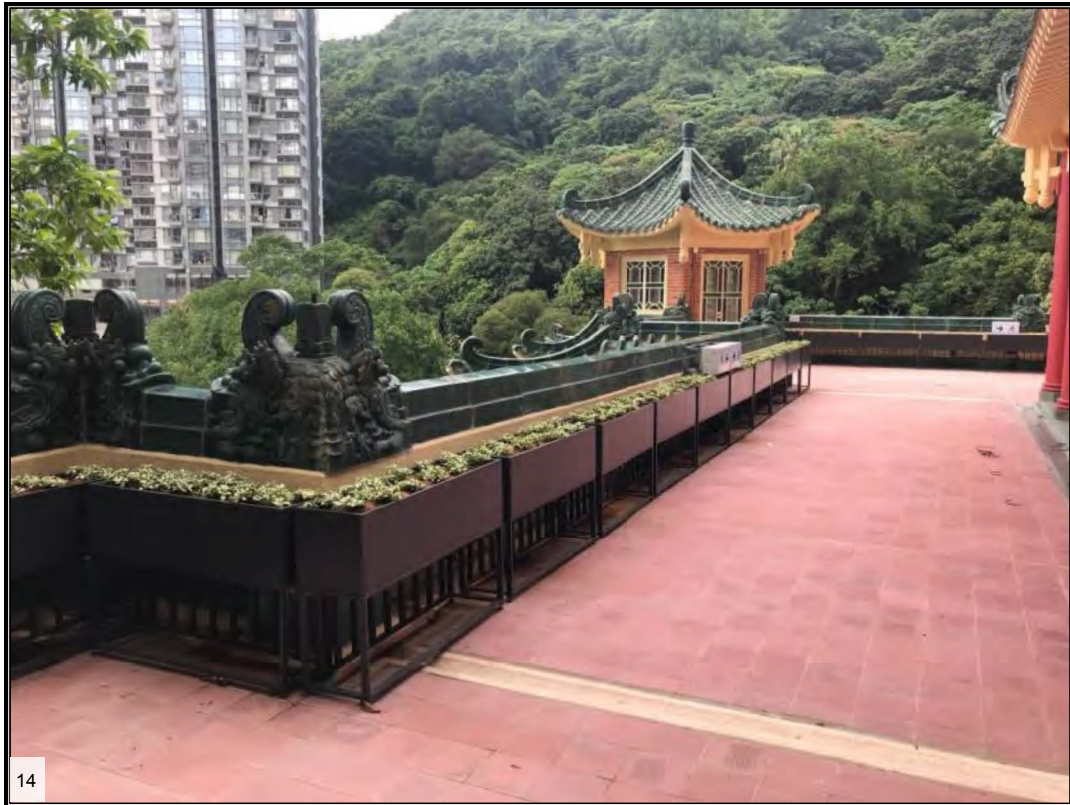
Type 2 pot planters along the parapet of the roof

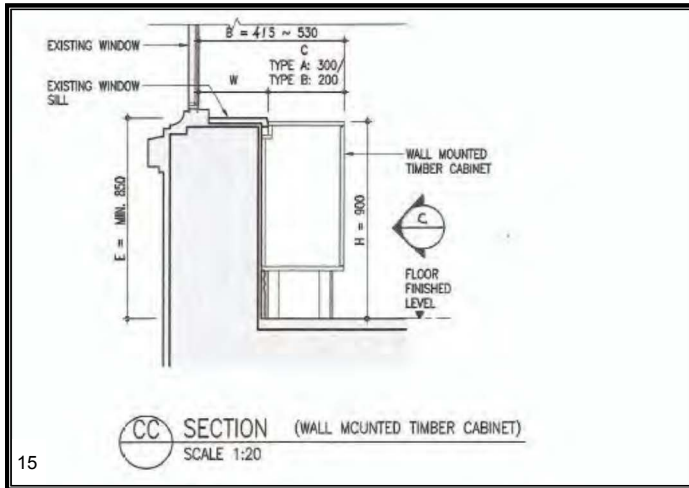
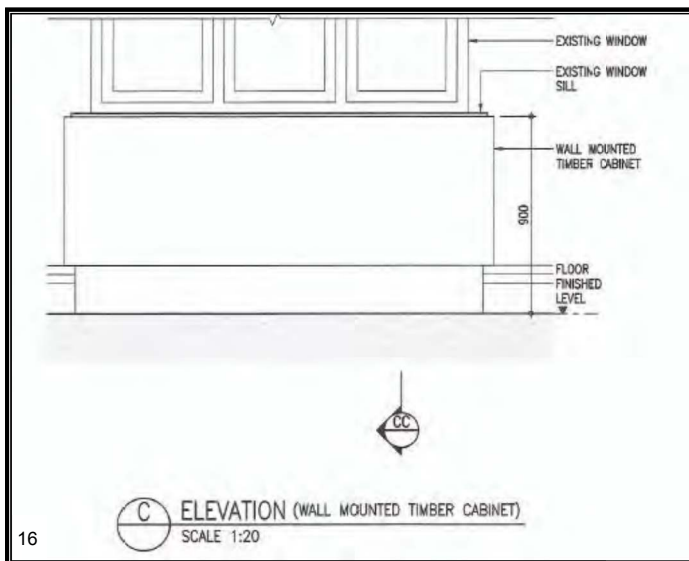
Section and elevation showing a cabinet installed in front of original window parapets

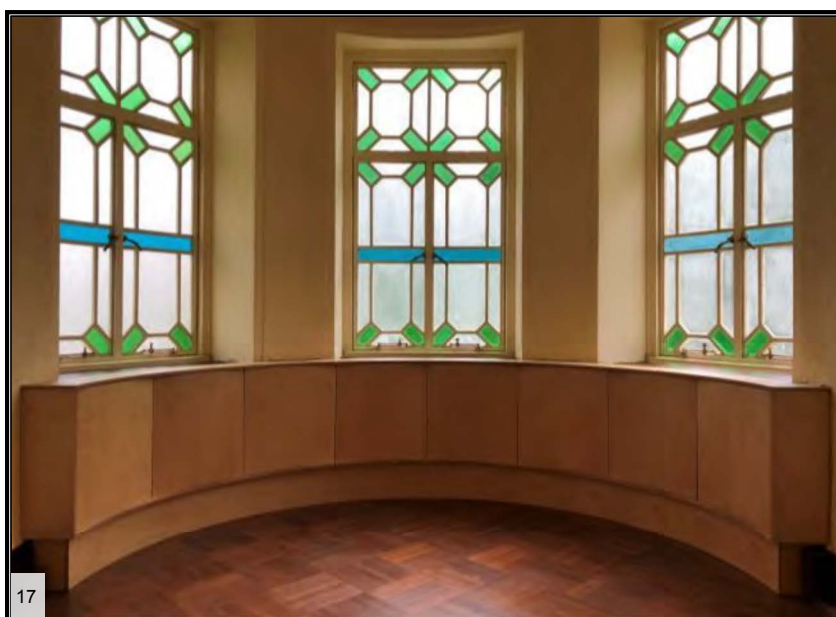
Cabinets fixed along the window parapet (Source: Design 2 (HK) Limited)

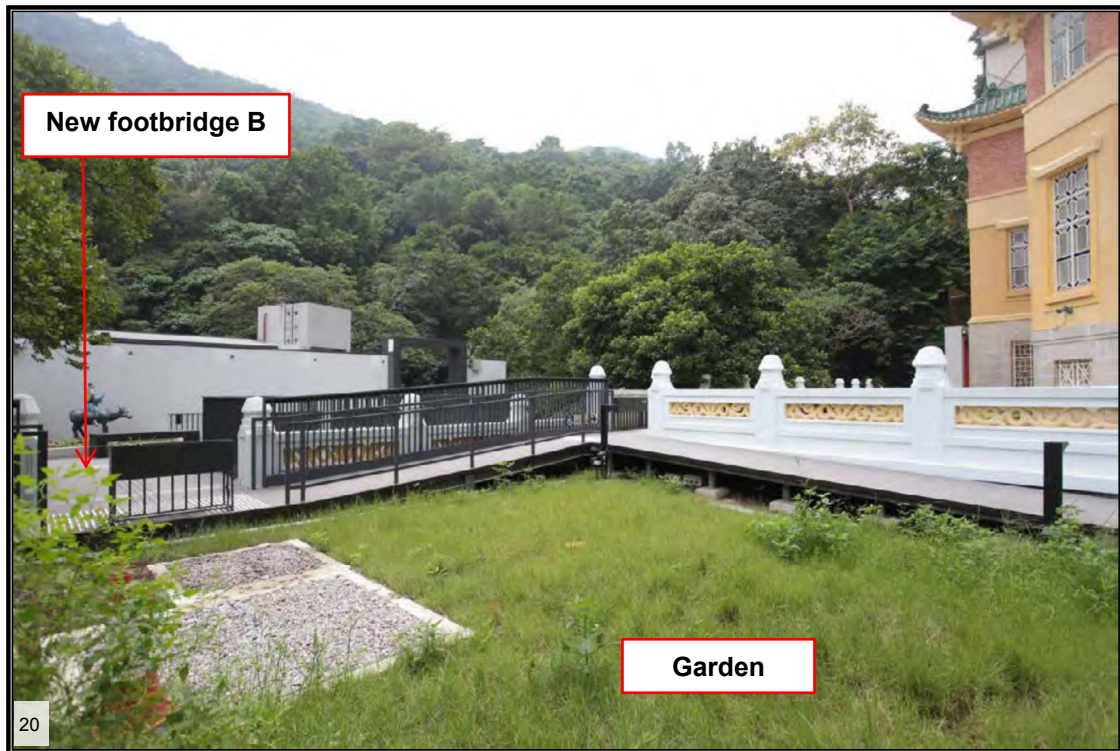
Photo of the Main Site (Source: Design 2 (HK) Limited)

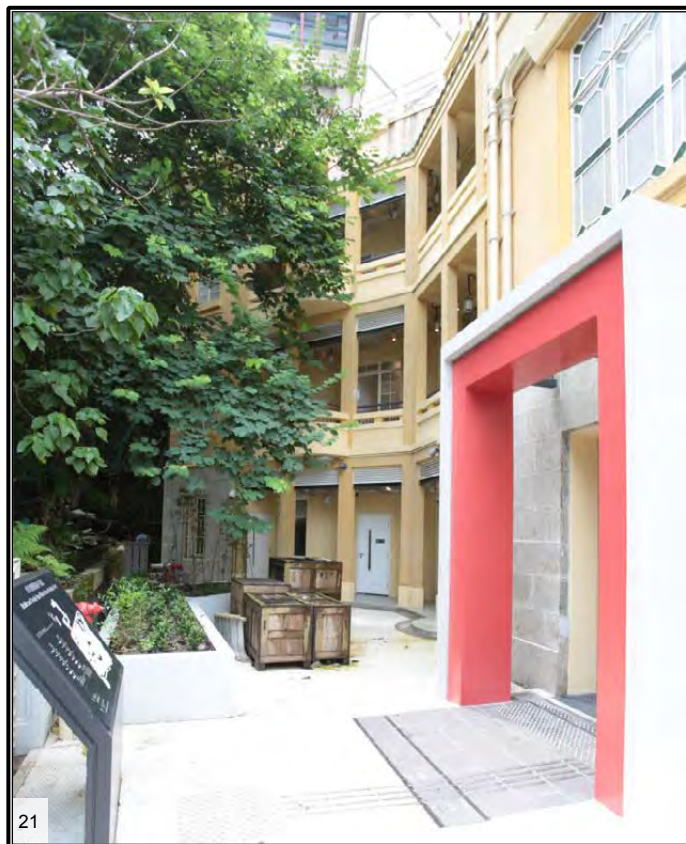
Photo of the new main entrance at the side of the mansion on LG/F

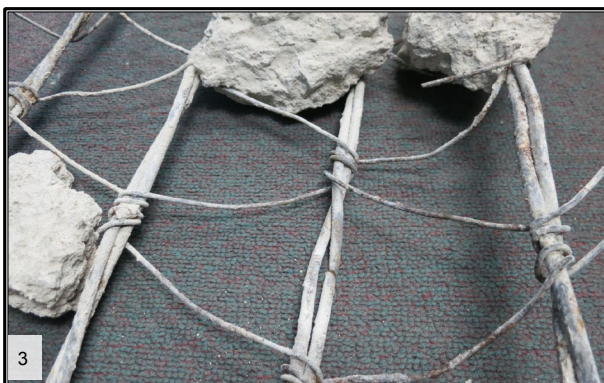
Twisted wires reinforcement revealed during open-up inspection  
(Source: Arup)

A comprehensive structural survey and appraisal, including opening-up inspections, as well as wide-ranging material and load tests, have been conducted to assess the structural integrity and condition of the buildings. Tests on construction materials, including historic brickwork, timber, granite, concrete, twisted wire reinforcement were carried out to verify the materials' strength. Reference has also been made to archival records of buildings of the same period in the United Kingdom as the existing buildings in the Compound are believed to have been built in conformity with contemporary British codes and standards.

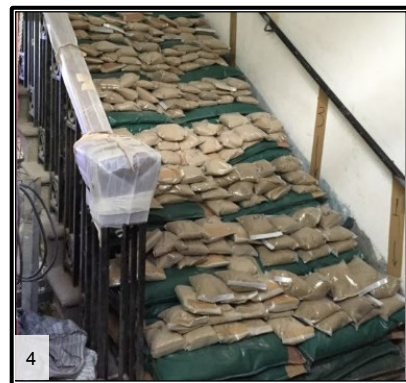
Proof load test of an existing granite staircase up to 1.25 times of the design load by using sand bags  
(Source: Arup)

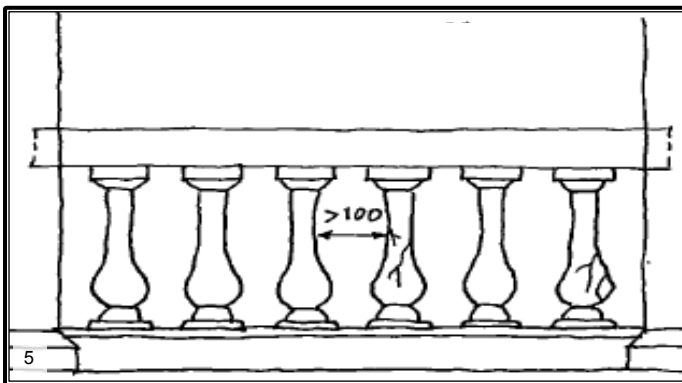
Existing hollowed-clay bottle balusters  
(Source: Arup)

The existing balustrades along the verandahs of Block 3 were constructed of hollowed-clay balusters topped by granite coping. The balusters have been strengthened by infilling them with non-shrink cementitious grout and doweling them at the top and bottom with stainless steel pins. This intervention improves public safety by enhancing the balustrade's ability to resist horizontally imposed loads while respecting the authenticity of the original historic fabric. In addition, load tests have been carried out to ensure that the structural performance conforms to the current loading requirements<sup>1</sup>.

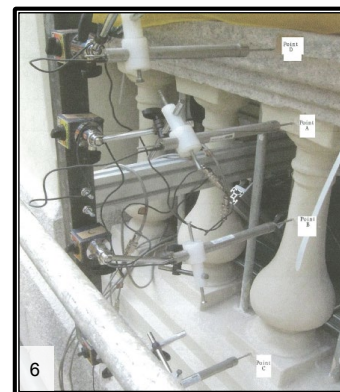
Proof load test to the clay bottle balusters after strengthening works  
(Source: Arup)

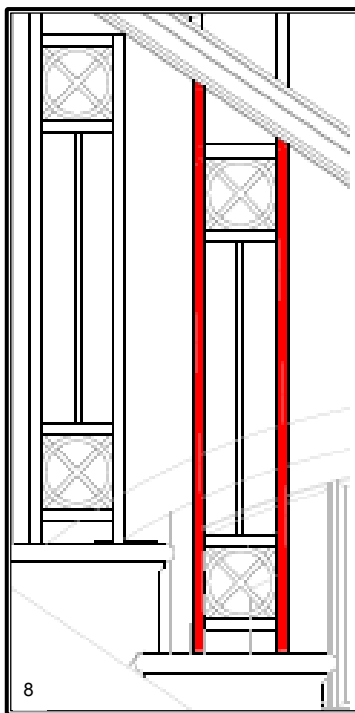
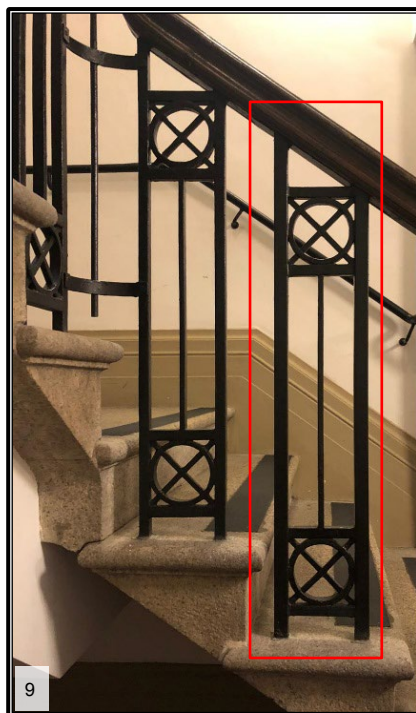
Balustrade strengthened by replacing the balusters at intervals with ones of slightly larger cross-section

Only at a very close look can one identify the subtle difference in the size of the balusters  
(Source: Purcell)

Metal balusters at the central staircase in Block 1 have been replaced at regular intervals by slightly larger square solid steel bars embedded into the existing granite steps. The inconspicuous new steel section provides an alternative load path and enhances the factor of safety of the existing metal balusters so as to meet the current loading requirements,<sup>3</sup> whilst retaining the authenticity of the original design.

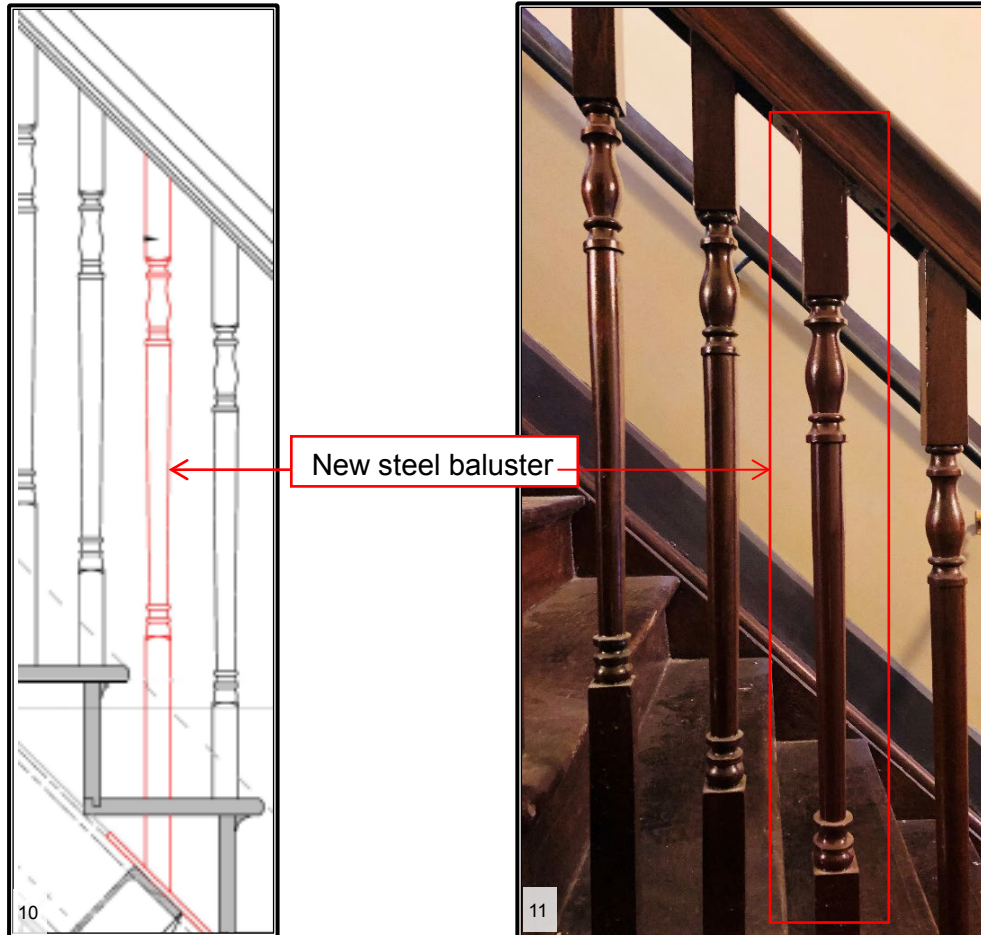
After painting, the replaced baluster blends in with the existing ones  
(Source: Purcell)

Similar to Solution 2 above, timber balusters in Block 6 and Block 7 have been replaced at regular intervals by new steel balusters of the same profile to enhance the factor of safety of the existing balusters.

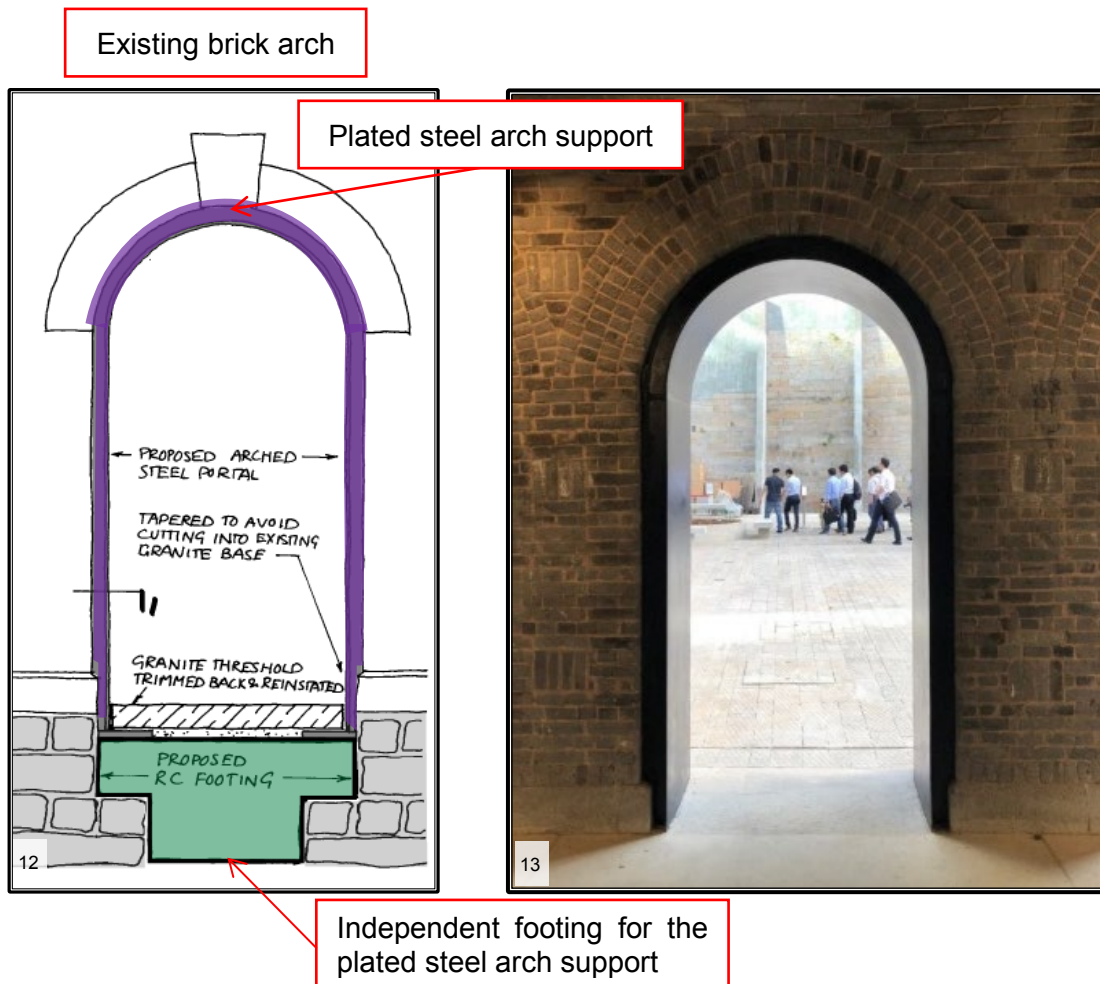
Plated steel arch support (in purple) resting on new footing (in green)  
(Source: Arup)

Steel arch supporting the existing brick arch  
(Source: Arup)

Inconspicuous plated steel arches supported by independent footings have been installed underneath the existing brick arches.
