# Practice Guidebook for Adaptive Re-use of and Alteration and Addition Works to Heritage Buildings 2012

**Practice Guidebook**  
**on**  
**Compliance with**  
**Building Safety and Health Requirements**  
**under the Buildings Ordinance for**  
**Adaptive Re-use of and**  
**Alteration and Addition Works to**  
**Heritage Buildings**

**Buildings Department**  
**Hong Kong**

**(2021 Edition)**

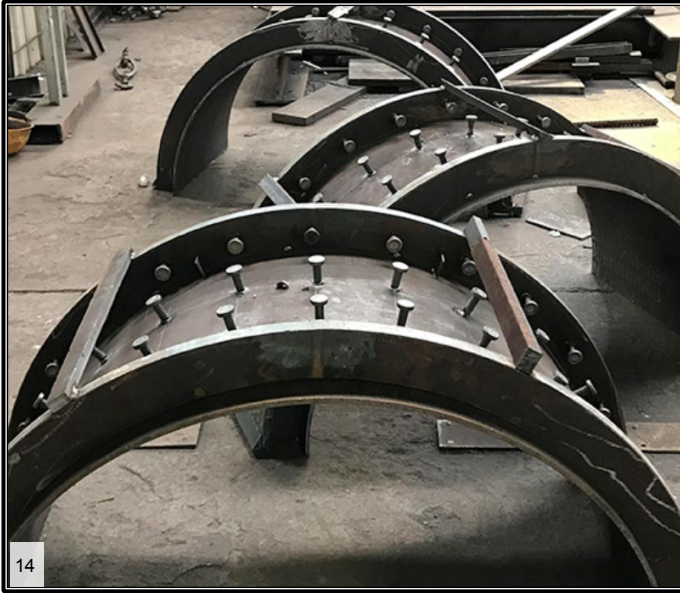
Plated steel arch to be installed under the existing arches  
(Source: Arup)

Inconspicuous plated steel arches supported by independent footings have been installed underneath the existing brick arches.

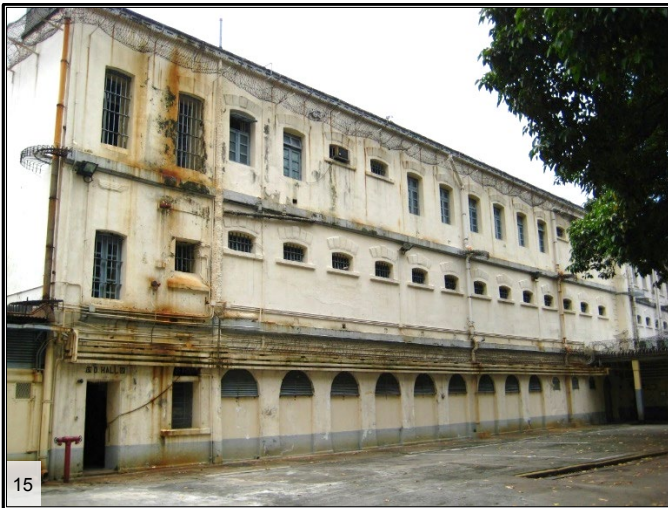
Brick arches before revitalisation  
(Source: Arup)

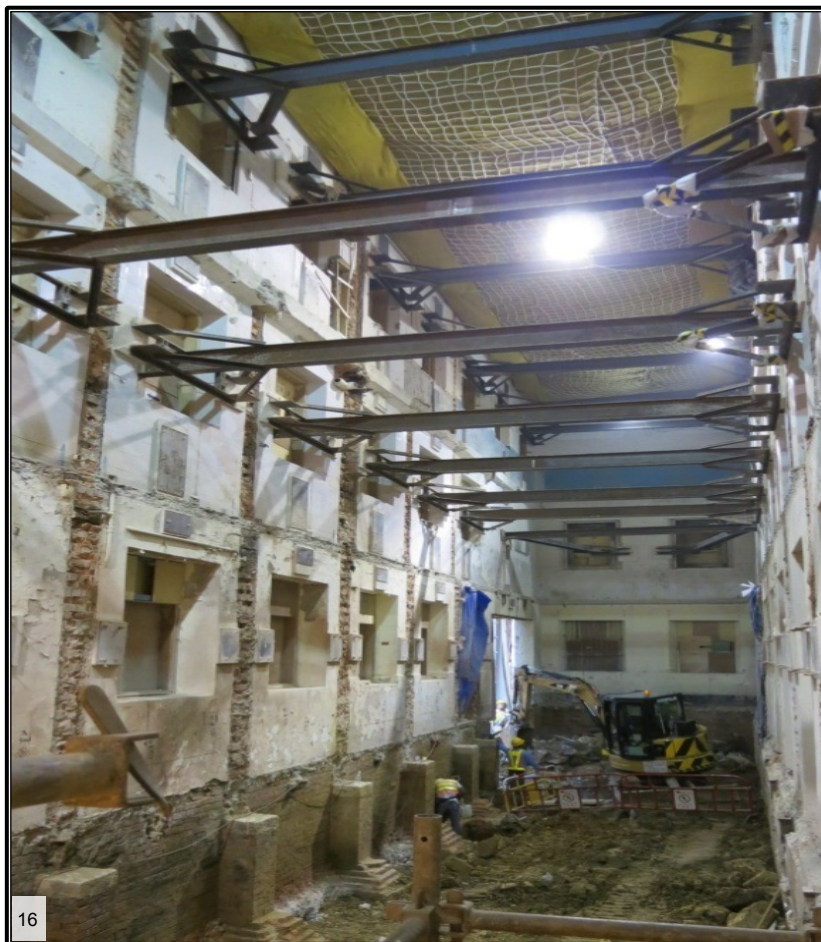
Temporary steel structures installed to provide lateral restraint to the retained facades during construction  
(Source: Arup)

The facades of the building are retained while all existing floor slabs and structural components inside the building have been removed. New internal structural steel frames supported on new foundations provide lateral resistance to the retained facades.

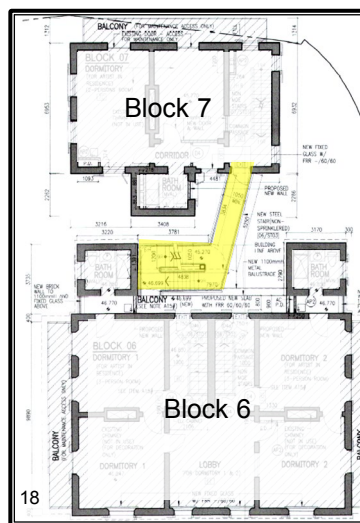
New external escape staircase (in yellow) between Block 6 and Block 7

A new external steel staircase connecting the two buildings has been added to serve as an escape staircase. Since only one escape staircase is available, the upper floors of the buildings are restricted for use as dormitories (i.e. domestic use) in accordance with the current requirements<sup>6</sup>.

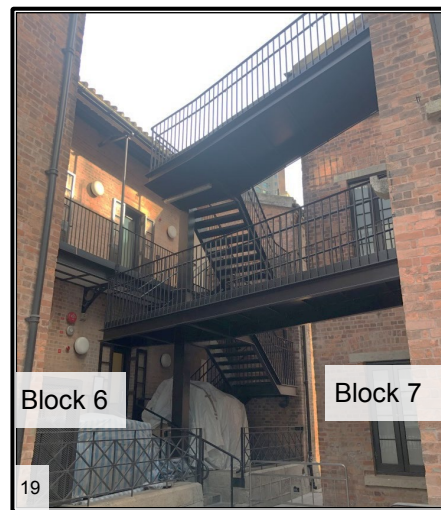
A new steel staircase added between Block 6 and Block 7 serving as an escape staircase

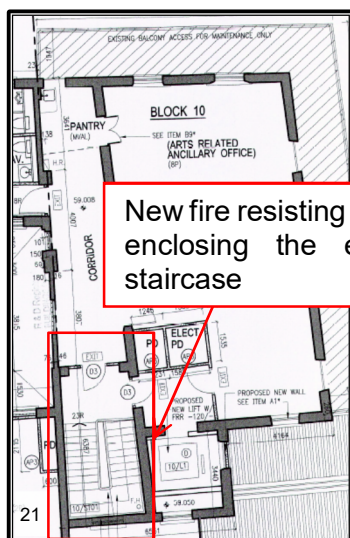
New fire resisting walls and doors enclosing the existing timber staircase

- (i) separation of the staircase from the rest of the building by new fire resisting walls and doors;
- (ii) non-slip nosing at staircase risers and warning signs at conspicuous locations;
- (iii) protection of the existing timber elements of the staircase with fire retardant treatment;
- (iv) installation of fire protective lining to the underside of the stair flights and landings;
- (v) installation of fast detection alarm system comprising fast response automatic sprinkler heads and smoke detectors within the staircase enclosure; and
- (vi) implementation of a management plan such as provision of closed-circuit television (CCTV) monitoring system.

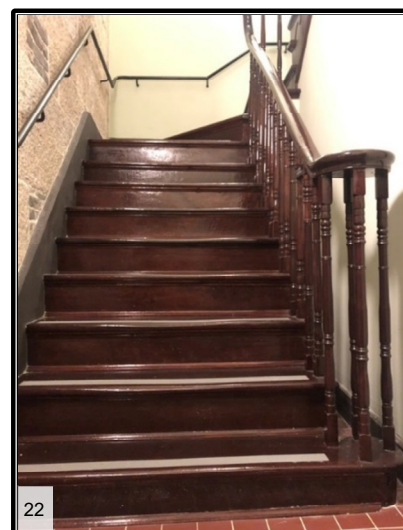
The upgraded timber staircase is used as an escape staircase

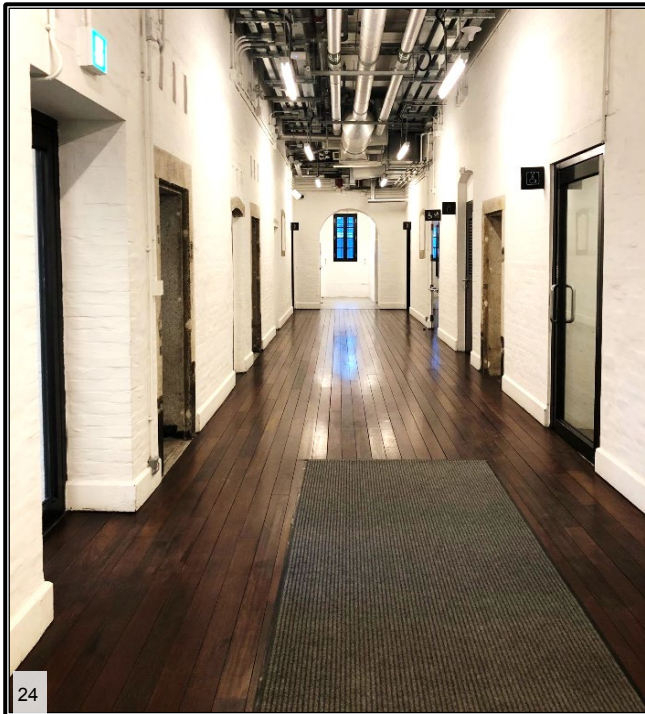
Long corridor at the former prison cells in Block 14

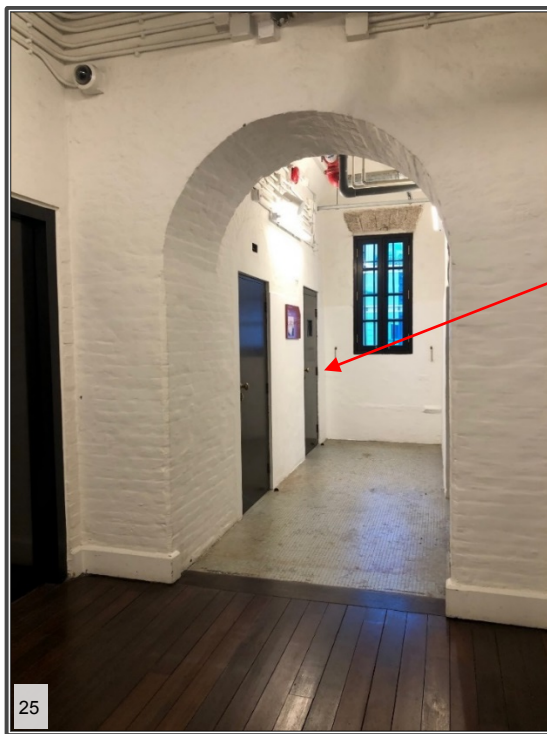
The vision panel of the locked door allowing visitors to view inside the mortuary

The mortuary located at the end of the corridor on G/F is turned into an inaccessible exhibition room with a locked door to resolve the excessive deadend travel distance. Visitors are allowed to view inside the room utilising the existing vision panel.

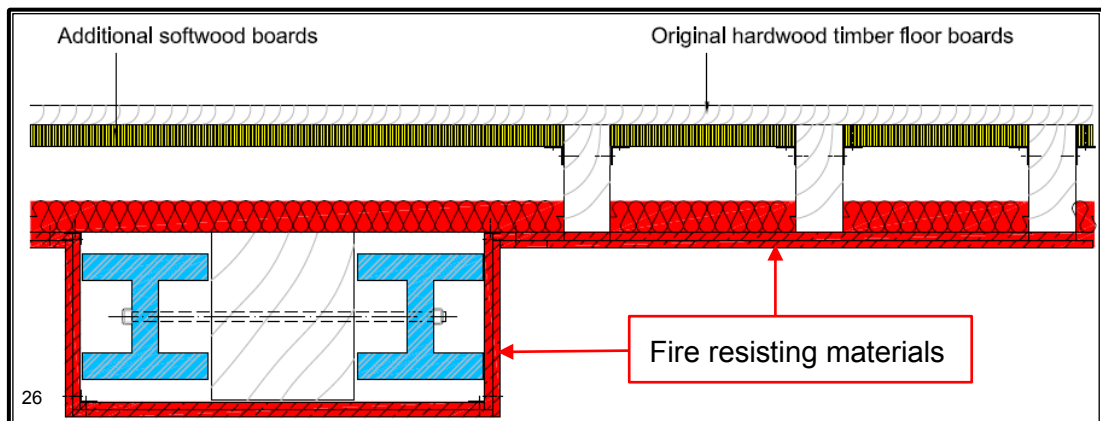
Original timber boards and timber beams/ joists strengthened with steel beams and protected with softwood board by charring (for fire from above) and fire resisting materials (for fire from below)  
(Source: Purcell)

Taking into account the charring rates of hardwood and softwood, the original timber boards are salvaged and fire resistance is provided by the addition of softwood board and fire resisting materials at the underside of the floor.

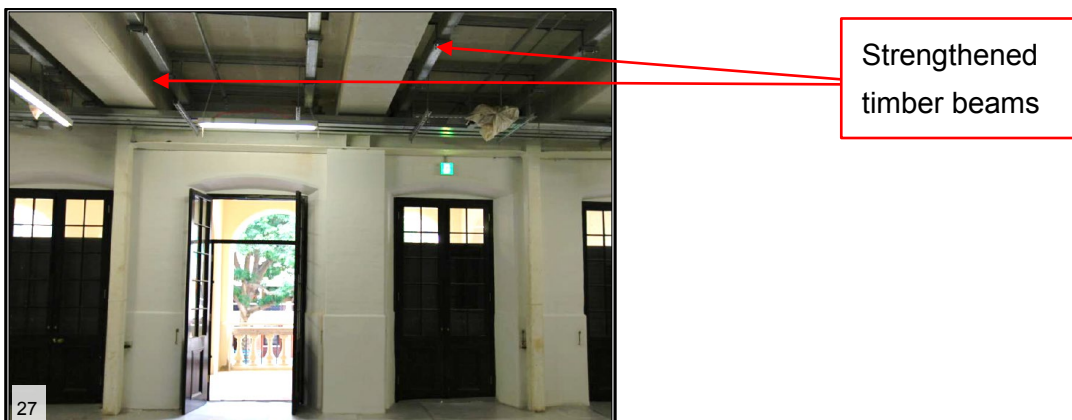
Fire resisting enclosure to strengthened steel beams  
(Source: Rocco Design Architects Associates Ltd)

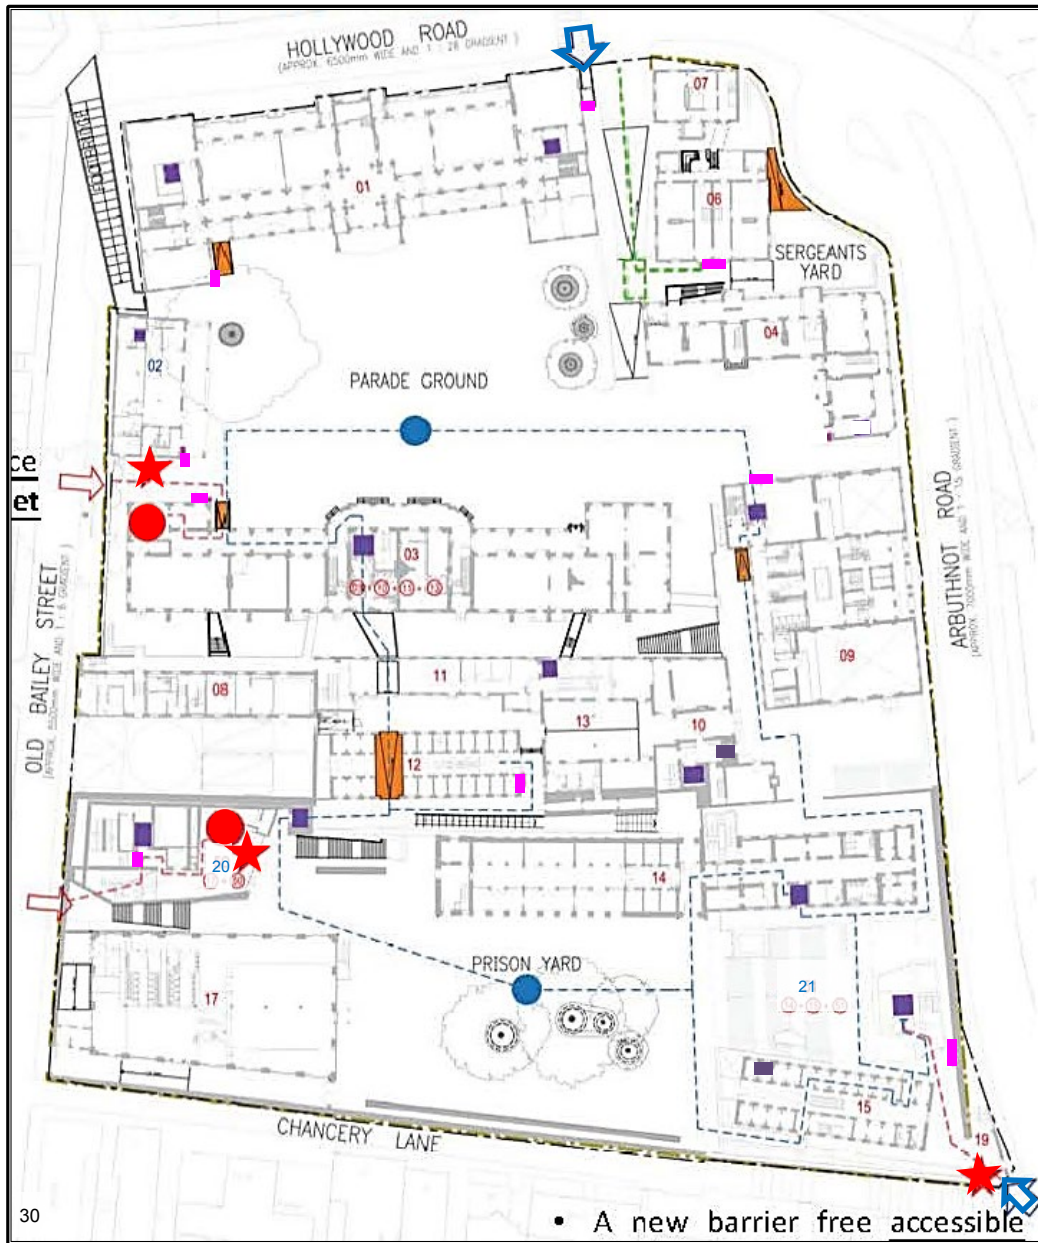
Accessibility strategy  
 (Source: Rocco Design Architects Associates Ltd)

- - Tactile guide path
  - Accessible lift/ platform lift
  - External ramp
  - Information counter
  - ★ Braille and tactile site maps
- Braille and tactile sign
  - Circulation route
  - ↑ Main accessible entrance
  - ↑ Secondary accessible entrance
  - - Drop-off point for Blocks 6 & 7

Vehicular drop off points are provided at accessible entrances located at the Lower Platform and the Upper Platform abutting Hollywood Road and Old Bailey Street respectively. Accessible lifts and vertical lifting platforms are provided within buildings to overcome minor level differences. Footbridges mentioned in Challenge 2 under item (e) above form the access routes for connecting the Lower Platform and the Middle Platform. The Middle Platform and the Upper Platform are connected by an accessible lift provided within one of the new buildings.

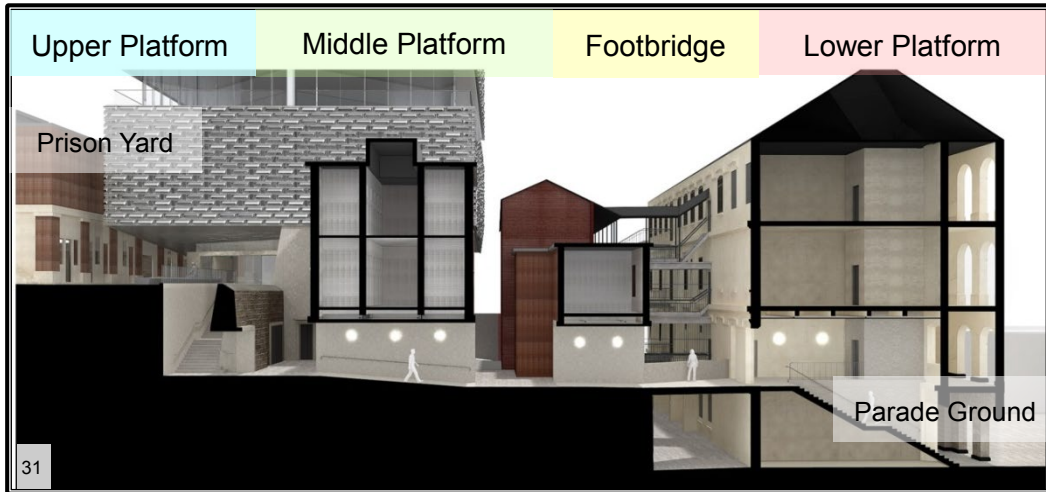
Connection between the Lower, Middle and Upper Platforms (section)  
 (Source: Herzog & de Meuron)

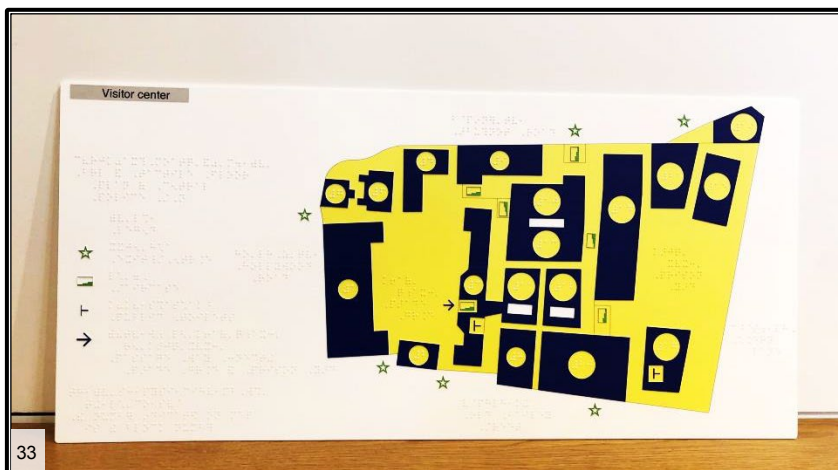
Hand-held Braille map is available from the visitor center

Persons with a disability (PwD) are given assistance at the information counters by the staff. Hand-held Braille maps are distributed at the information counters to PwD to facilitate their moving around the site. Braille and tactile building signs are fixed at the main entrance of each individual building as well. PwD are encouraged to visit the center's website to understand the information regarding accessibility of the Compound prior to their visits, and to join guided tours.

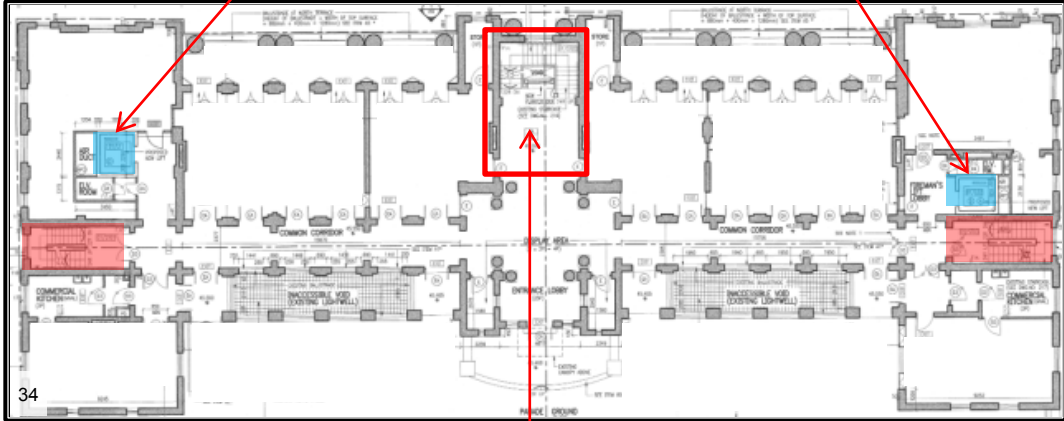
G/F Plan of Block 1

New accessible lifts are added at the proximity of the existing substandard staircases to discourage the use of the staircases

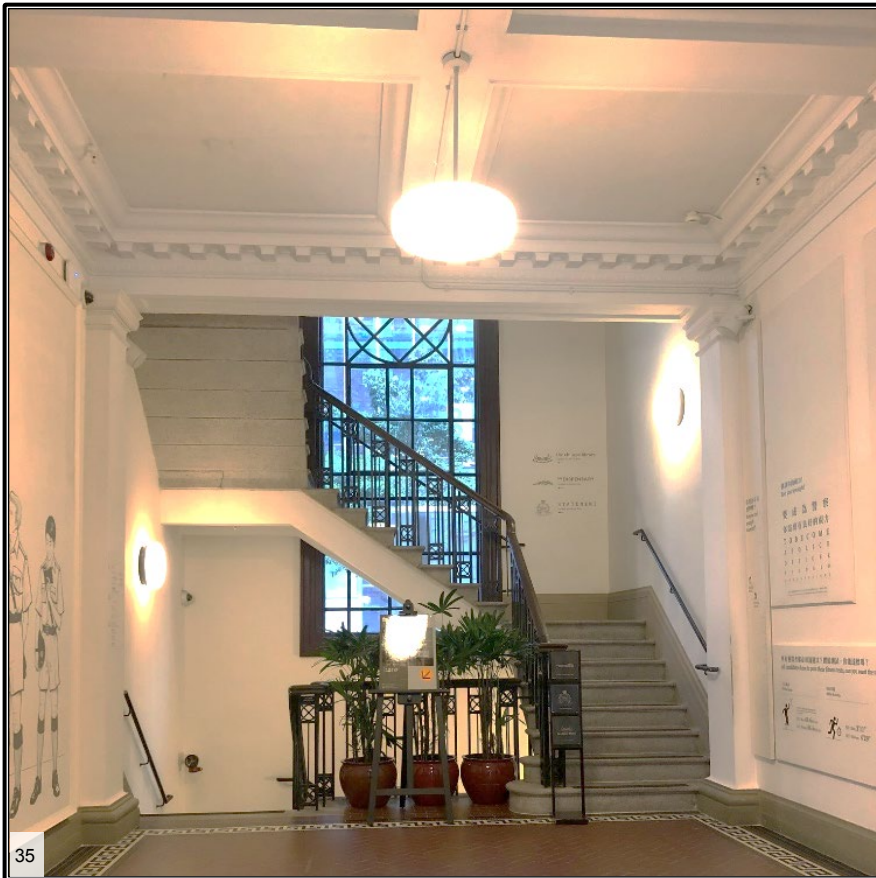
Planter boxes are placed on the floors/landings along the balustrades of the central staircase with open well design

Planter boxes along the balustrade of the central staircase at G/F of Block 1

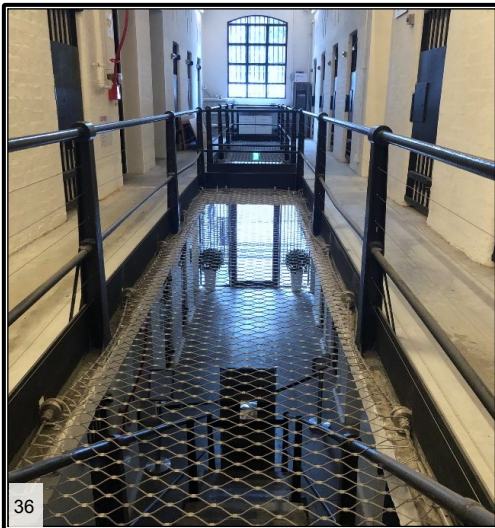
New wire mesh over the void at prison block after conversion

Horizontal safety meshes have been added over the existing voids with the implementation of compensatory measures, including provision of non-slippery surface along the corridors, implementation of management plan, close monitoring by CCTV, safety announcement by PA system, posting of warning signs, etc.

The horizontal safety mesh is similar to an inaccessible roof in terms of its impact load resistance<sup>15</sup>. Other than that, wires are also added between the existing guard rails at intervals of not more than 100mm. The upper floors are designated as office and supporting space for the adjacent multi-purpose hall only to which public access is not allowed.

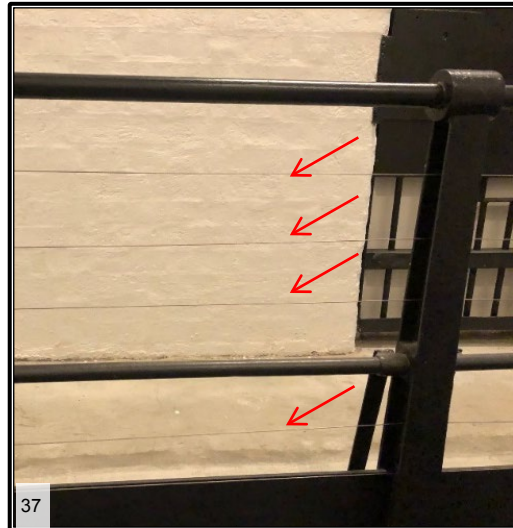
Wires (pointed by red arrows) added between existing rails

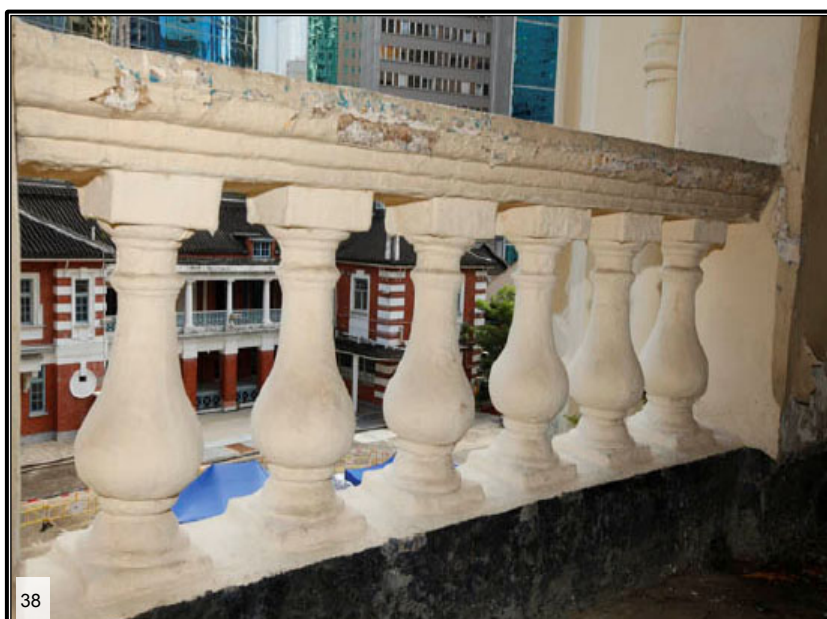
Hollowed-clay bottle balustrade before revitalisation

The existing hollowed-clay bottle balustrades along the verandahs at 1/F to 3/F of Block 3 are less than 1100mm high with gaps larger than 100mm, which cannot meet the current standard<sup>13</sup>. Adding railings and glass panels up to the required height are visually undesirable, due to the glare from glass reflection.

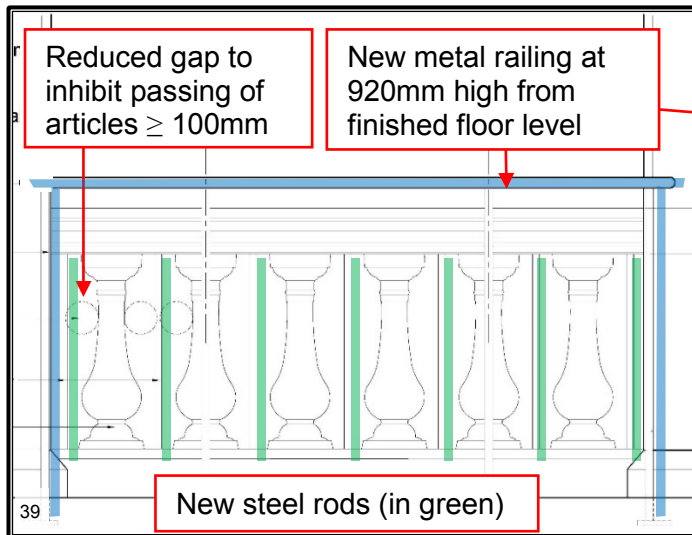
Upgrading works to clay bottle balustrade  
 (Source: Rocco Design Architects Associates Ltd)

<sup>16</sup> For protective barrier of height less than 1100mm but not less than 900mm at balconies and verandahs, it will be favourably considered if the sum of the width of the top surface measured from centerline of the barrier and the height of protective barrier is not less than 1220mm. Section 5.31(e) of this Practice Guidebook refers.

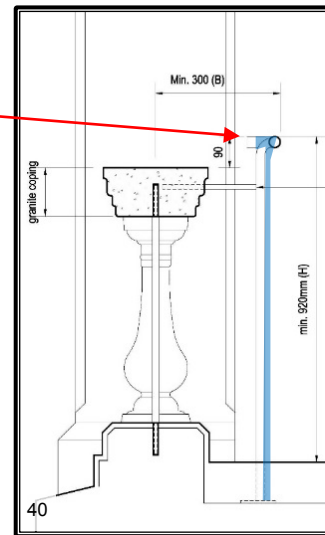
Section of upgrading works to clay bottle balustrade  
 (Source: Rocco Design Architects Associates Ltd)

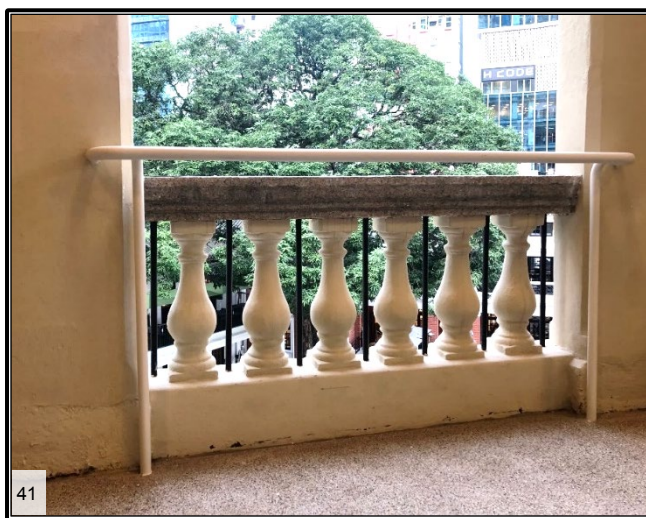
Addition of new railings and metal rods for the clay bottle balustrade of Block 3
