# Practice Guidebook for Adaptive Re-use of and Alteration and Addition Works to Heritage Buildings 2012

**Practice Guidebook**  
**on**  
**Compliance with**  
**Building Safety and Health Requirements**  
**under the Buildings Ordinance for**  
**Adaptive Re-use of and**  
**Alteration and Addition Works to**  
**Heritage Buildings**

**Buildings Department**  
**Hong Kong**

**(2019 Edition)**

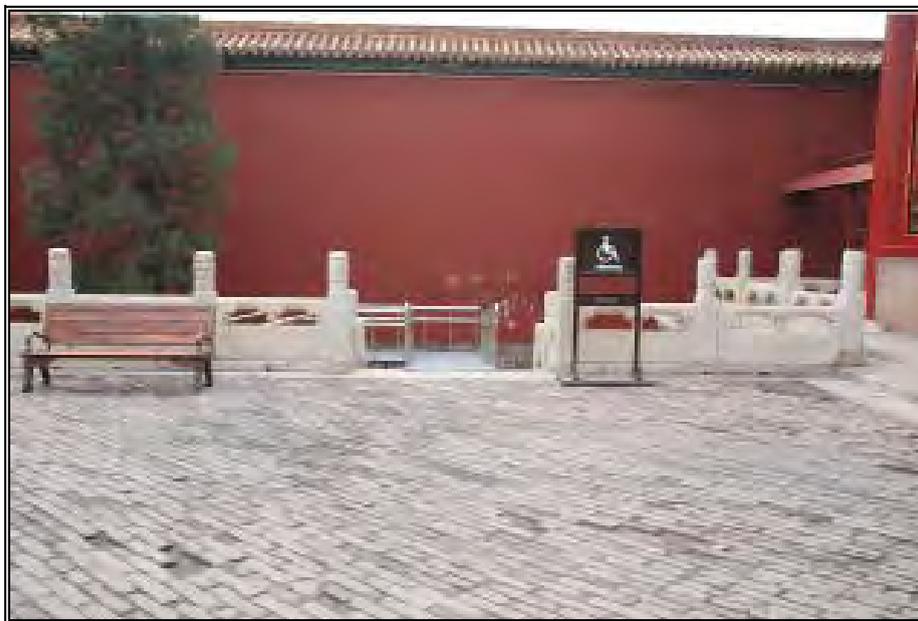
Photo 3 An access ramp for persons with a disability in the Forbidden City, Beijing.

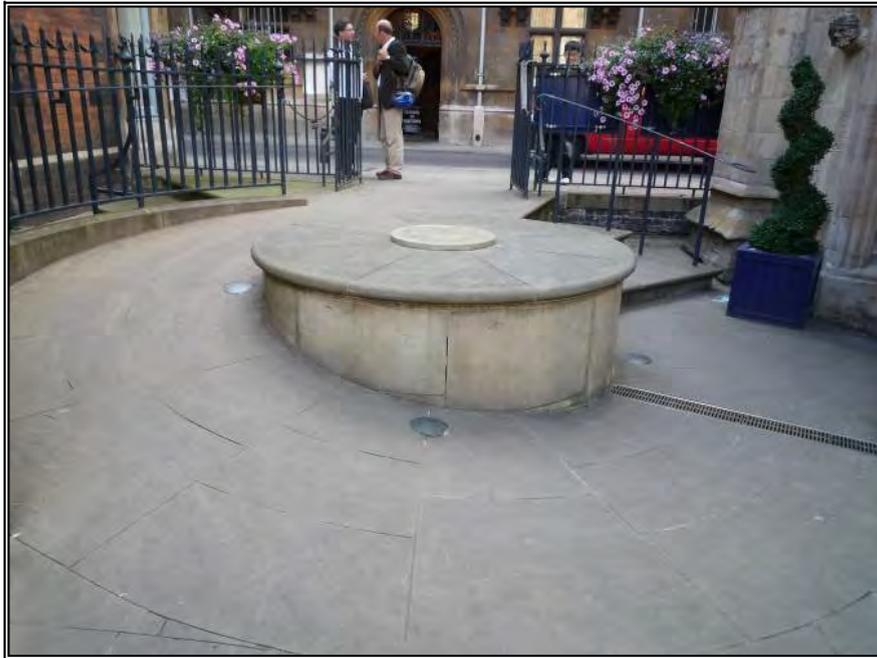
Photo 4 A circular access ramp to a church in Cambridge, UK

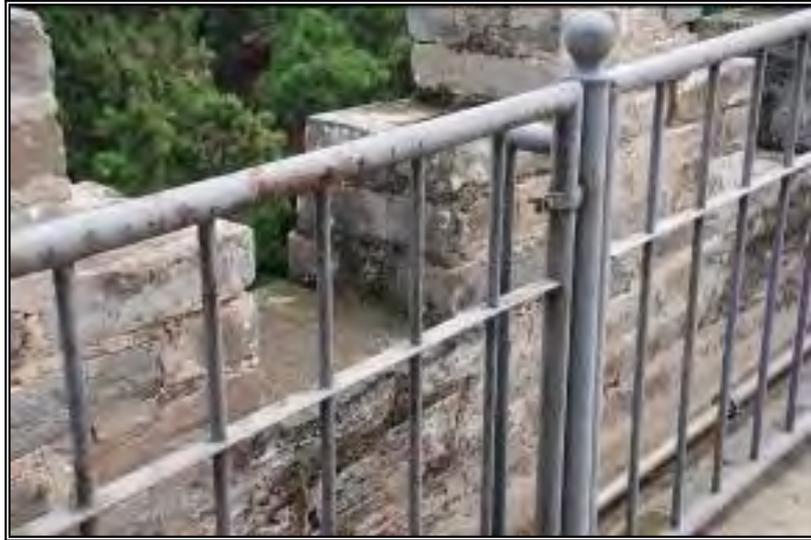
Photo 5 A protective barrier on the parapet wall of a building at the Tombs of the Thirteen Ming Emperors

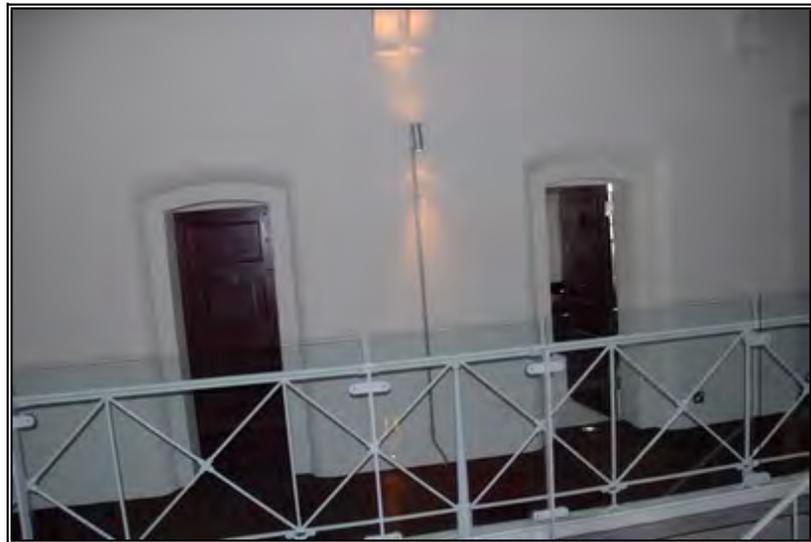
Photo 6 A glazed panel added behind the existing balustrade to meet the current safety requirement in Oxford Castle, UK

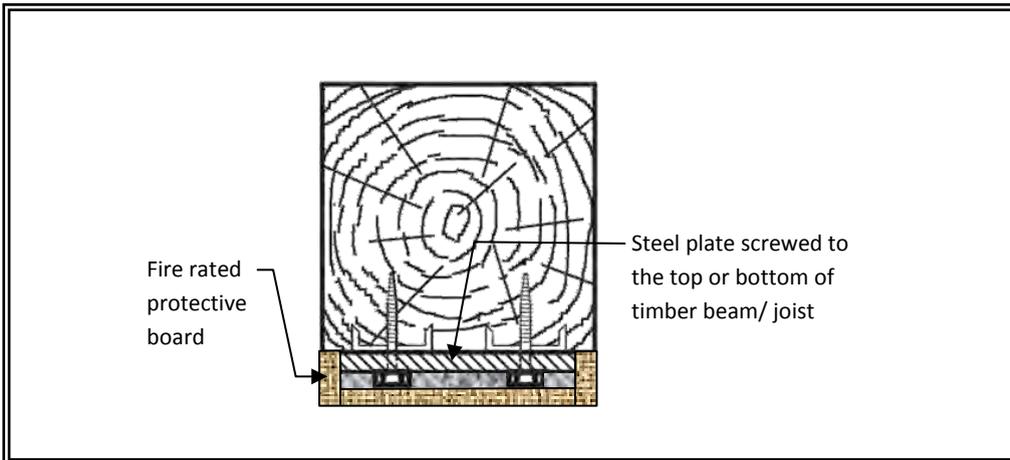
Figure 1 Steel plate for strengthening a timber beam/ joist (with composite action)

To increase the flexural strength of timber beams or joists against bending moment, it is possible to insert a steel plate at the bottom or the centre of the timber beam/ joist to form a composite section with the timber or constructing a new steel beam underneath the existing timber beam/ joist to increase its carrying capacity (as in Figure 1). The steel plate, which may form a composite section with the timber, must be fixed to the timber section with connectors at suitable spacing capable of transmitting the horizontal shear forces. The steel plate should be adequately protected to achieve the required fire resistance rating (FRR).

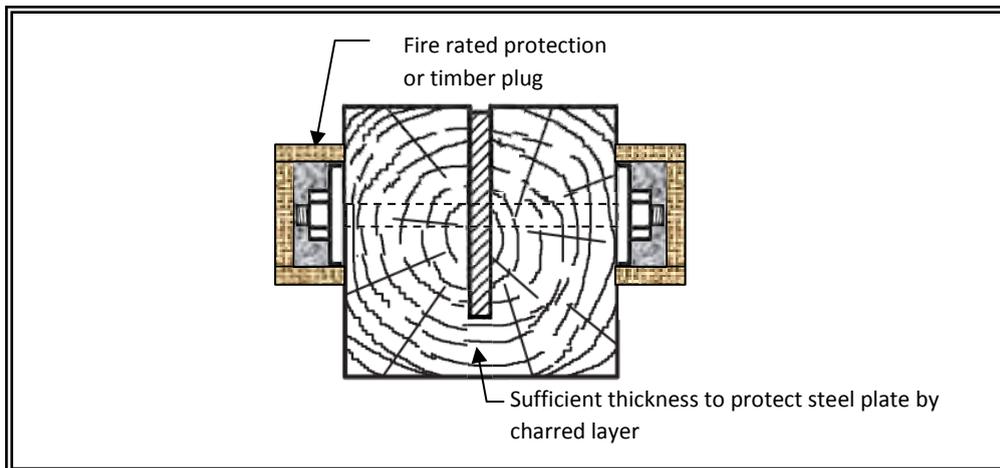
Figure 2 Steel strengthening plate in vertical sawn slot

It is also possible to add timber joists or steel plates bolted alongside the joists. Where the inserted steel plate is used (as in Figure 2), the plate and associated connections should be protected with timber plugs against fire in accordance with BS5268 Part 4.1.

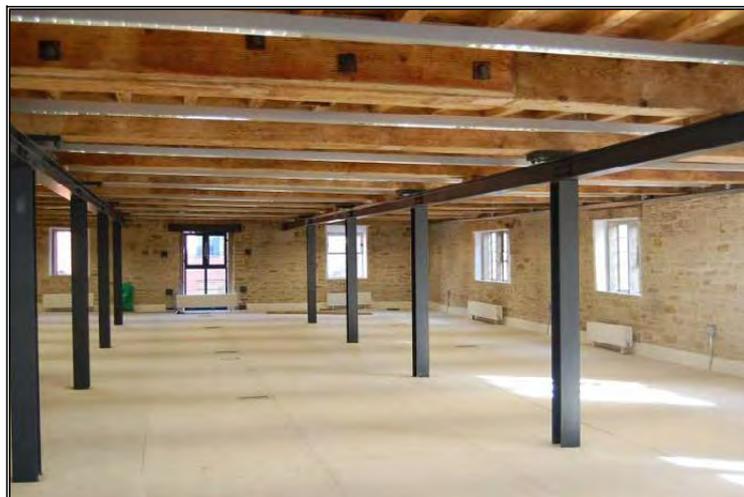
Photo 7 New beams and columns underneath the timber Joists

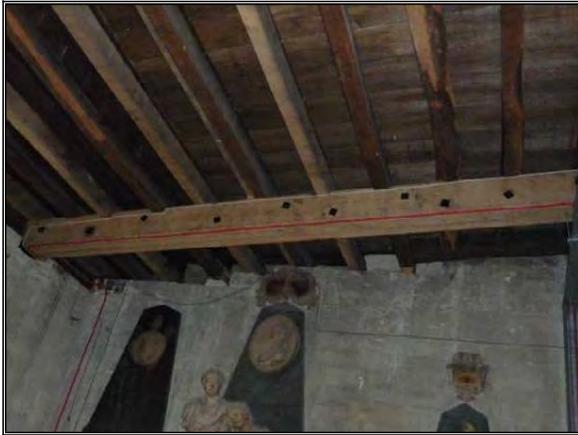
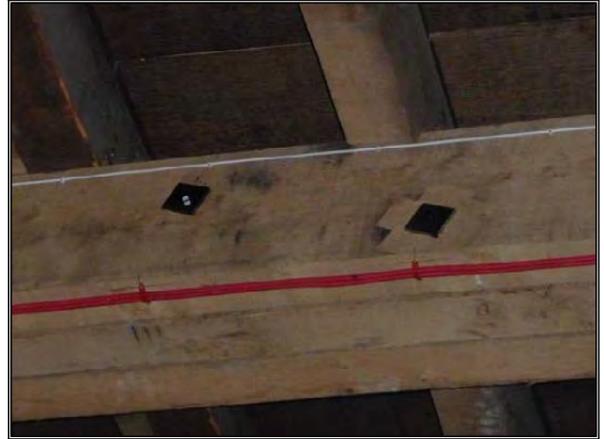
Photos 8 and 9 Three timber joists bolted together

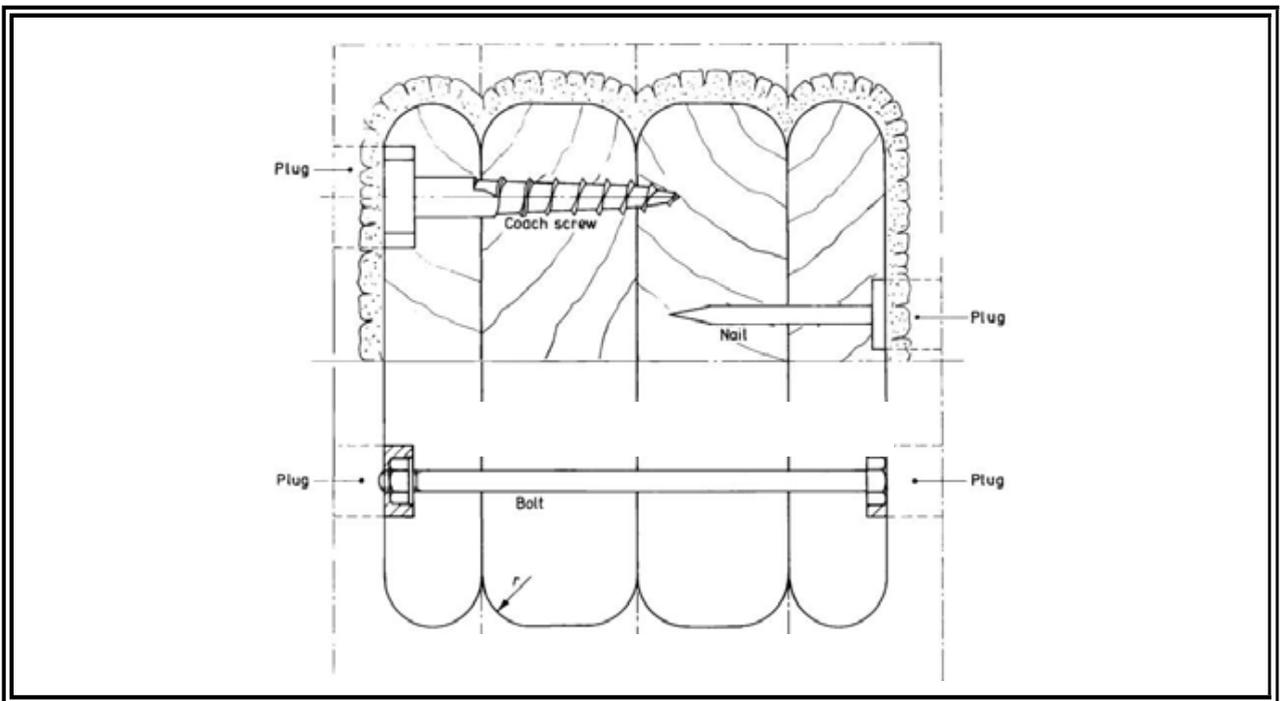
Figure 3 Charred timber section with steel connections to BS 5268 Part 4.1

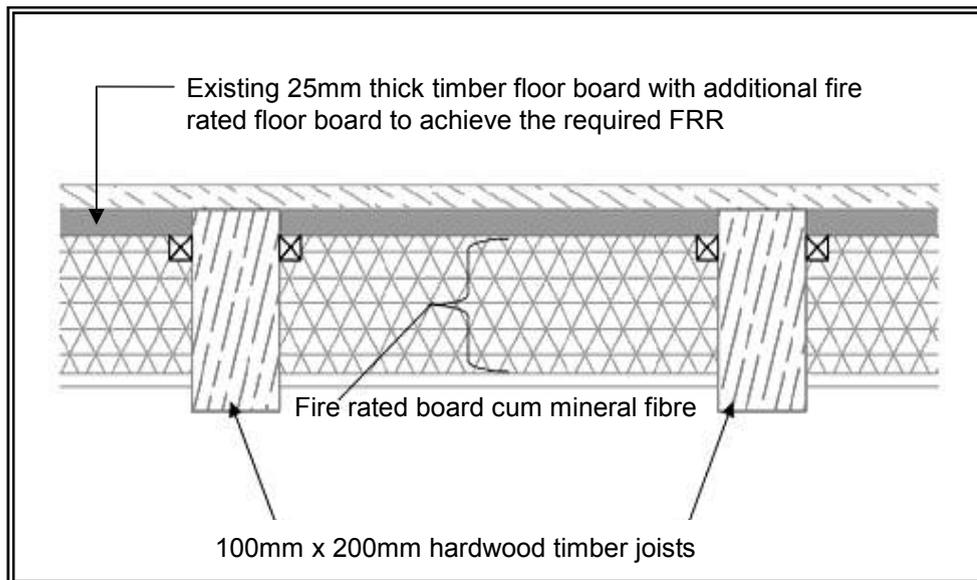
Figure 4 Additional fire rated protective board fixed at underside of floor board with additional fire rated board installed underneath the top timber planking

When the existing timber floor board is required to achieve certain FRR under the FS Code, additional fire rated floor board can be installed beneath the existing timber floor planking (Fig. 4 refers). If the top surface of the existing timber floor board is exposed to fire, the additional fire rated floor board installed underneath can still provide structural support to the imposed floor loads. Details of the upgraded timber floor should also be included in the Schedule of Building Materials and Products under PNAP APP-13 when applying for occupation permit or certifying completion of the respective A&A works.

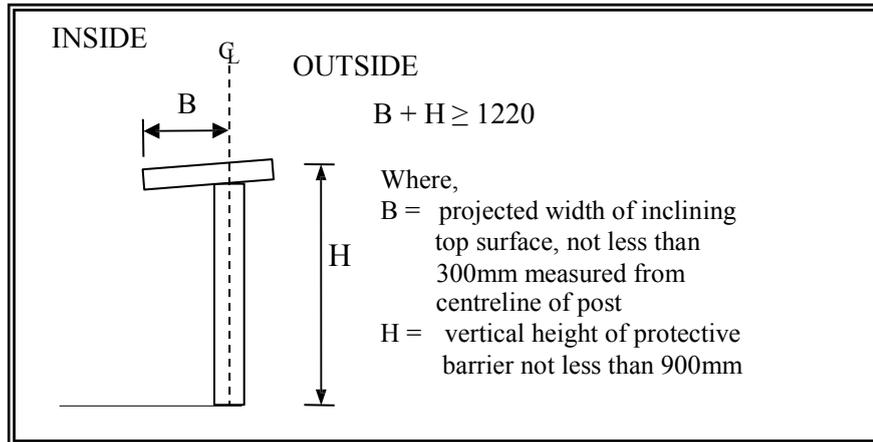
Figure 5 Relationship between the height of protective barrier (H) and minimum width of top surface (B)

- (i) the height of the protective barrier is not less than 900mm;
- (ii) the sum of the width of the top surface measured from centreline of the barrier being not less than 300mm and the height of protective barrier being not less than 900mm, is not less than 1220mm. Figure 5 refers;

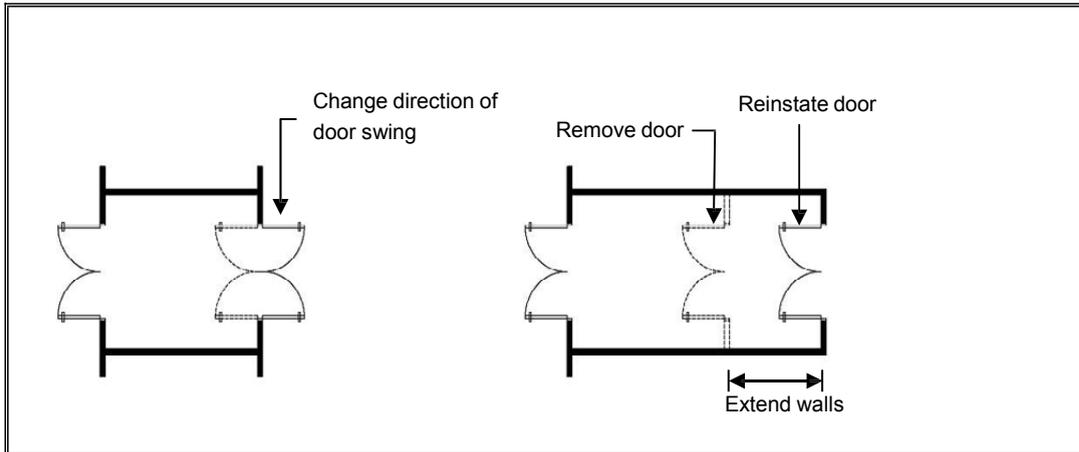
Figure 6 Change door swing direction

Figure 7 Lobby extension

It may be possible to either change the direction of door swing or to replace the door hinges by those allowing double action such that the full length of the lobby being not less than 1200mm can be allowed for manoeuvring wheelchairs (Figure 6 refers). If the latter one is to be adopted, a check mechanism shall be provided to prevent the door swinging beyond the closed position and a transparent vision-panel with a bottom edge not more than 1000mm and the top edge not less than 1500mm above the finished floor level shall be provided.

Alternatively, where there is enough space, it may also be possible to extend the walls of the lobby to achieve the minimum length requirement subject to the AMO's agreement. Figure 7 refers.

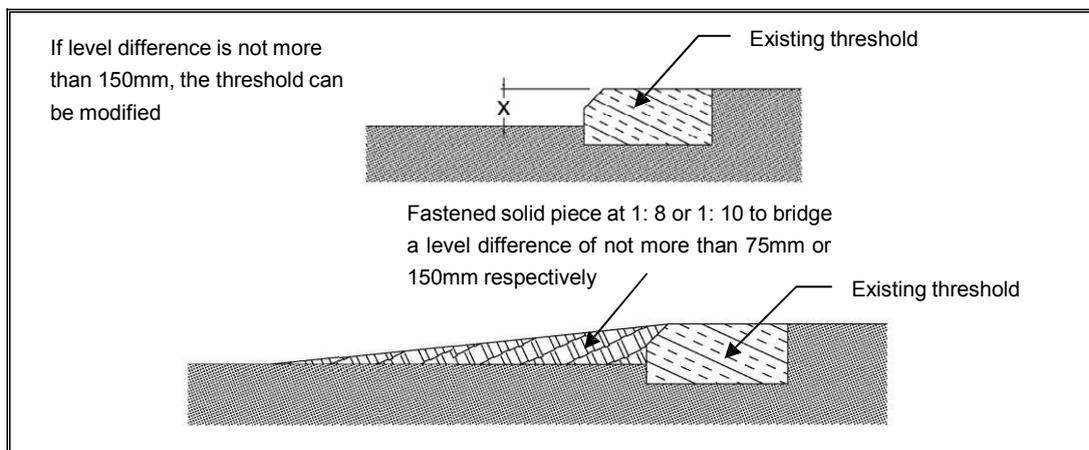
Figure 8 Installation of solid piece

It may be possible to fasten a wedge-shaped solid piece having gradient of not less than 1:8 or 1:10 to bridge a level difference of not more than 75mm or 150mm respectively if its maximum length is not more than 600mm and 1500mm respectively. Figure 8 refers.

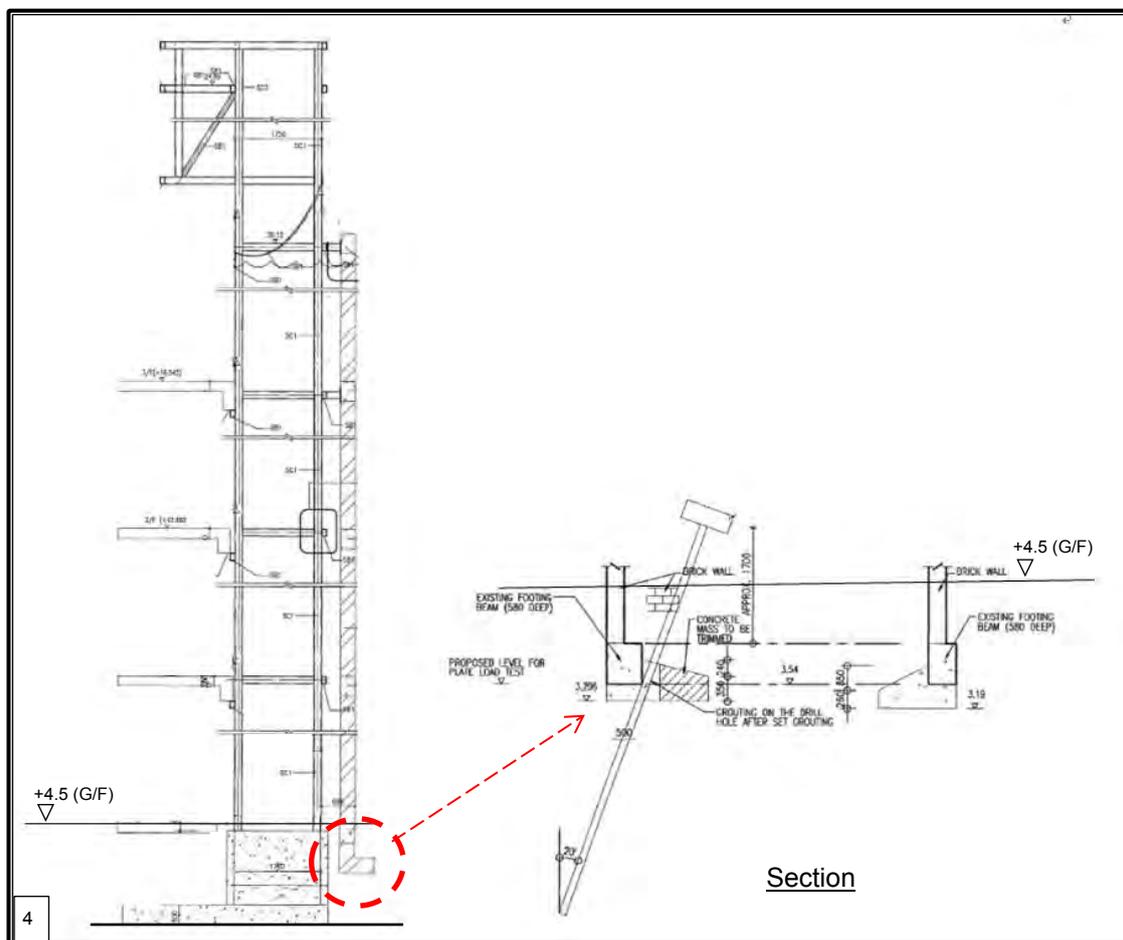
New steel structure, footing for accessible lift and ground improvement works by injecting cement grout into ground soil underneath existing footing

To accommodate a new accessible lift, a structurally independent new steel frame has been constructed on a new spread footing within the existing building. To allow space for the new footing, a portion of the existing footing has been trimmed and modified. Ground improvement underneath the affected footing has also been carried out locally to enhance the bearing capacity.

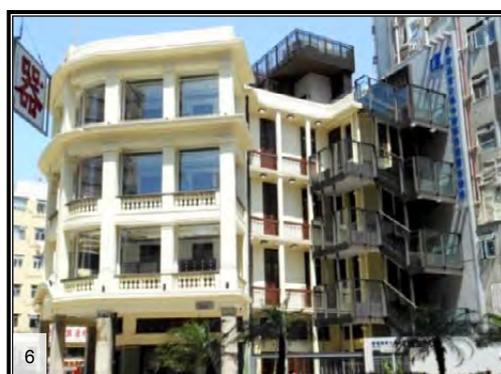
6 The new external staircase

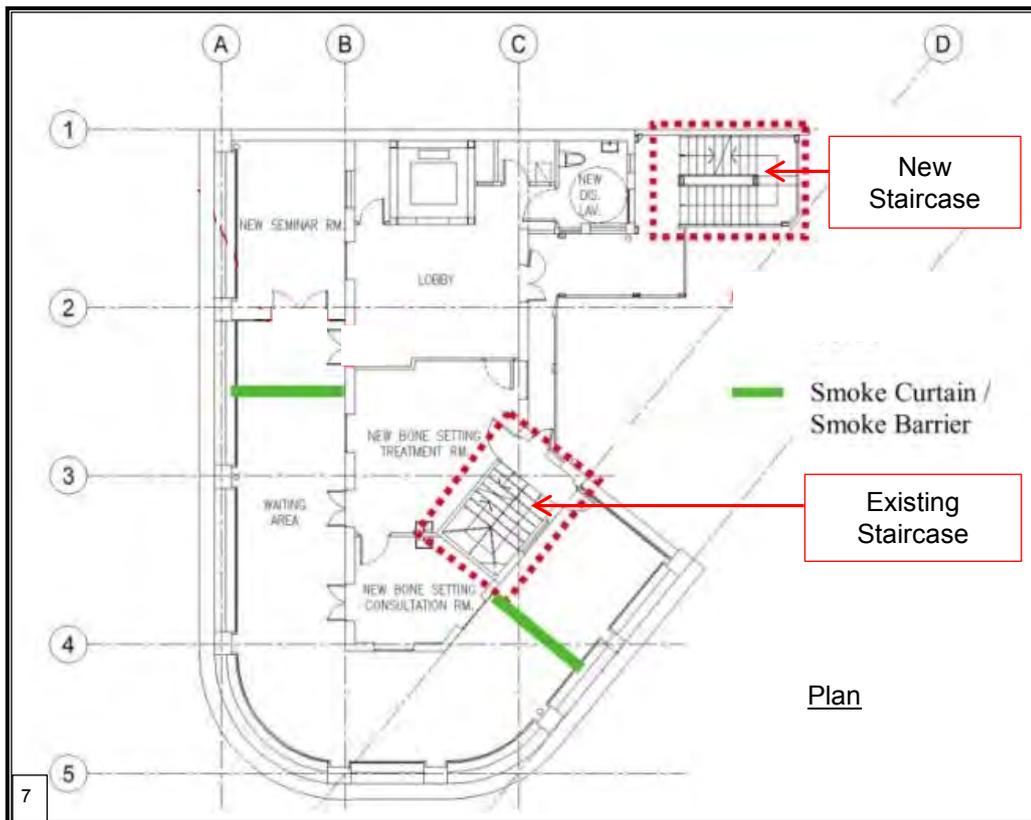
Locations of required staircases and smoke curtains for 1/F – 3/F

LSC has the following constraints in meeting the current fire safety requirements: (i) there is only one staircase of about 900mm wide with winders and one exit door of 710mm wide<sup>2</sup>, (ii) the vertical spandrel between 1/F and 2/F is 600mm<sup>3</sup>.

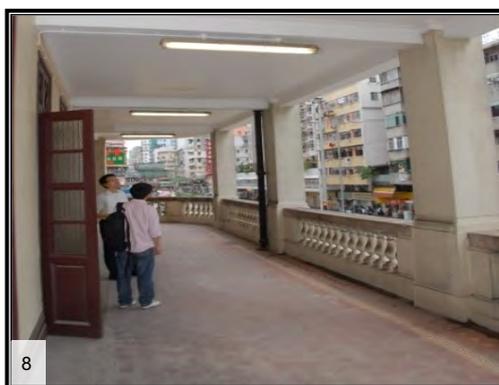
Open verandah with existing bottle balustrades lower than 1100mm

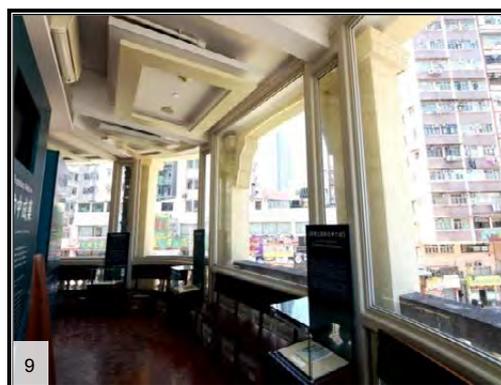
Enclosed verandah with new glass walls

Considering the need to convert the verandahs into consultation rooms, patient waiting areas and pharmacy, the verandahs are enclosed with full height tempered glass walls. Apart from preventing the danger of falling to meet the statutory requirements, the tempered glass panels provide weather protection, traffic noise barrier and air quality control serving the functional needs of the new rooms.

The new glass walls have been set back from the balustrade to avoid intruding the preserved facade. The new structural frames and mullions of the glass walls are positioned behind the existing columns to minimise visual impact on the elevations. The existing configuration and features of the verandahs are thus retained with minimal intervention.

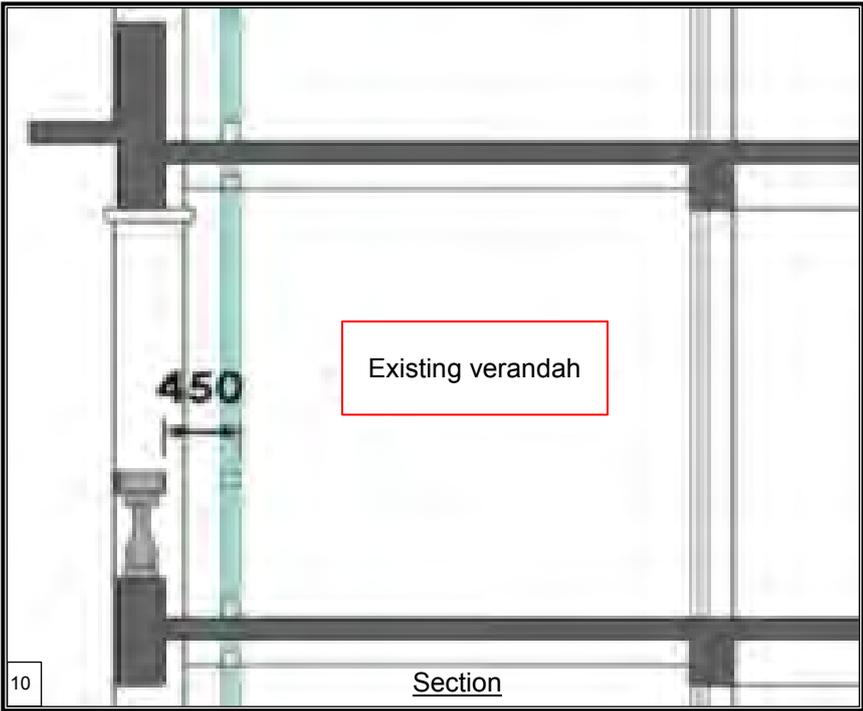
Setting out of tempered glass wall and existing balustrade

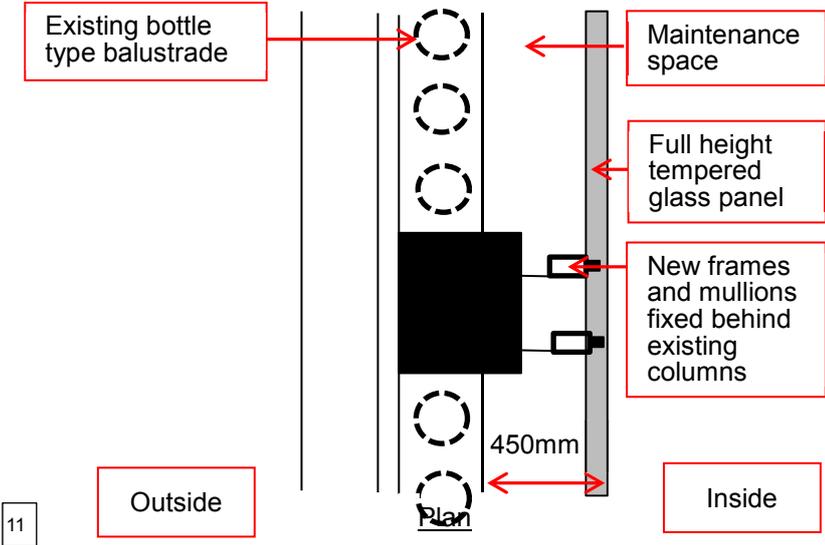
Typical layout of new glass walls and existing balustrade

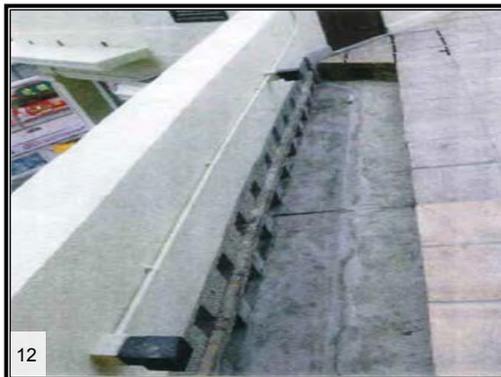
Canton tiles with insulation layer removed along the parapet walls

Part of the canton tile deck with insulation layer of about 200mm high adjoining the parapet walls on roof are removed to lower the adjoining floor level. Potted plants are placed along the parapet walls as a management measure to prevent the users from getting close to the parapet walls.

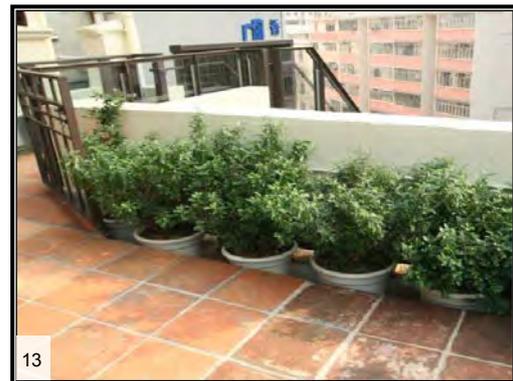
Potted plants to prevent users from getting close to low parapet walls

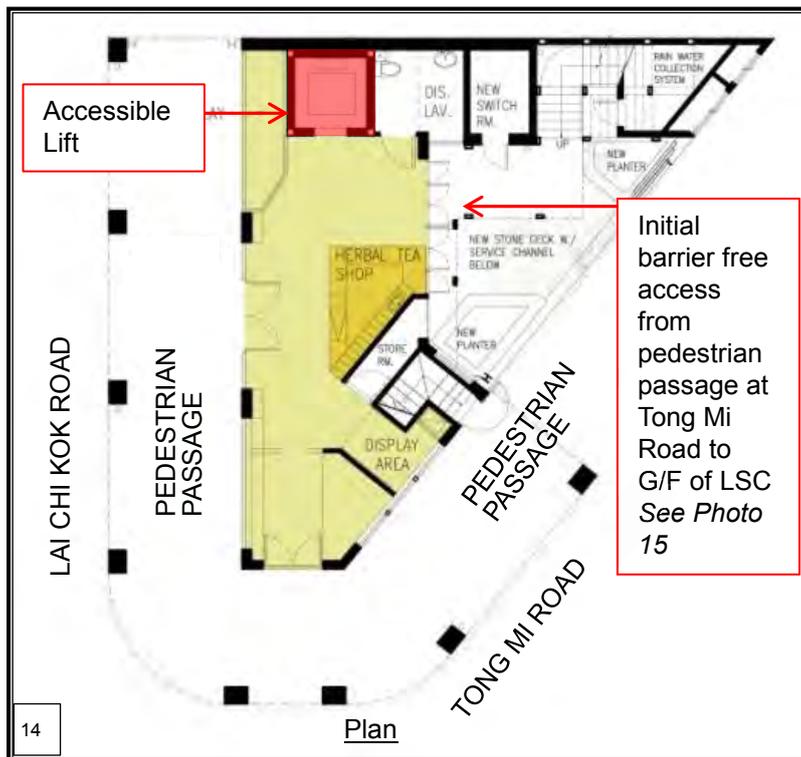
Barrier Free Access arrangement on G/F

The courtyard facing Tong Mi Road has been leveled up and finished with stone deck to eliminate the level differences between the internal area of LSC and the pavement of Tong Mi Road for providing initial access to the building and the accessible lift near by. Drainage slots are provided at the stone deck to drain off outdoor surface water.

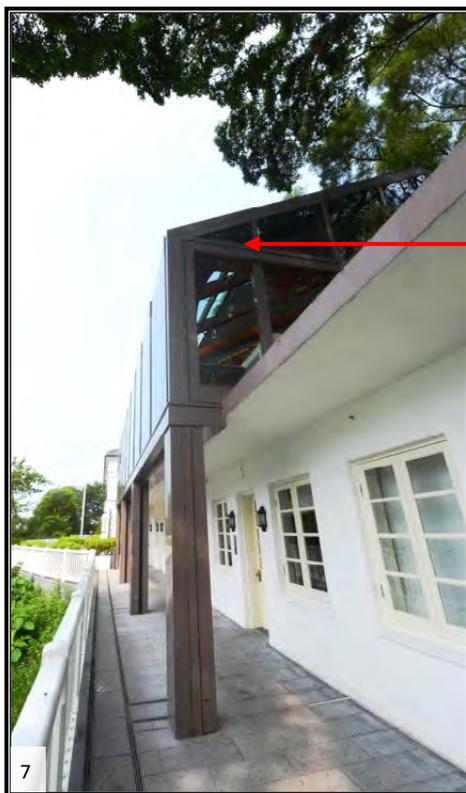
To provide a new roof for the restaurant but without inducing further additional loads on the existing structure, a structurally independent metal pitched roof and new pad footings were constructed.

Independent structure of the new roof for the restaurant

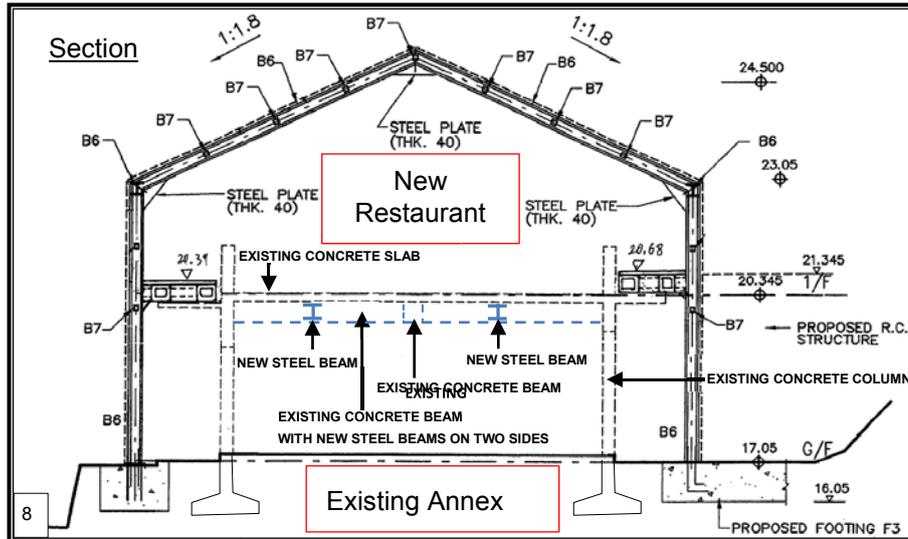
The new restaurant use on the existing roof of the Annex was made possible by reinforcing the concrete roof slab with new steel beams supported by the existing concrete columns resting on the existing pad footings without further strengthening works.

Roof detail

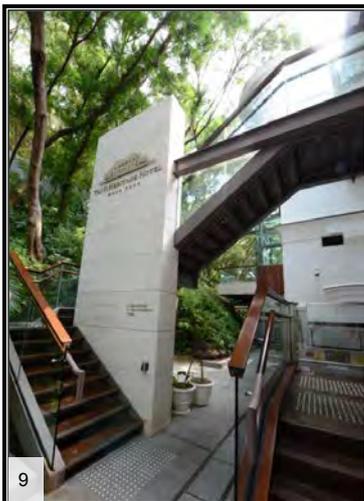
New staircase to the Main Building

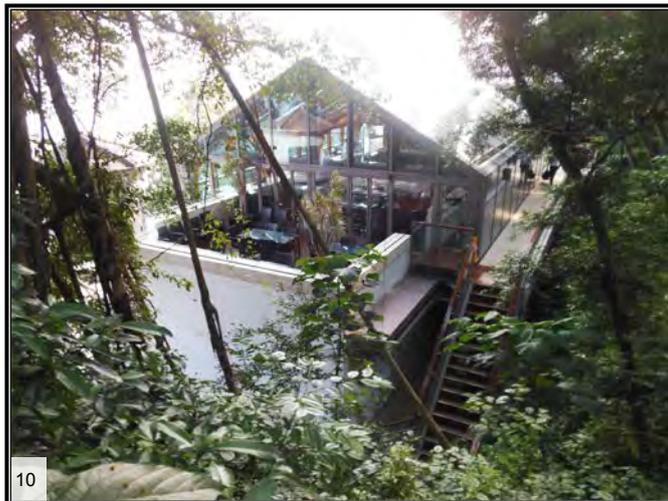
New staircase to the Annex

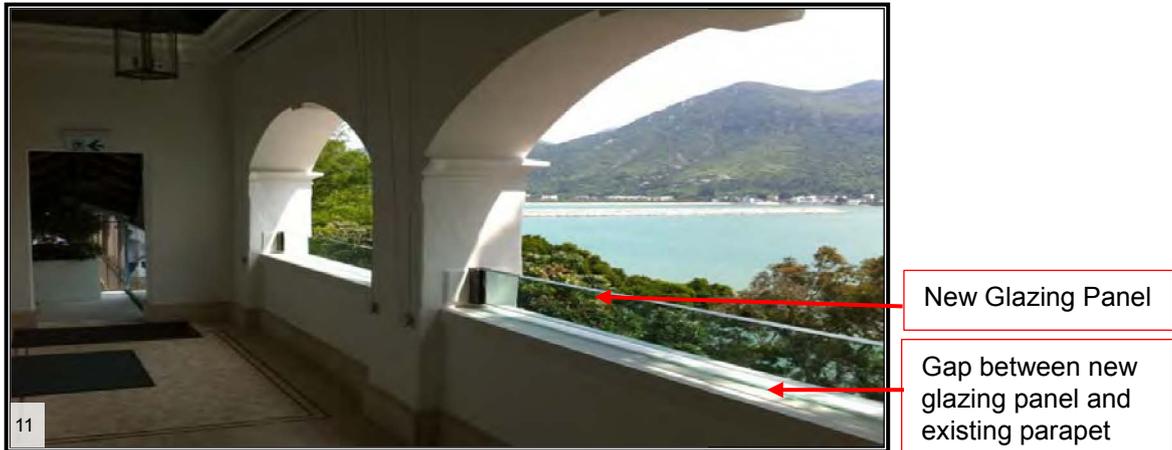
For the parapet walls on 1/F of the Main Building, a small gap is reserved between the new glazing panels and the existing parapet walls so that the panels can be removed without damaging the existing parapet walls in future. The glazing panels are supported by the nearby columns.

Additional glazing panels to add height to the existing parapet walls in the Main Building

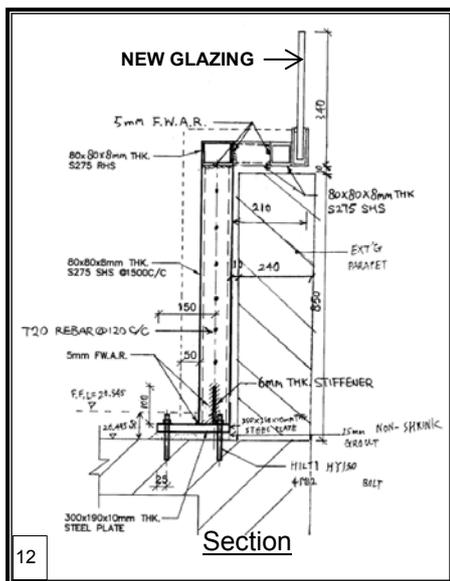
Similarly for the parapet walls at the Annex, the new glazing panels are fixed by independent steel frame mounted on the structural floor.

Fixing detail of steel frame for additional glazing panel at Annex

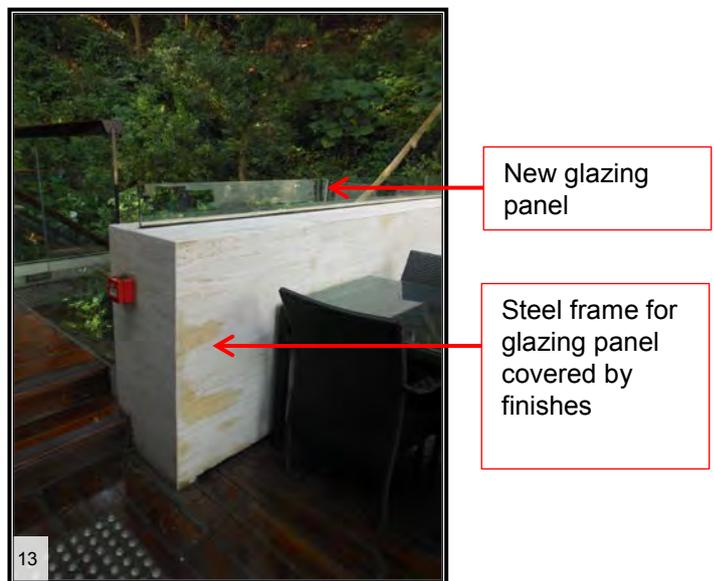
Additional glazing panel at Annex

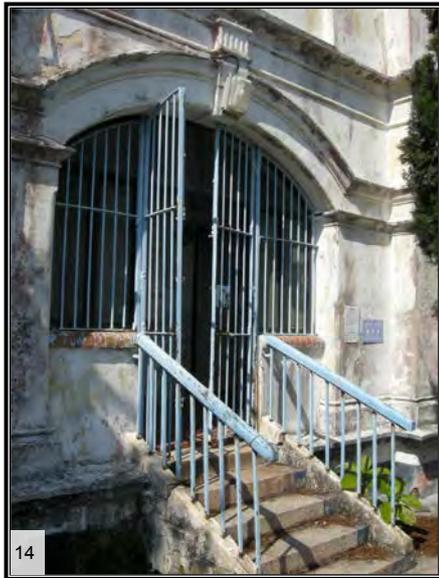
The existing parapet walls on G/F of the Main Building are also of insufficient height for serving as protective barriers<sup>5</sup>. The ground level of the adjoining open garden is raised so that protective barriers are not required at the verandahs.

Before levelling

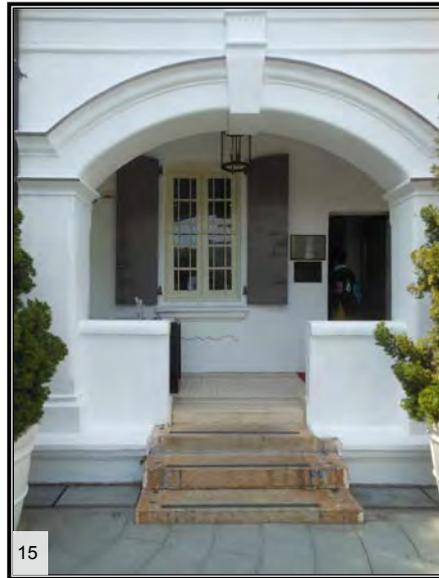
After levelling

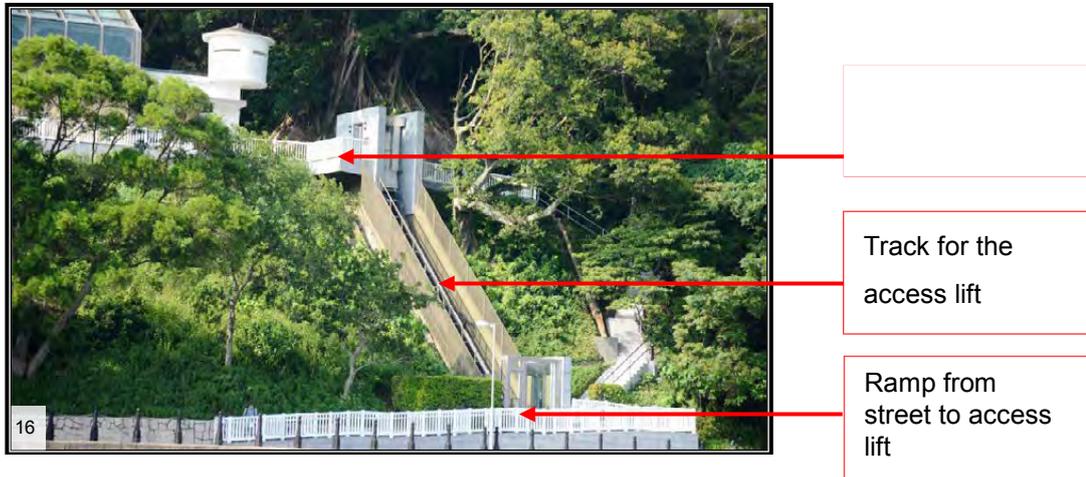
An inclined lift respecting the existing slope profile is added to provide access for persons with a disability (PwD) from Shek Tsai Po Street to the entrance level of the compound.

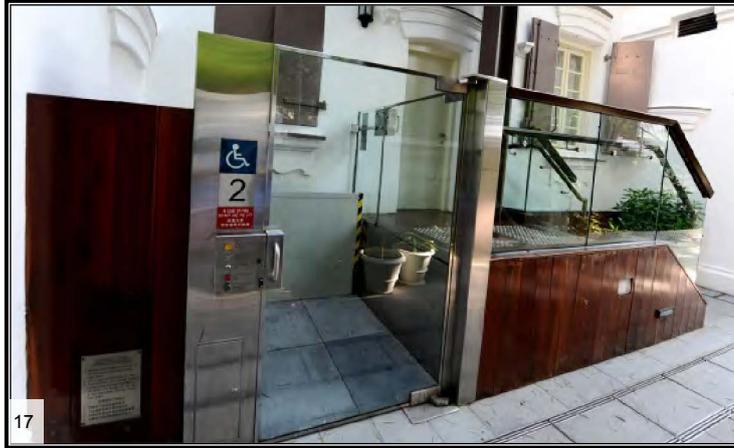
Vertical lifting platform to the Main Building

To overcome the level differences, two vertical lifting platforms are added. One is at the rear of the Main Building to provide access to the Reception and Interpretation centre (Photo 17). Another one is installed on G/F of the Main Building to provide access to 1/F (Photo 18).

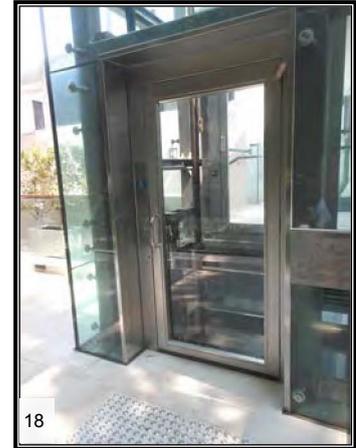
Vertical lifting platform to 1/F

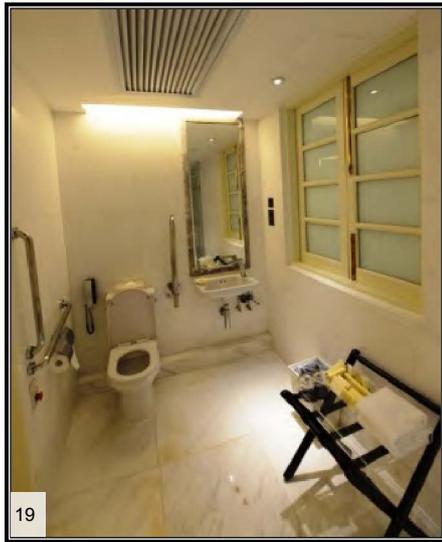
Accessible toilet

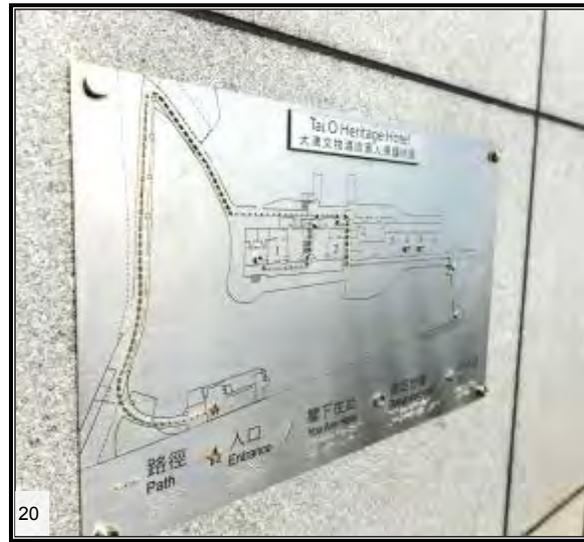
Braille and tactile floor map

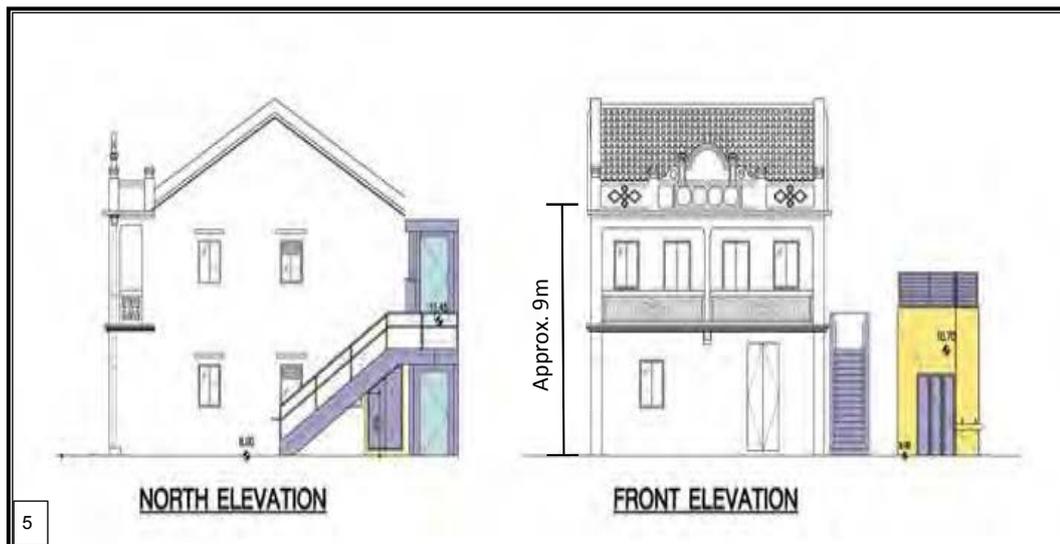
Elevations (new structures shown in colour)

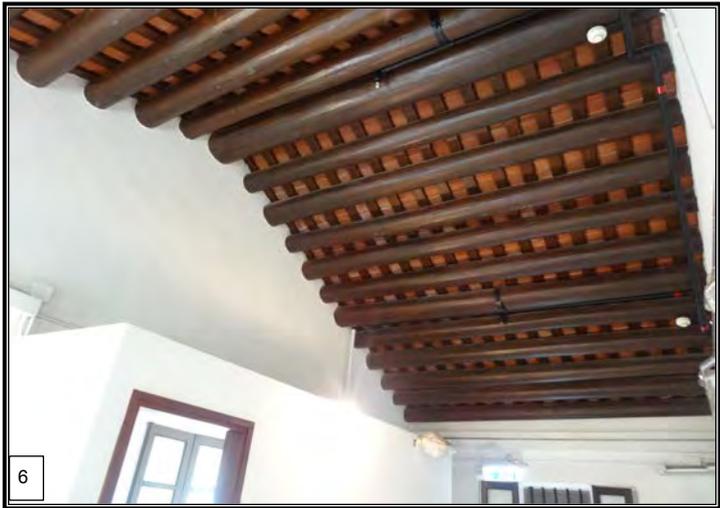
The original timber pitched roof was replaced by metal roof supported by metal truss around 1998. A new pitched roof has been reconstructed with timber purlins and battens as well as clay pan-&-roll roof tiles to restore the original design. Concealed bolts have been used to secure the roof tiles to meet the current requirements<sup>1</sup>.

Reconstructed timber roof

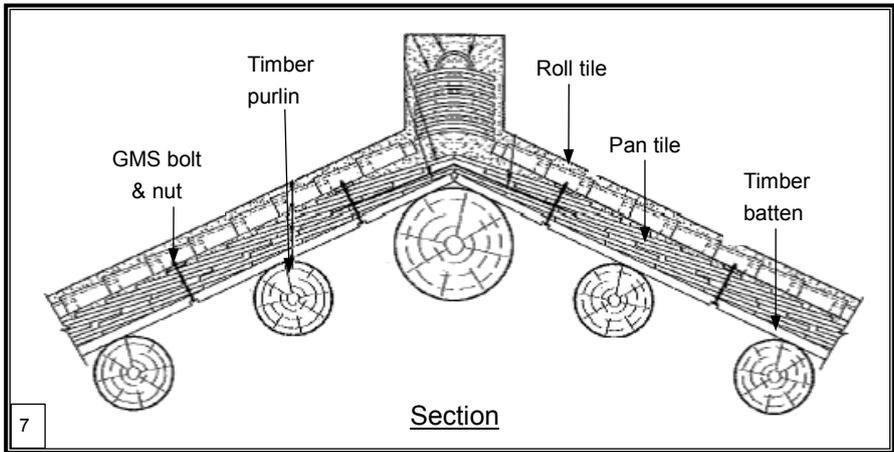
Detail of new timber roof

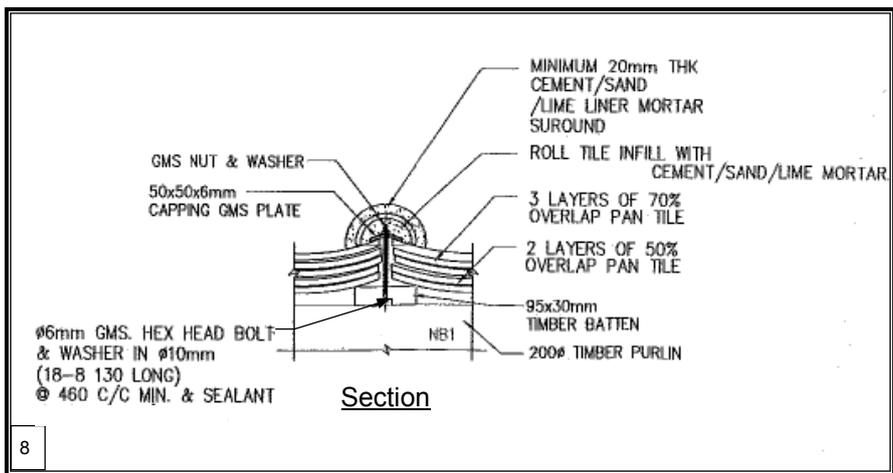
Fixing details of tiles

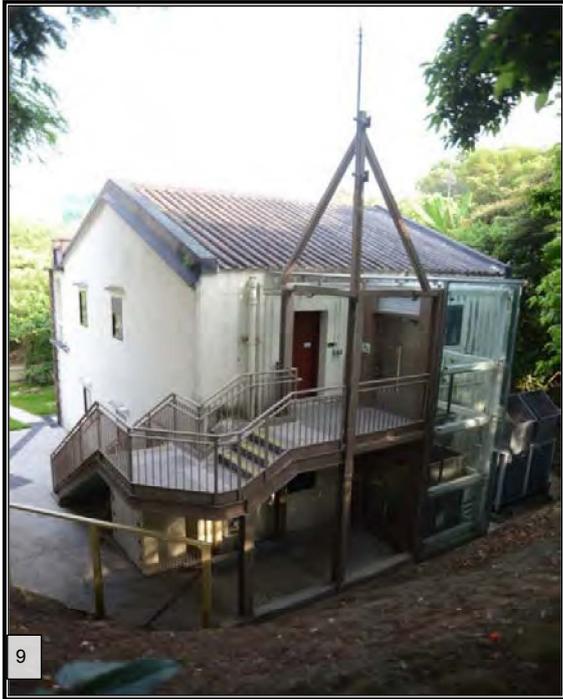
A new external metal staircase added at the side and rear elevations

- (ii) The existing external concrete staircase is replaced by a new metal staircase of 1200mm wide
- (iii) The existing openings of the building within 6m of the new open staircase are protected by new fire-rated door or dampers with adequate FRR

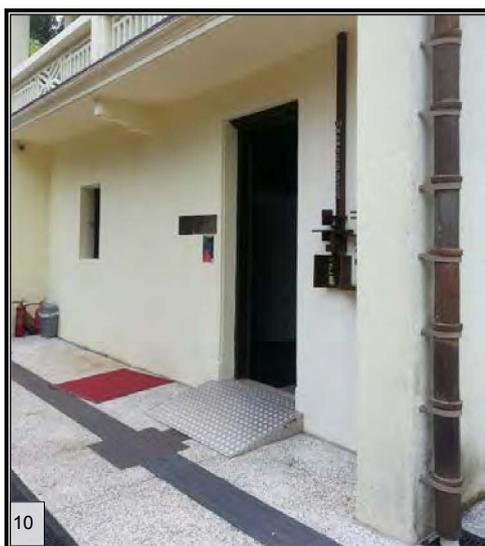
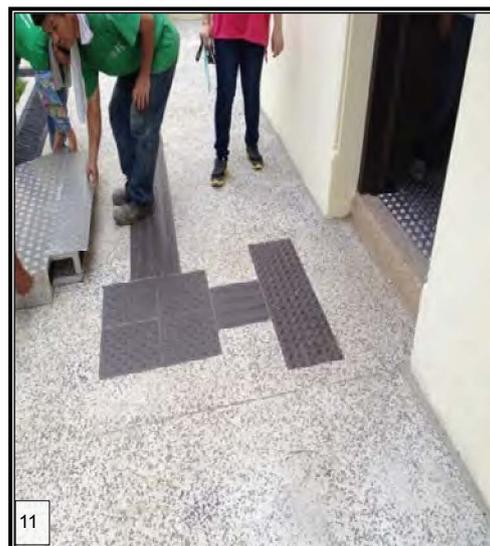
Apart from providing tactile warning strips near the threshold, a barrier free access management plan has been adopted to enhance the barrier free access including the operation of a standby movable ramp and provision of trained staff during operation hours of FYSH to assist persons with a disability to enter or leave the building.

Tactile warning strips and movable ramp at G/F entrance

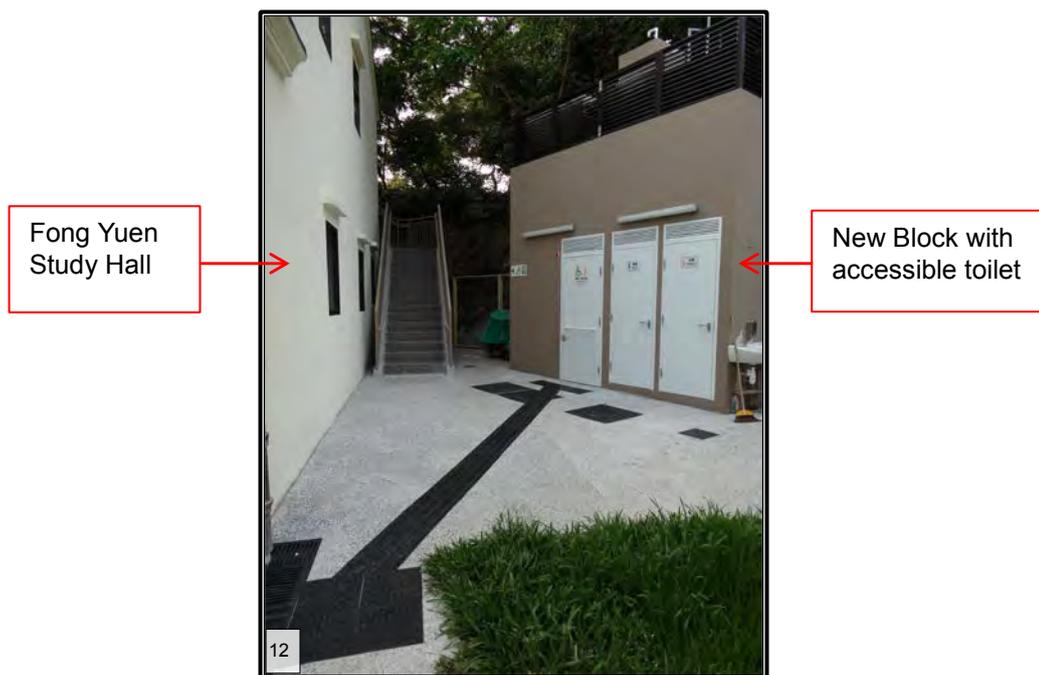
FYSH has very restricted space, provision of new accessible toilets within the building<sup>9</sup> is not feasible. An accessible toilet and other ancillary building services is provided in a new block adjacent to FYSH.

Provision of accessible toilet

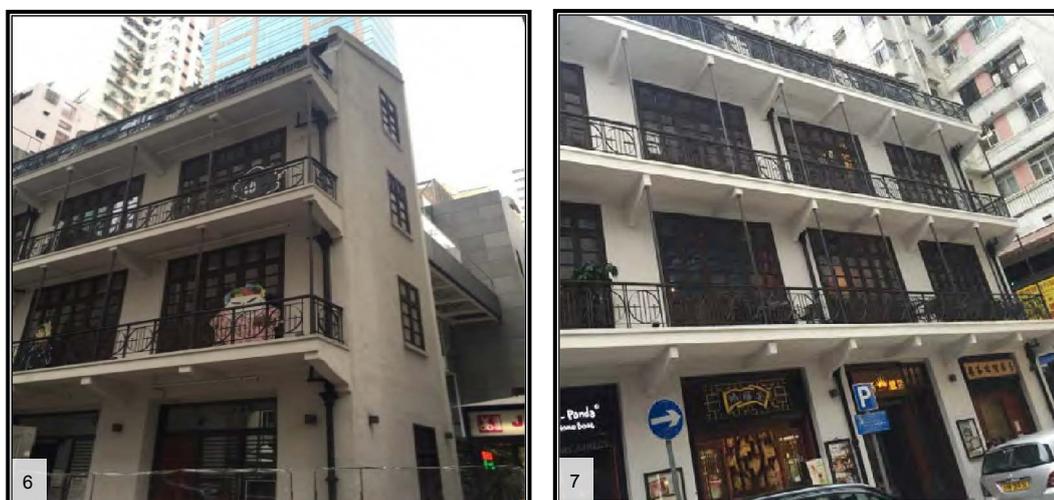
The existing cantilevered balconies project over the two streets. Due to their unsatisfactory structural conditions, the balconies had to be reconstructed replicating the original profile. They are permitted to project over the adjoining streets through exemptions under the Buildings Ordinance but are accountable for gross floor area calculation under the Building (Planning) Regulations<sup>2</sup>.

Reconstructed balconies facing Burrows Street and Mallory Street

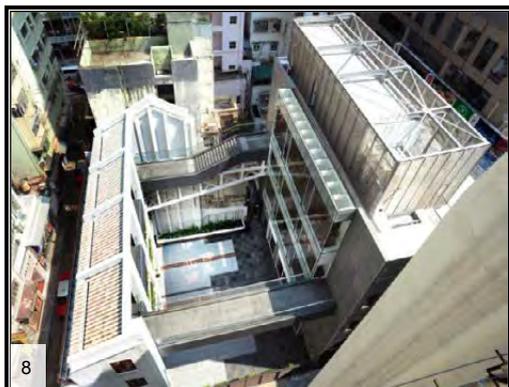
These two trusses also serve as connecting footbridges offering vistas to the public open space in the central court.

Aerial photo showing the trusses connecting the New Annex and the existing facade
