# Practice Guidebook for Adaptive Re-use of and Alteration and Addition Works to Heritage Buildings 2012

**Practice Guidebook**  
**on**  
**Compliance with**  
**Building Safety and Health Requirements**  
**under the Buildings Ordinance for**  
**Adaptive Re-use of and**  
**Alteration and Addition Works to**  
**Heritage Buildings**

**Buildings Department**  
**Hong Kong**

**(2019 Edition)**

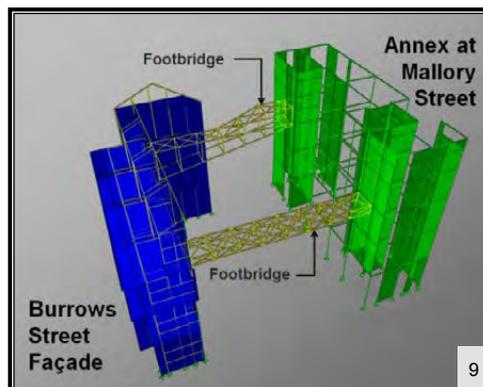
Three-dimensional structural model showing arrangement of the structural system

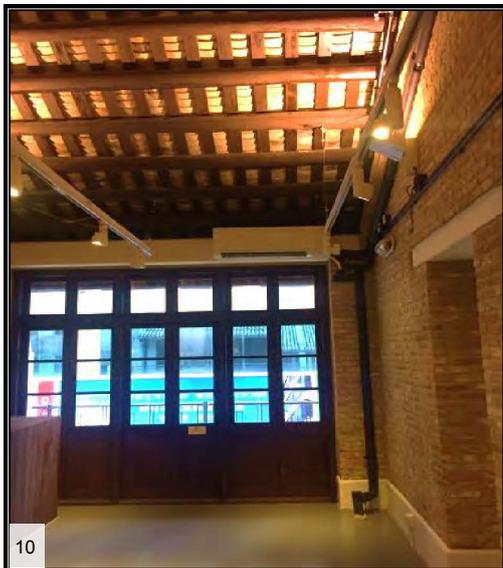
The Chinese-style tiled and timber roof

New steel members have been integrated with the restored timber purlins and heatproof materials; and new steel fixings were embedded in traditional Chinese double-layer pan-and-roll tiling construction to meet the current requirements on structural safety<sup>3</sup>. The original distinctive outlook of the timber pitched roof which is one of the CDE can therefore be retained.

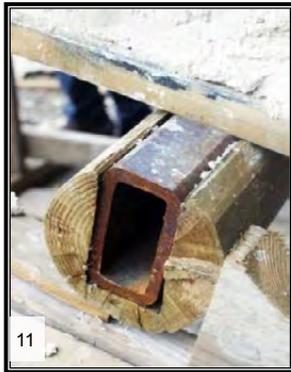
11  
New steel members embedded in timber purlin

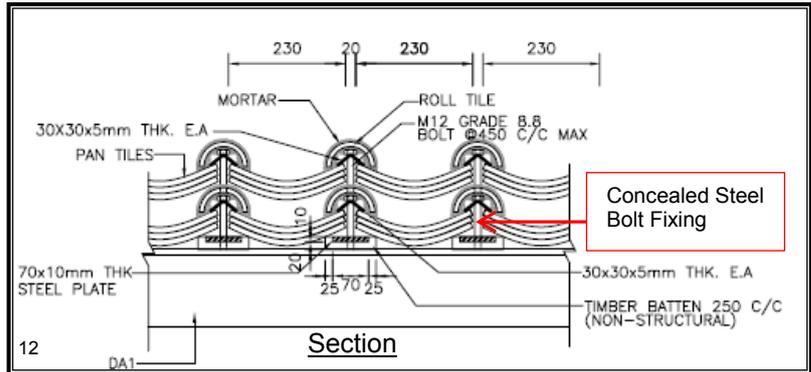
12  
Fixing details of double-layer pan-and-roll tiles

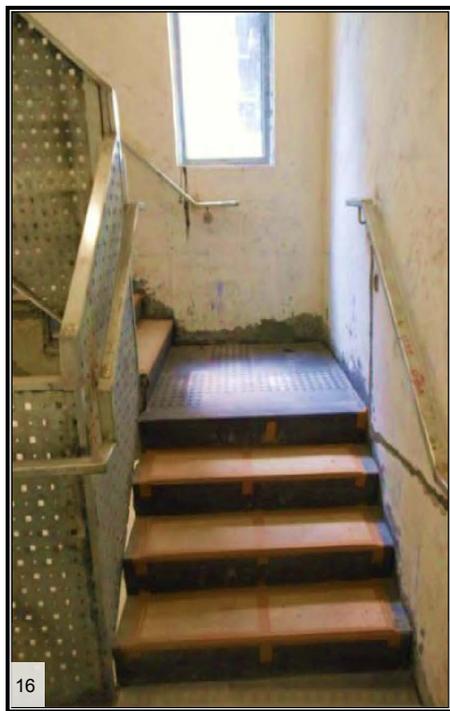
The new additional staircase

<sup>5</sup> For the subject building, a required escape staircase shall be of a minimum width of 1050mm in accordance with Building (Planning) Regulation (B(P)R) 41 and Code of Practice for Fire Safety in Buildings 2011 (FS Code).

<sup>6</sup> Floors and escape staircases shall be constructed of non-combustible materials with adequate fire resistance rating in accordance with B(C)R 90 and the FS Code.

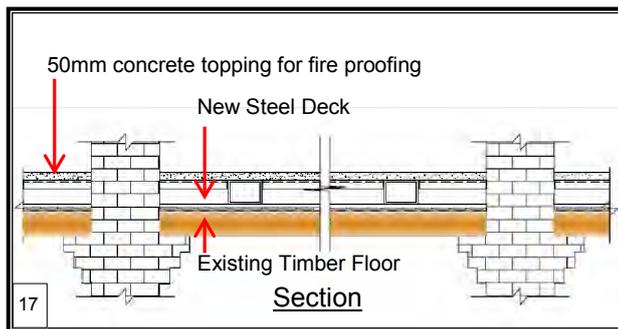
Typical floor system

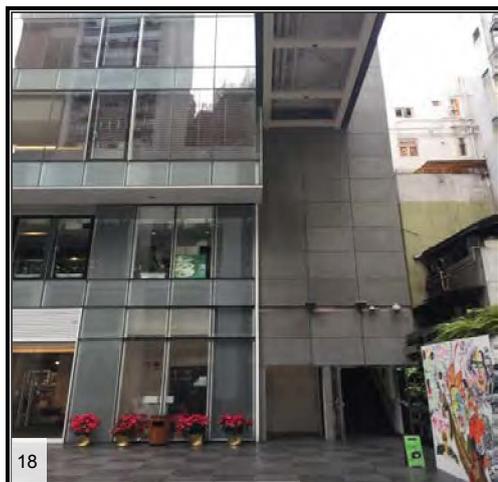
A fireman's lift has been added at the new Annex Block to meet the current safety standards as well as to enhance the vertical mobility of Persons with a Disability (PwD) and servicing.

The new Annex Block

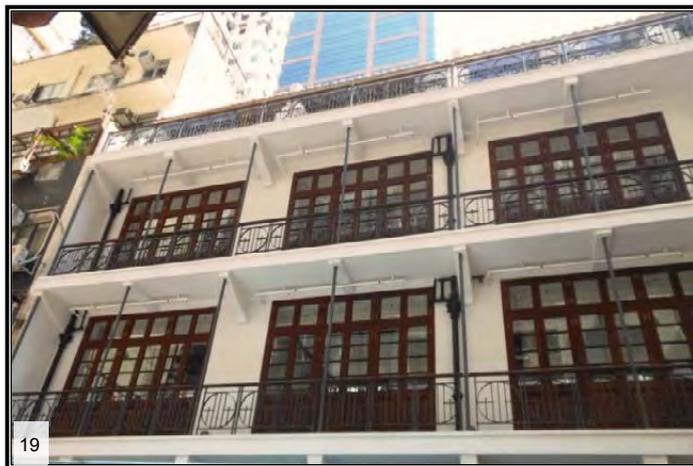
Existing railings are inaccessible and retained for visual enjoyment

For the accessible balconies, secondary barriers made of clear tempered glass panels of 1100mm are installed behind the railings for meeting statutory requirements<sup>7</sup>. Original state of the railings in other balconies has been retained for visual enjoyment only from a distance, to prevent the risk of falling.

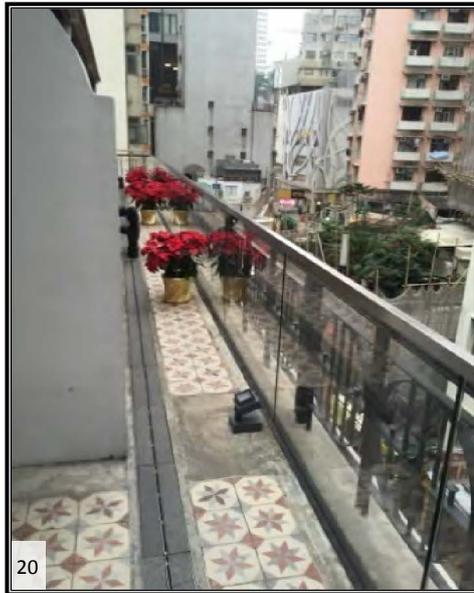
New glass balustrade added behind the existing railing at accessible balconies

<sup>7</sup> Protective barriers shall be at a height above the higher of the adjacent levels of not less than 1100mm; and constructed as to prohibit the passage of articles more than 100mm in their smallest dimension in accordance with B(C)R 8.

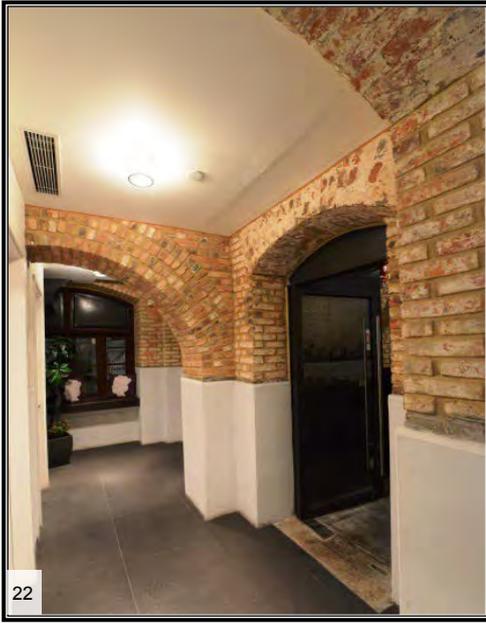
Existing brick arched doorways 800mm - 825mm wide are inadequate to serve as passageway required under DMBFA for PwD<sup>8</sup>. Alternative access routes are provided in less conspicuous locations so that prestigious doorways in prominent locations can be preserved.

Preserved prestigious doorways

<sup>8</sup> Passageway shall have a clear width of not less than 1050mm in accordance with the Design Manual: Barrier Free Access 2008 (DMBFA).

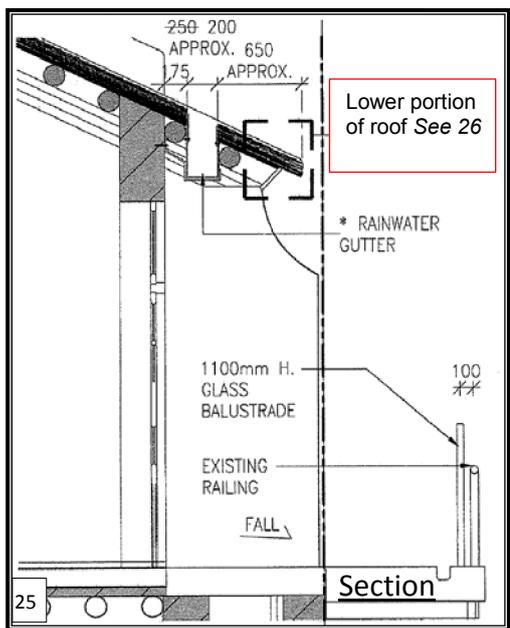
As the conventional method of installing gutter along the eaves to meet current requirement<sup>10</sup> would impair the traditional appearance of the Chinese-style pitched roof, gutters have been installed at a 650mm setback. Exemption from relevant statutory requirements has been granted permitting rain on lower portion to discharge directly to the floor of the balcony and then to the surface water channels.

The glass balustrade and rain water gutter

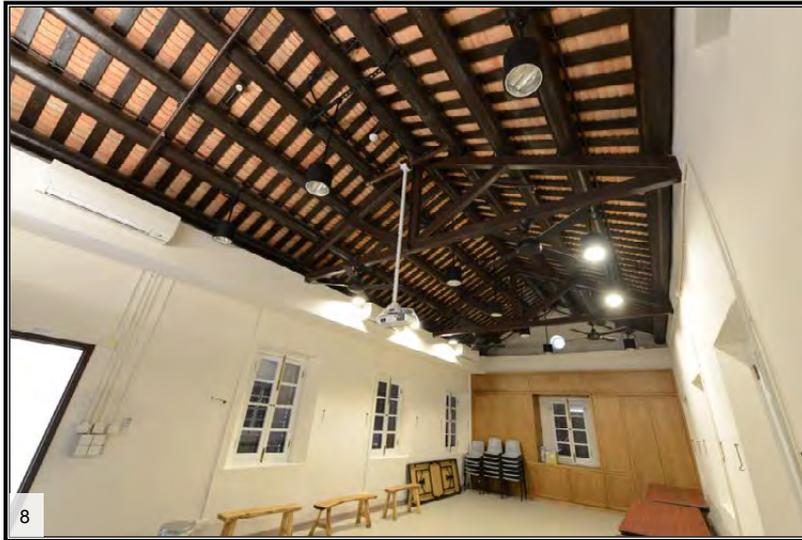
8

New timber roof for the multi-function room in the Main Building

In the Main Building, the original timber pitched roofs are partially replaced by steel purlins and battens. After obtaining approval and consent under the Buildings Ordinance (BO), the relevant portions are reconstructed with timber purlins, timber battens and double-layer clay pan-&-roll roof tiles to restore the original design. To meet current requirements on structural safety<sup>1</sup>, concealed metal bolts are introduced to fix the roof tiles in positions against wind uplifting.

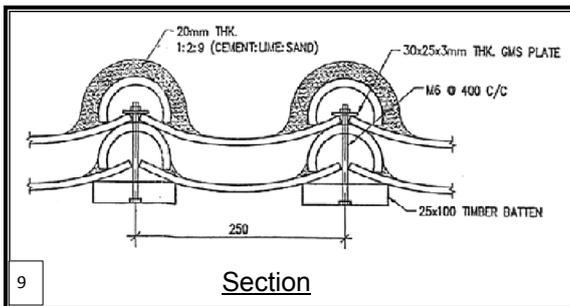
9

Fixing details of roof tile

<sup>1</sup> Wind loadings are assessed in accordance with Code of Practice on Wind Effects in Hong Kong 2004.

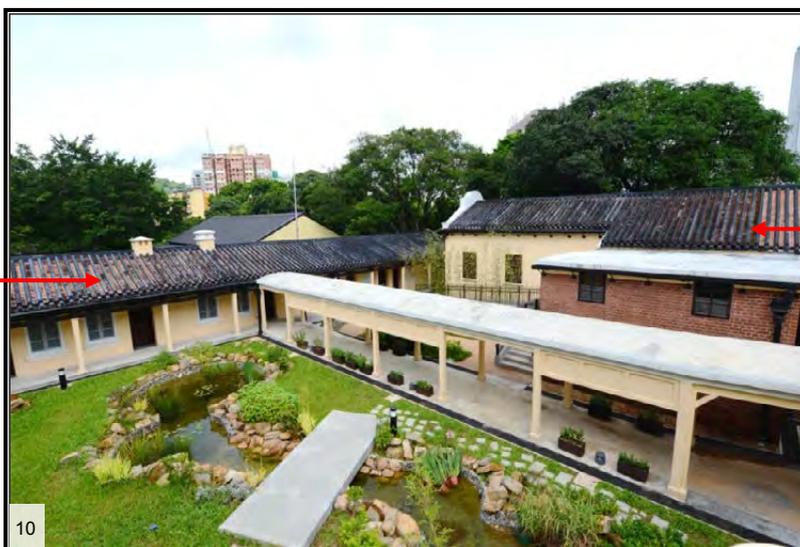
The existing timber roofs of the Ancillary Staff Quarters Block and the steel roof of the Canteen Block are repaired following the simplified requirements under the Minor Works Control System (MWCS).

The existing timber roof repaired under MWCS

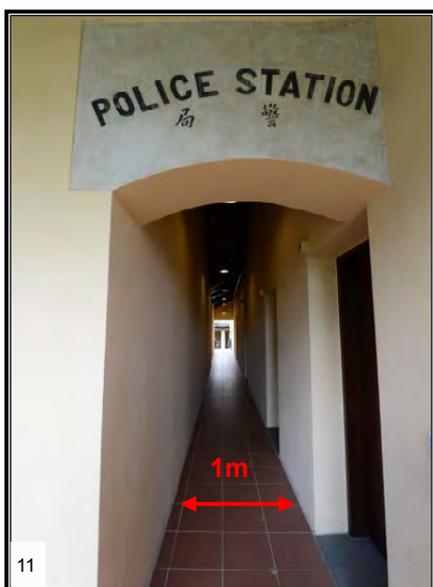
The existing corridor adjacent to the 3 guestrooms in the Main Building, being a required exit route, is only 1m wide and cannot meet the current requirements<sup>2</sup>.

Existing corridor adjacent to the guestrooms

Noting that the total occupant capacity of the guestrooms is only 6 persons, a secondary escape route for the guestrooms is available, the subject building is only 1 storey high, the importance to keep the original design and that the corridor is one of the Character-Defining Elements (CDE), the slight deficiency in the width of this corridor is accepted as not compromising fire safety standards.

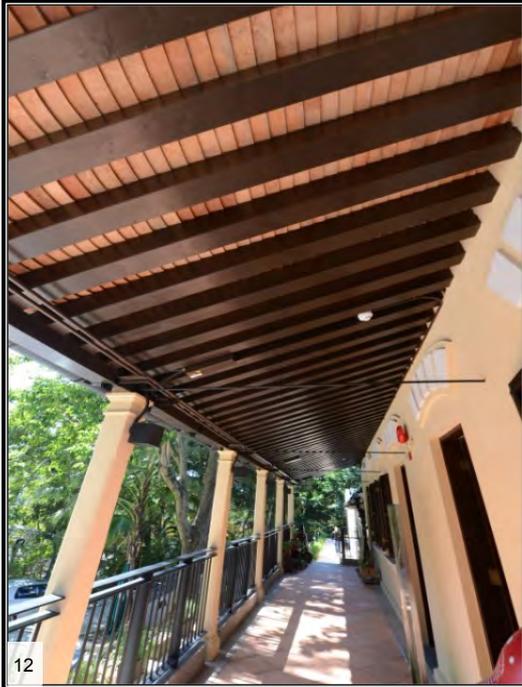
The purlins and battens of the reconstructed timber roof are protected with fire retardant paint to achieve the required Class 1 surface spread of flame tested in accordance with the requirements of BS 476 Part 7, and covered with non-combustible clay tiles.

Existing timber purlins and battens are protected with fire retardant paint

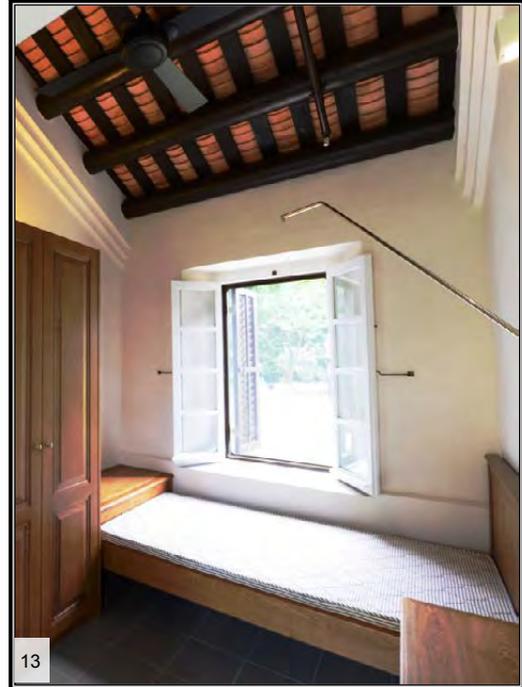
Reconstructed timber purlins and battens are protected with fire retardant paint

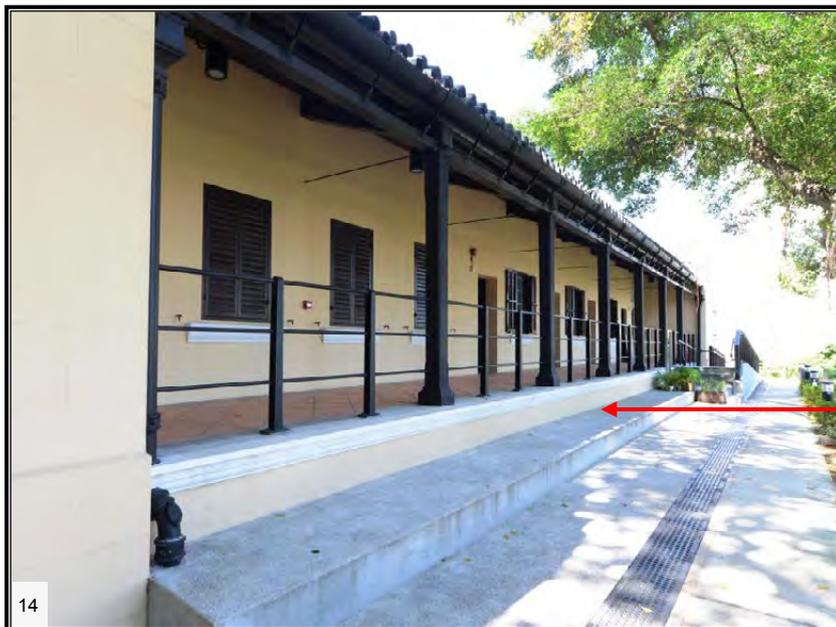
An intermediate platform is added to mitigate the level drop at the same time offering outdoor bench seating.

Intermediate platform added to mitigate level difference

A level difference of over 600mm is found between the verandahs of the Main Building and the adjoining passageway. However, the design of the original balustrade cannot meet the current requirements for protection against falling<sup>5</sup>.

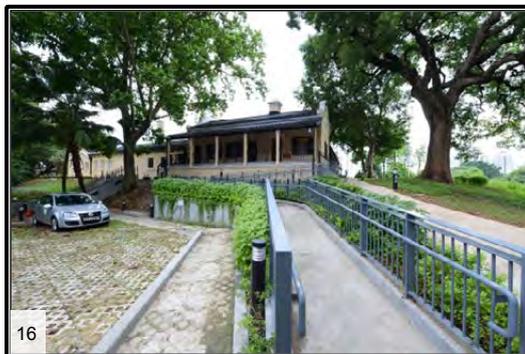
The compound is on elevated platforms about 2m higher than the adjoining street. In order to provide barrier free access, new ramps are added for connecting different platforms.

Initial access ramp to the compound

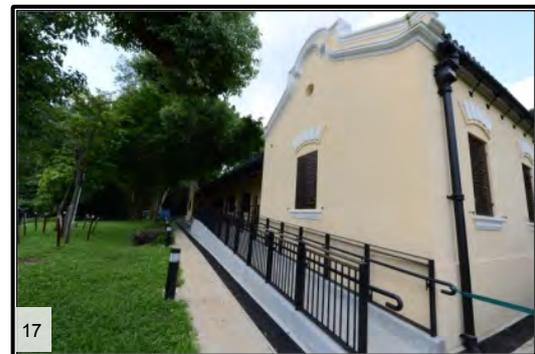
Ramp to the Main Building

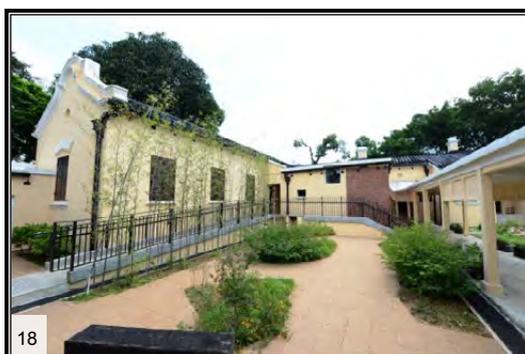
Ramp connecting the Main Building and courtyard

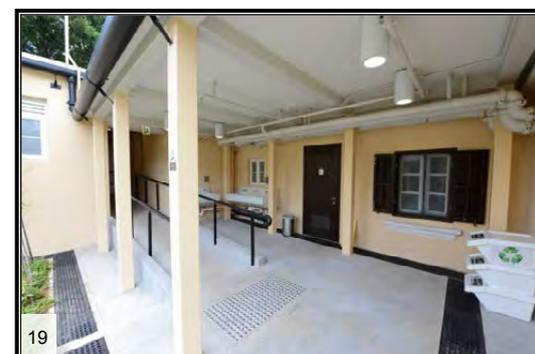
Ramp connecting the Main Building and guestrooms

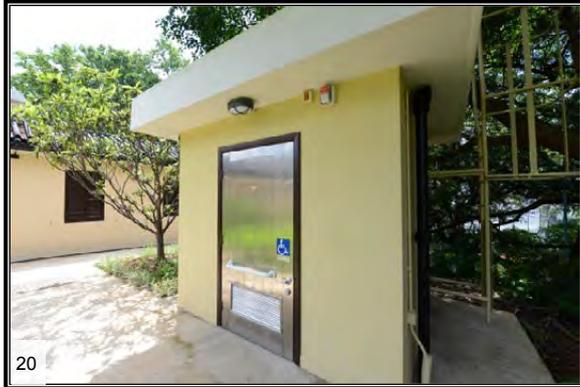
An existing store is converted into an accessible toilet.

New accessible toilet

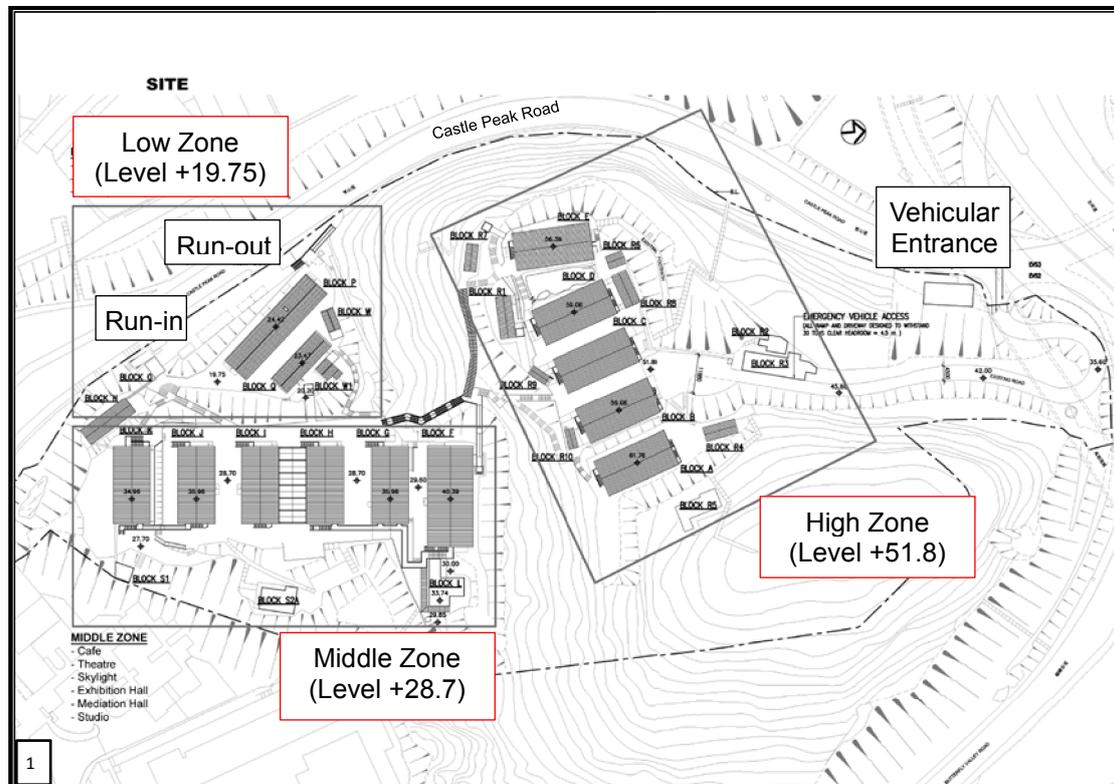
Site Plan (Source: P&T Architects and Engineers Ltd.)

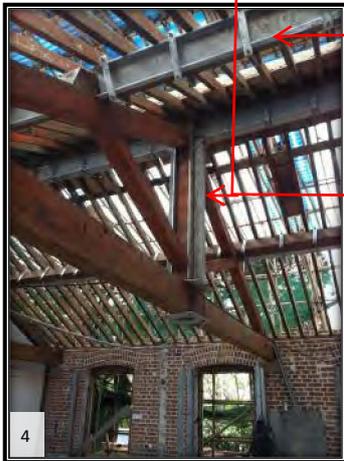
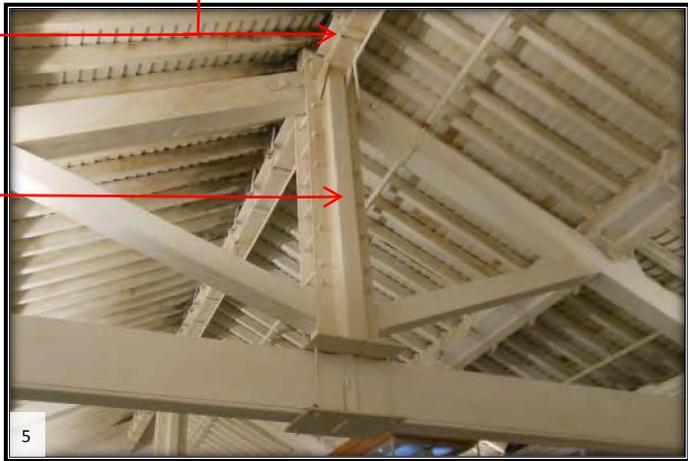
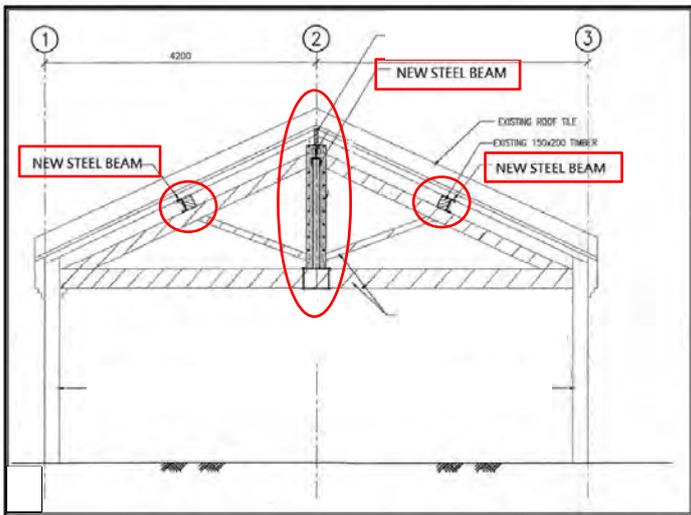
“Sandwich” strengthening by through bolts

New steel beam

Photo and section showing strengthening to the structural elements and connection joints of roofs of buildings in the Low Zone (Source: P&T Architects and Engineers Ltd.)

Location	Pitched Roofs		1/F Floor slabs	
	Original	<b>Additional</b>	Original	<b>Additional</b>
Low Zone (1-storey)	Timber trusses and purlins	<b>Repair and Enhancement Works</b> Localised strengthening by adding steel beams and plates to existing timber structural members	N/A	N/A
Middle Zone (2-storey)	Timber / steel truss and purlins	<b>Repair and Enhancement Works</b> Adding horizontal steel bracings to existing trusses	Reinforced concrete slabs	<b>A&amp;A Works</b> Existing deteriorated timber joists are replaced by new steel beams
High Zone (2-storey)	Steel trusses and purlins	<b>A&amp;A Works</b> Existing steel roof sheets and purlins are replaced by new steel corrugated sheets and steel purlins	Reinforced concrete slabs	<b>Repair and Enhancement Works</b> Adding steel beams to existing floor slabs

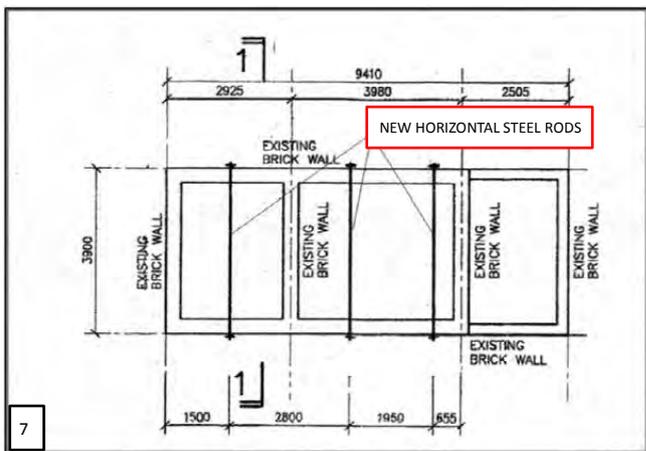
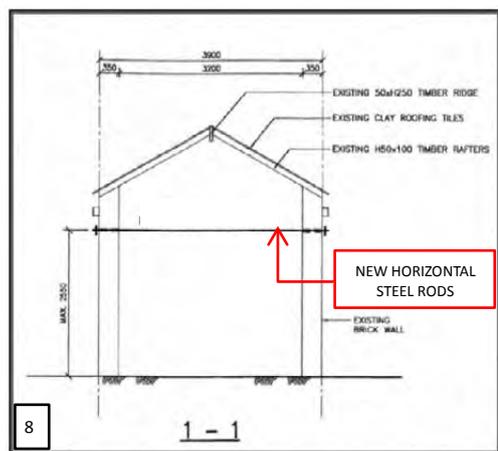
Plan and section showing strengthening works by horizontal steel rods in buildings at the Low Zone

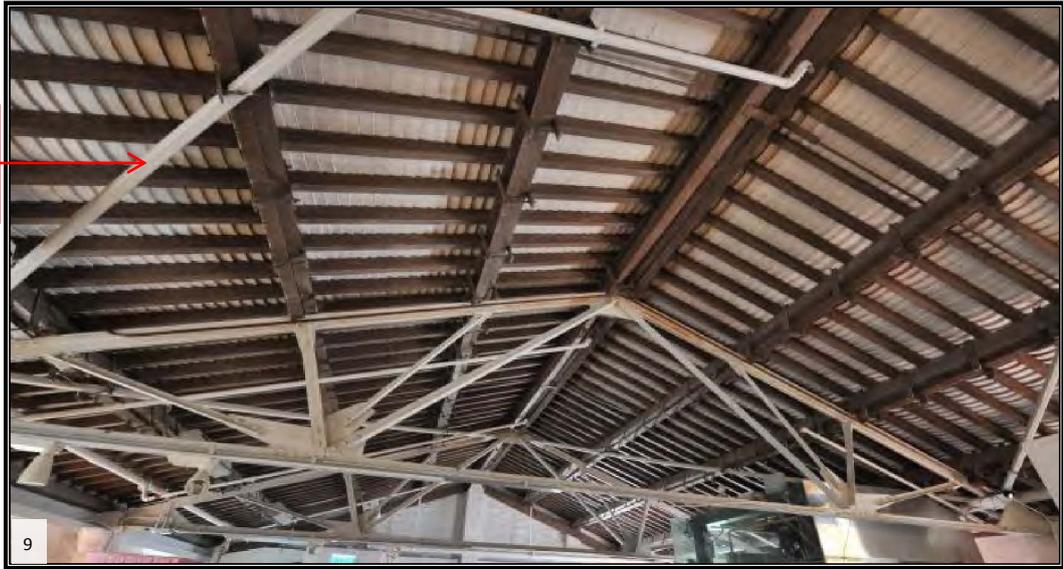
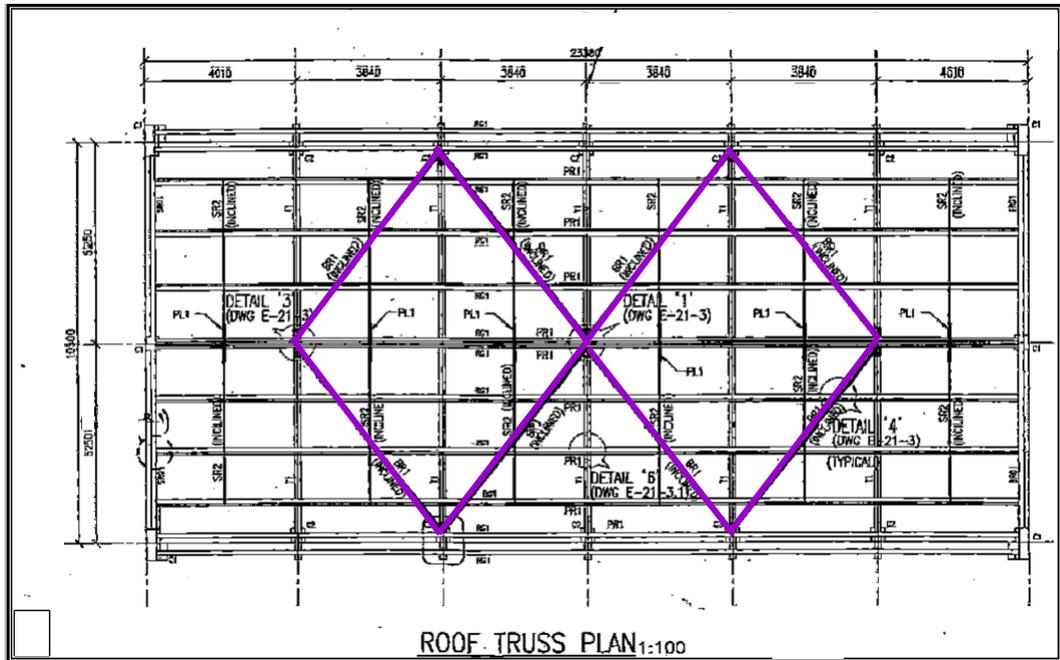
— Diagrammatic indication of additional steel bracings

Additional steel bracings for roofs of existing buildings in the Middle Zone

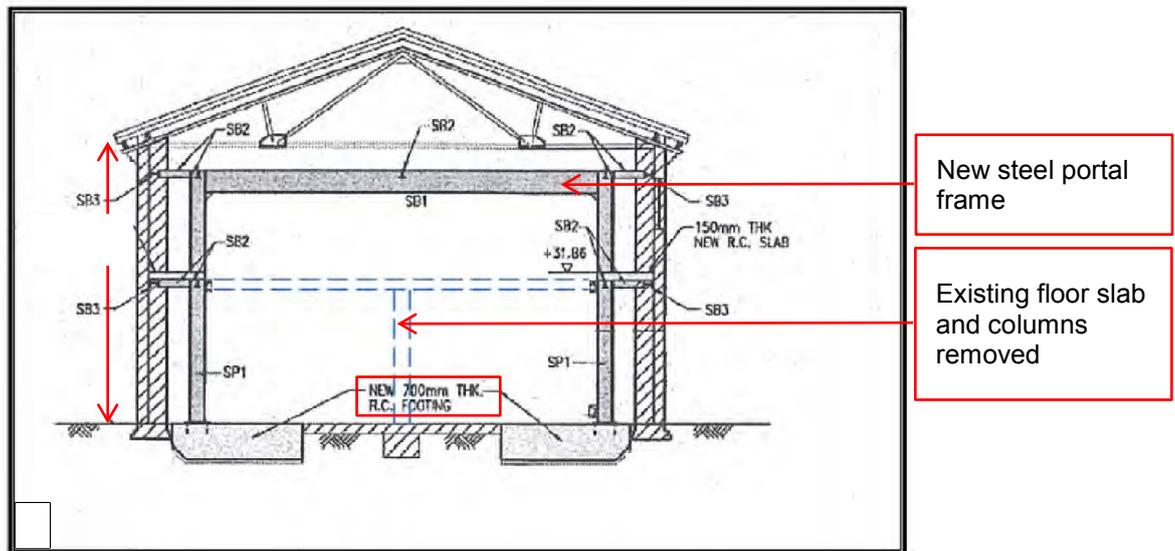
Section showing additional steel portal frame

As such alteration would reduce the lateral load resisting capacity of the building to a significant extent, new steel portal frames with new footings are erected to provide proper wind resisting system.

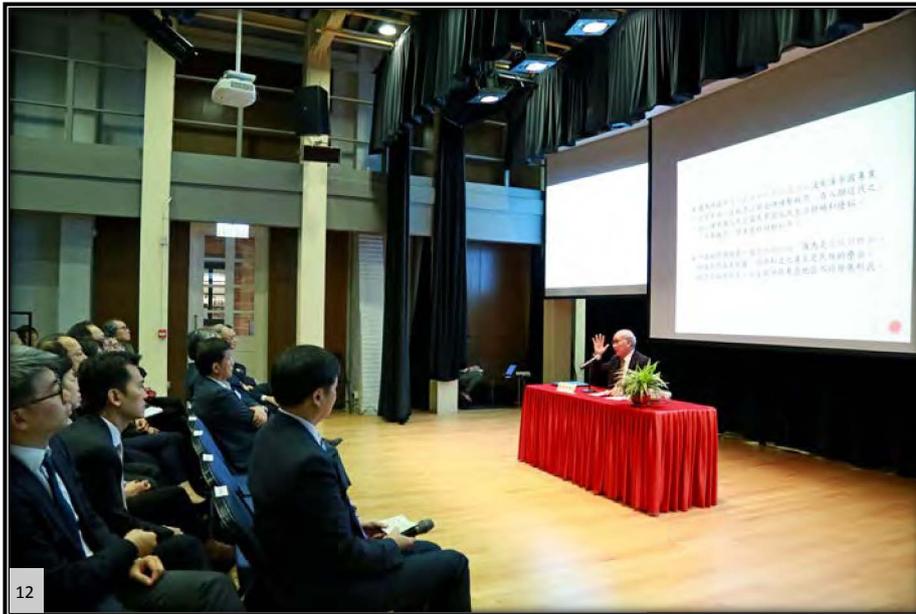
To strike a balance between maintaining architectural authenticity of the buildings and creating spacious environment for functional needs, headroom of one of the buildings in the Middle Zone is doubled by removing the first floor slab and the associated columns.

First floor slab removed to form a multi-function room with high headroom  
(Source: P&T Architects and Engineers Ltd.)

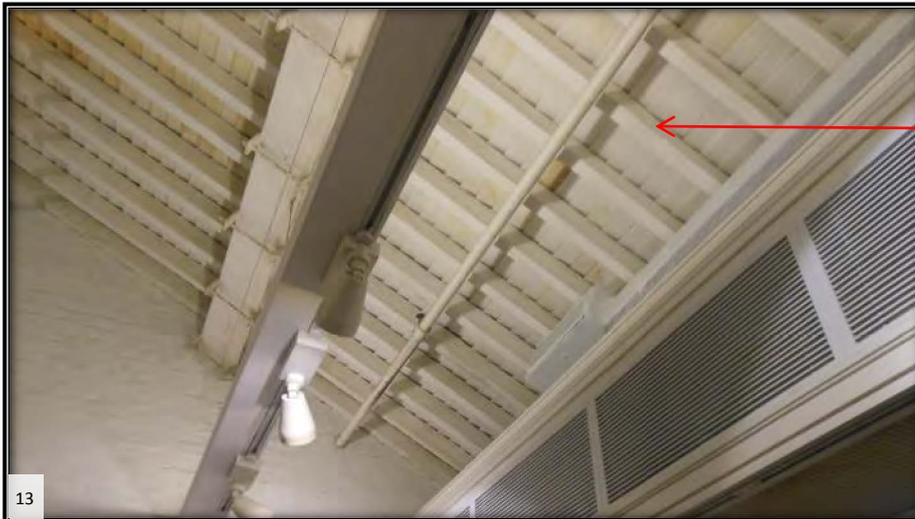
Timber pitched roof protected with fire retardant paint

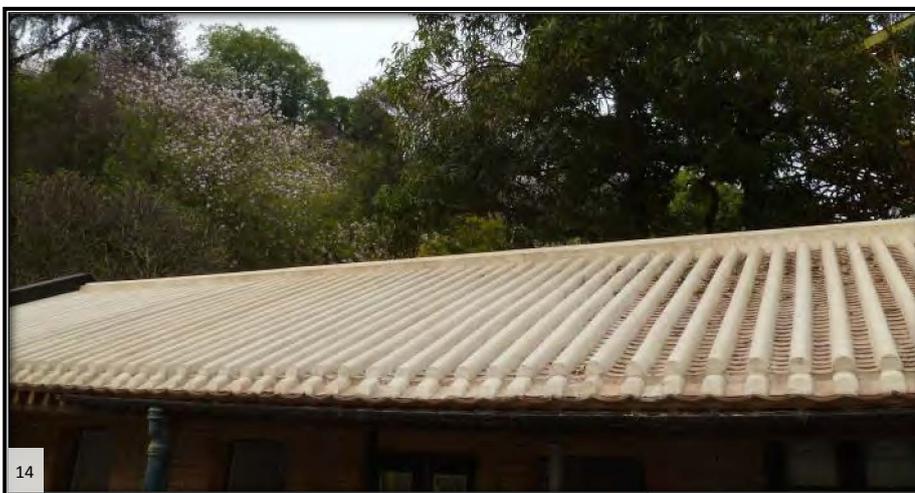
Timber pitched roof covered with non-combustible clay tiles

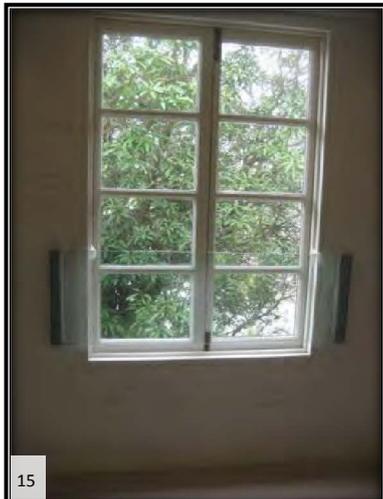
Fixed glazing panels are added to serve the function of protective barriers.

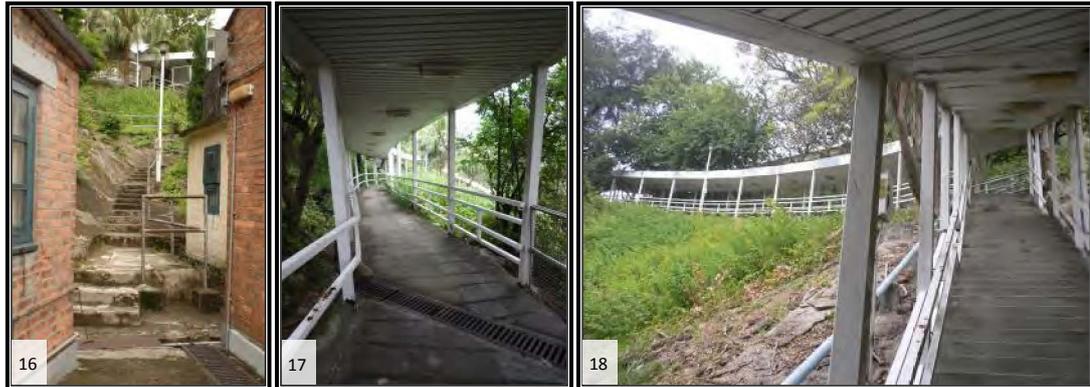
Photos taken before revitalization

(Left) The Low and Middle Zones are linked by flight of steps

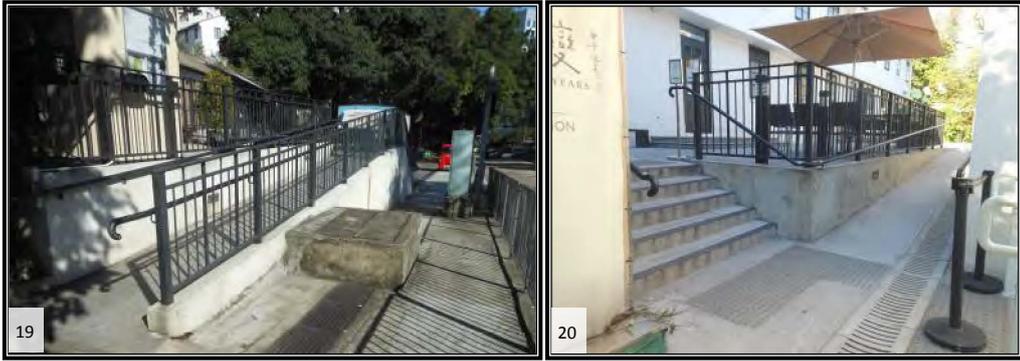
New Accessible ramps at the entrance and other locations within the site

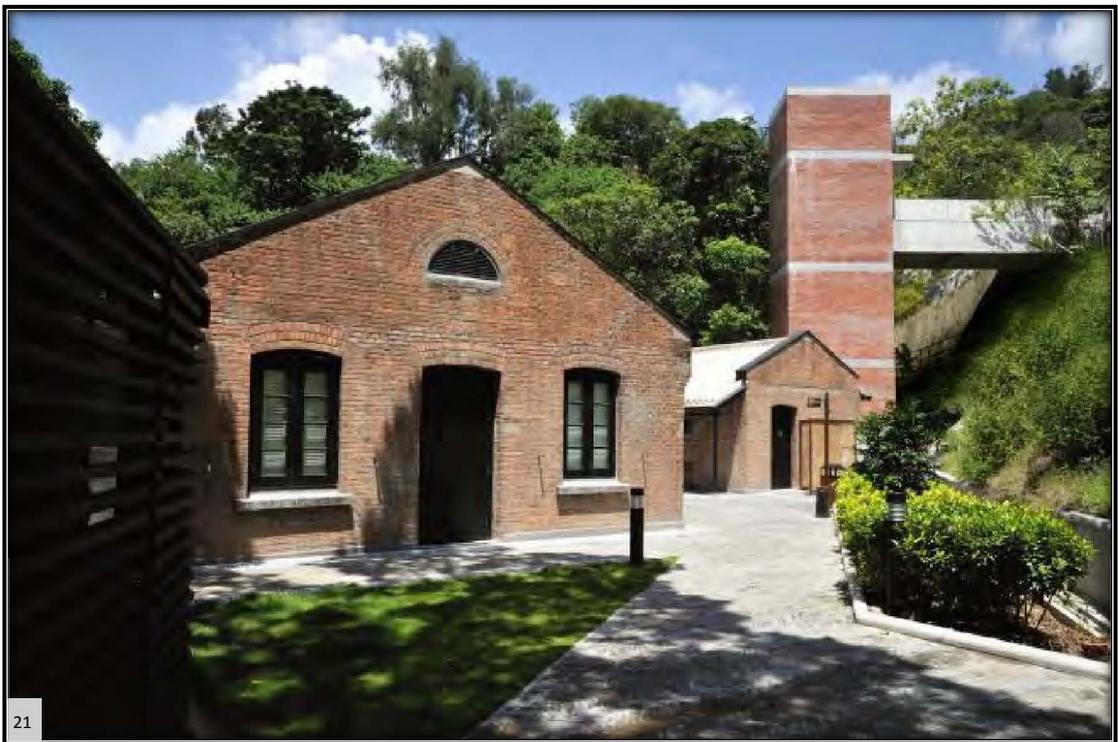
New accessible lift and link bridge connecting the Low and Middle Zones  
(Source: P&T Architects and Engineers Ltd.)

The connection between the Low and Middle Zones is enhanced by a new accessible route comprising lifts and link bridges. New lifts, lifting platforms and ramps are also added in various locations over the vast compound to enhance accessibility.

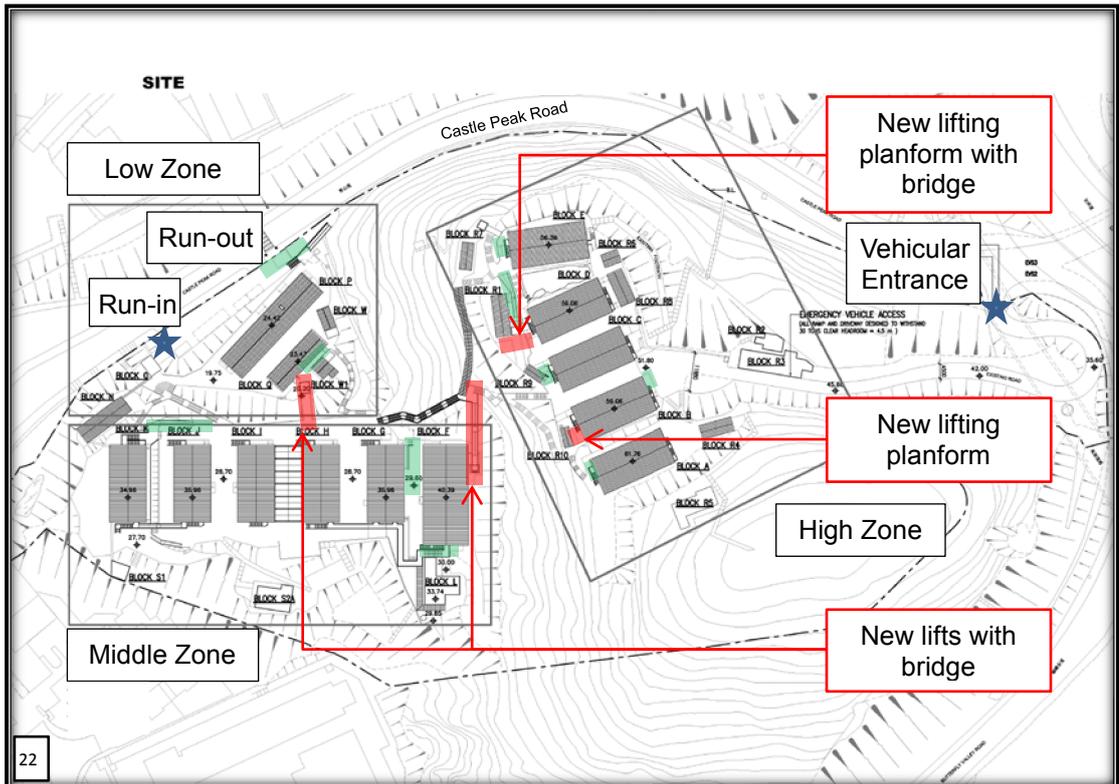
Site plan showing entrances (blue star), new ramps (green), new lifting platforms/lift towers and bridges (red)

The site has a difficult terrain, in particular the Middle and High Zones are connected by a steep and winding footpath and steps. It is therefore impractical to have a common entrance linking up all the three Zones. In the circumstances, each of the Low and High Zone is provided with an entrance at the lot boundary accessible to persons with physical limitations. Shuttling between the two zones by vehicles is acceptable.

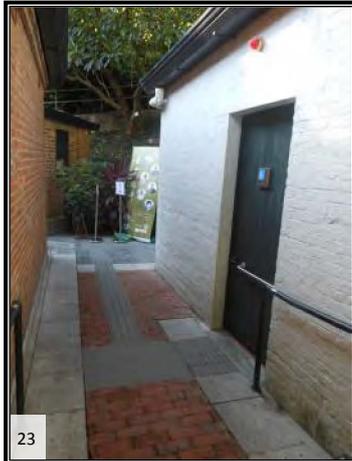
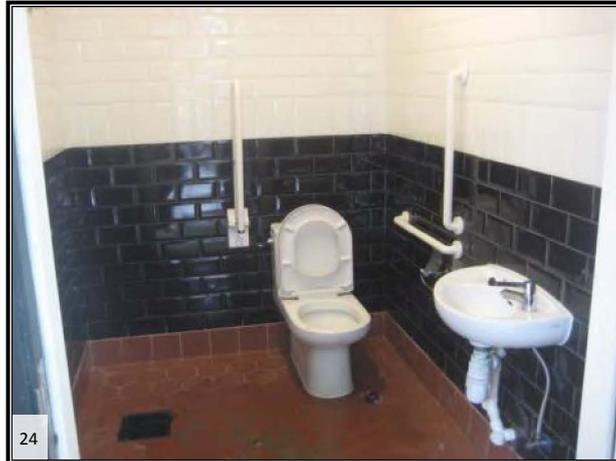
Accessible toilets, tactile guide paths, tactile warning strips, etc are provided. At least two out of the eighty-nine nos. of hostel rooms are designed as accessible rooms.

Other barrier free facilities, such as tactile guide path and accessible toilet

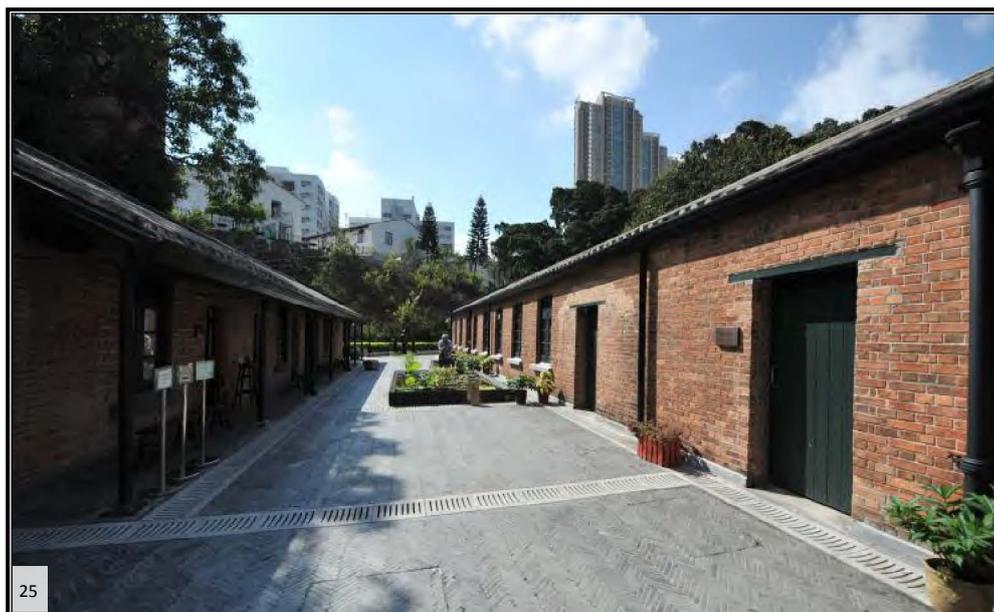
Level difference between the external and the internal areas of exhibition halls, multi-function rooms and cafeteria are eliminated. New surface water channels are provided at the courtyards to prevent influx of surface water to the buildings.

New surface water channels added at the courtyard

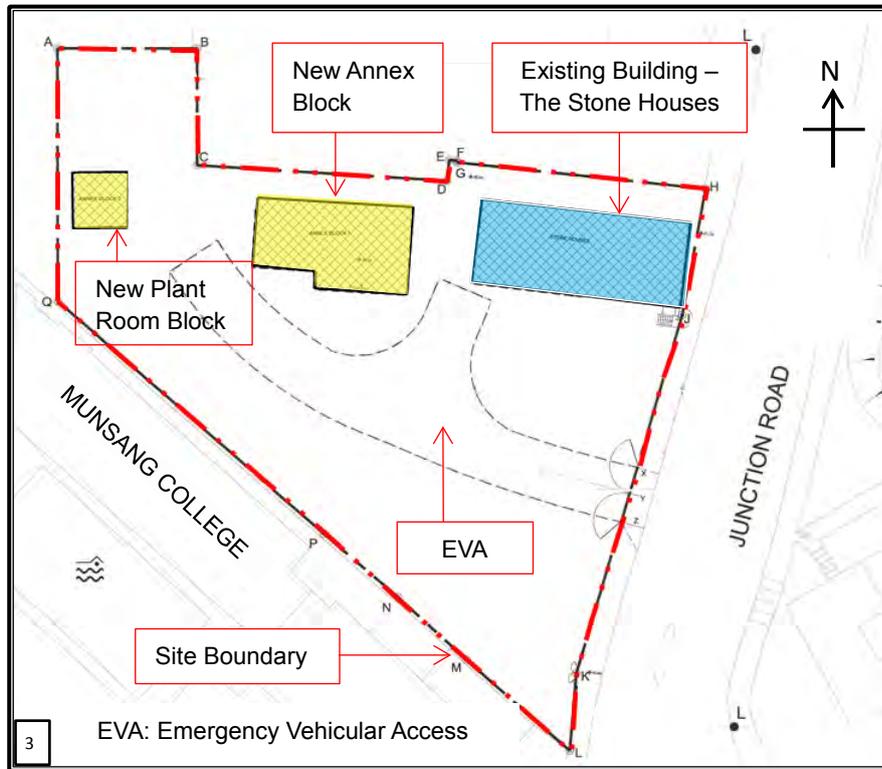
Site Plan (Approximate Scale 1:800)

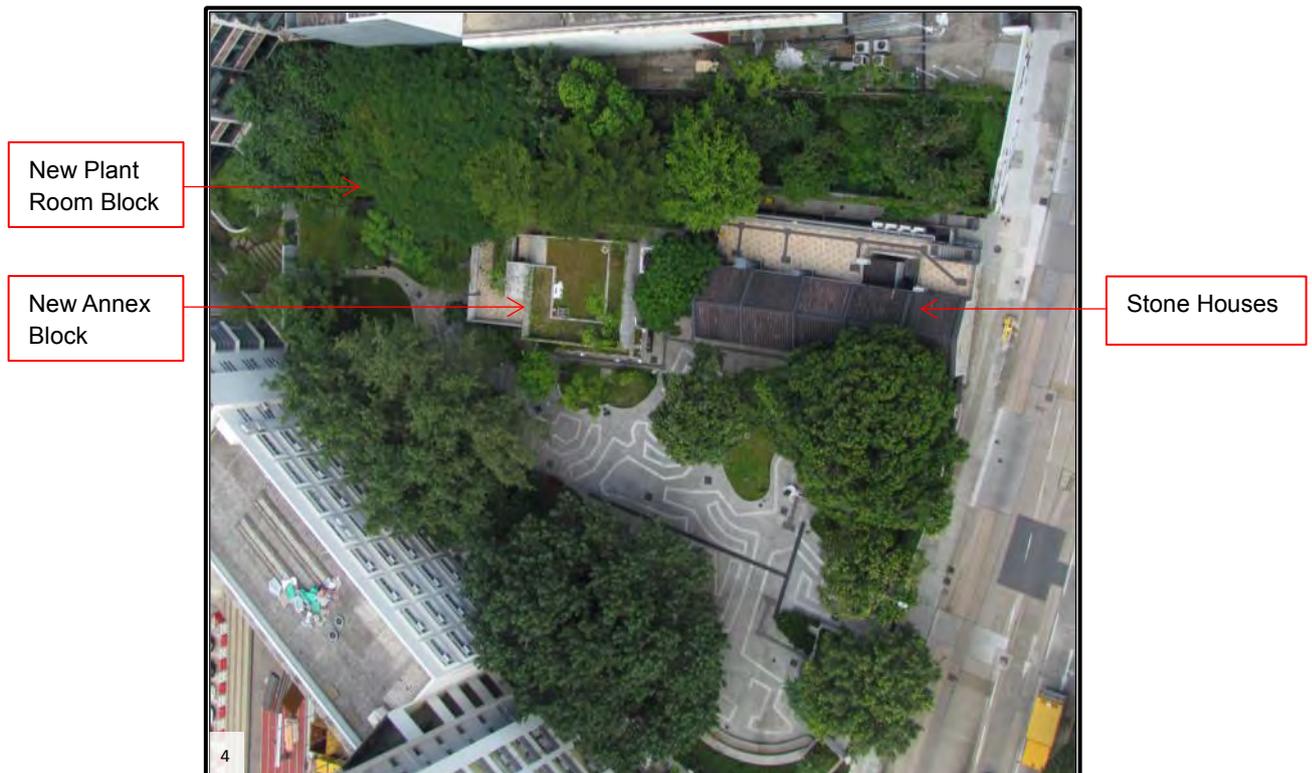
Stone Houses, New Annex Block and Plant Room

Two new single-storey blocks for use as a multi-function room and plant rooms were built to share the extensive area of the courtyard with the existing buildings.

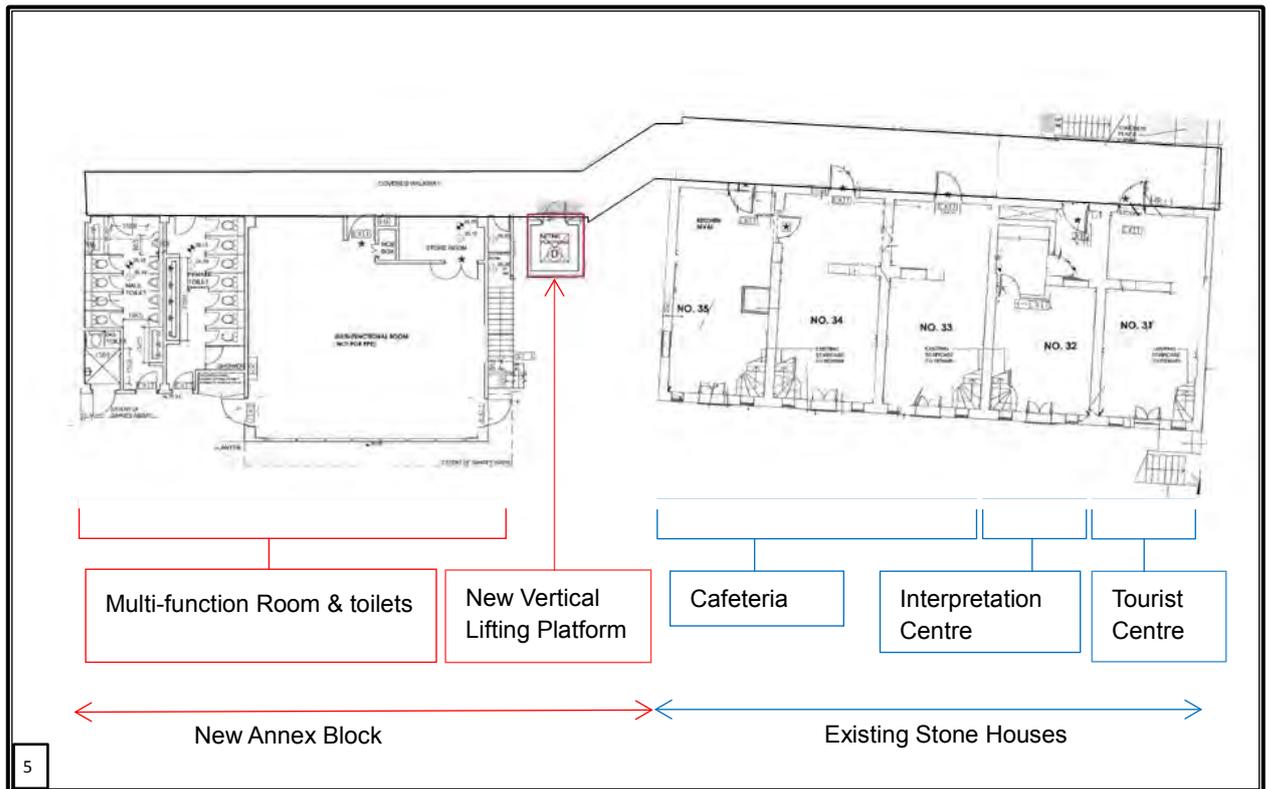
Ground Floor Layout Plan after revitalisation (Approximate Scale 1:300)

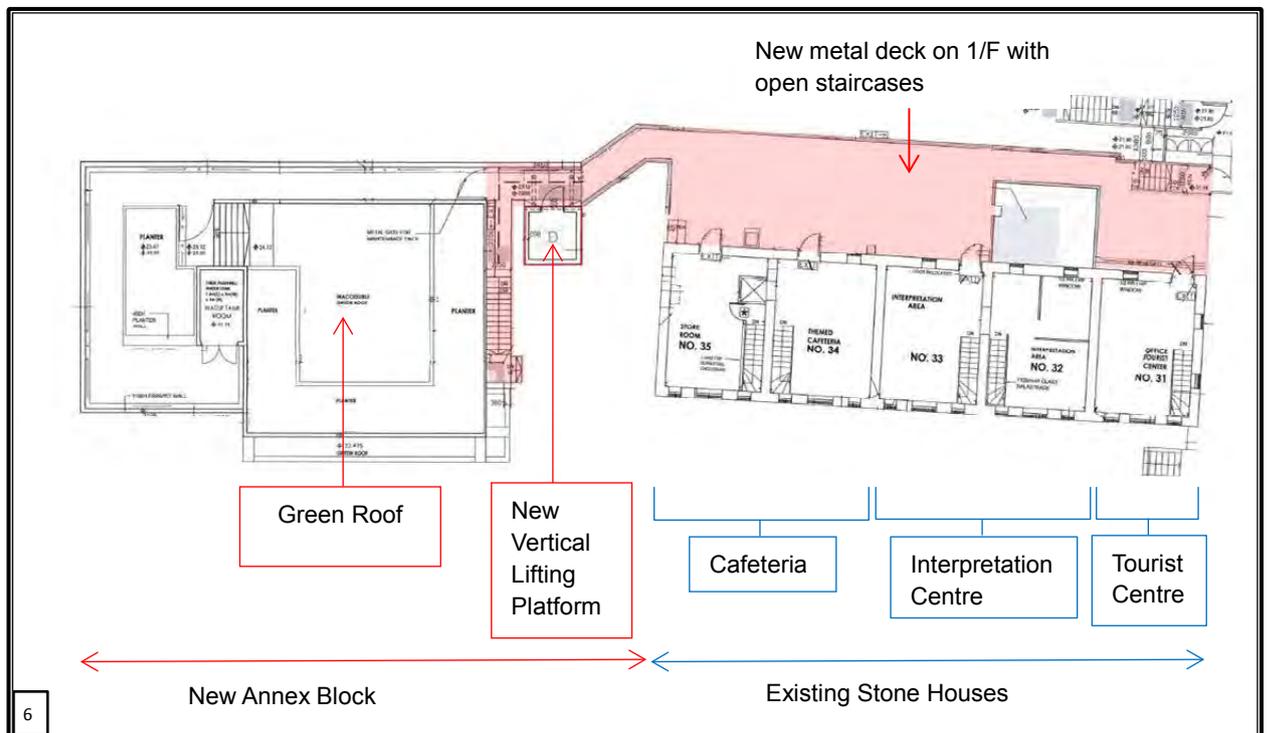
First Floor Layout Plan after revitalisation (Approximate Scale 1:300)

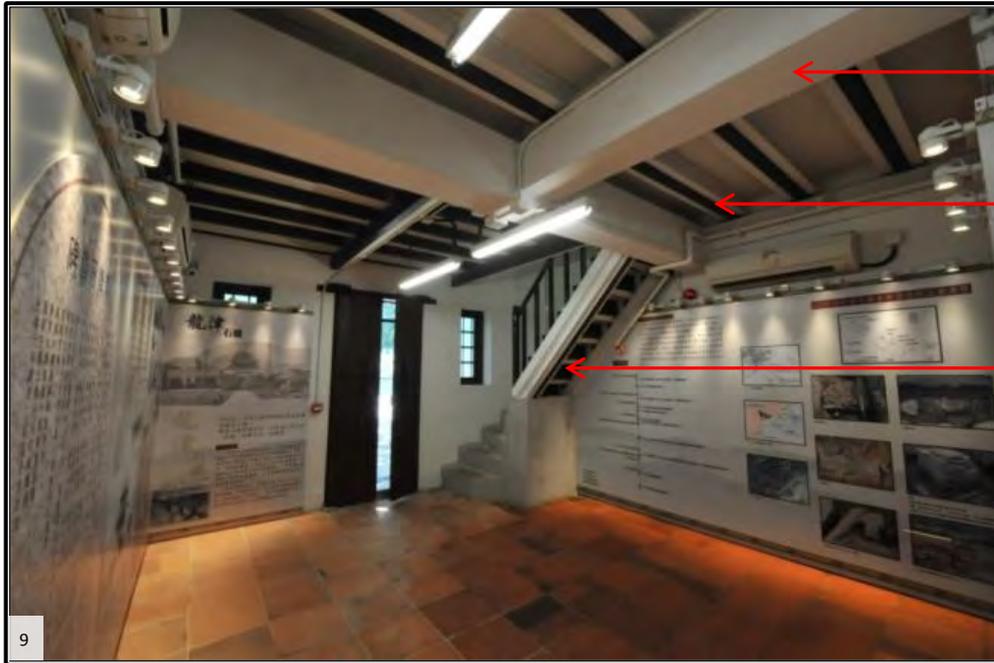
Existing RC beams supporting timber floor & staircase

New steel beams at the sides of existing timber joist

The timber floors and staircases of the remaining four units are replaced with new steel decks, beams, frames and columns supported by new reinforced concrete raft footings. Some original timber planks and floor tiles are salvaged and relayed on the new structures as floor finishes.
