# Practice Guidebook for Adaptive Re-use of and Alteration and Addition Works to Heritage Buildings 2012

**Practice Guidebook**  
**on**  
**Compliance with**  
**Building Safety and Health Requirements**  
**under the Buildings Ordinance for**  
**Adaptive Re-use of and**  
**Alteration and Addition Works to**  
**Heritage Buildings**

**Buildings Department**  
**Hong Kong**

**(2019 Edition)**

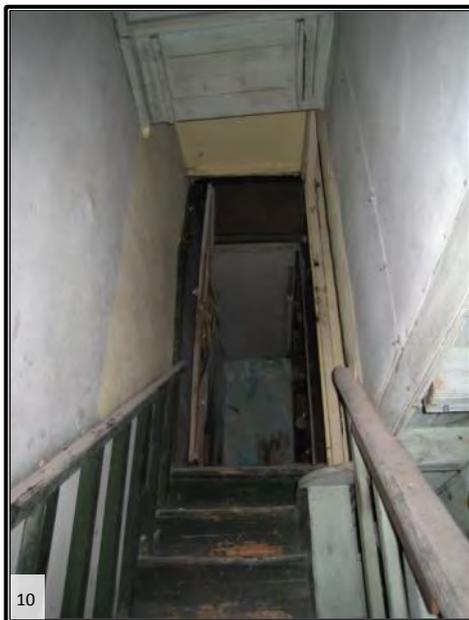
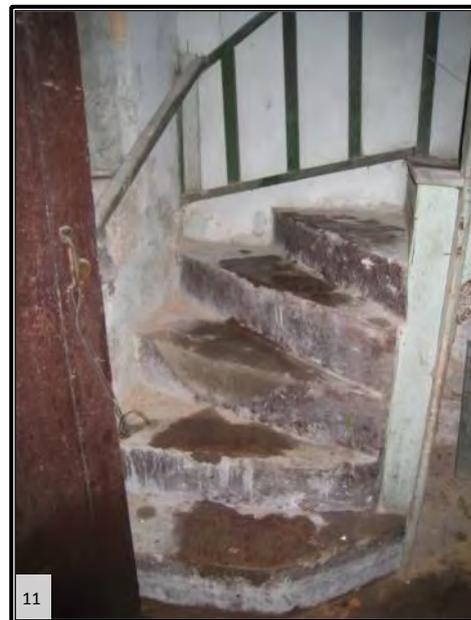
Existing timber staircase with solid winders at the bottom before revitalisation

The existing timber stairs connecting G/F and 1/F are 725mm wide, with risers 200mm high, treads 200mm deep and solid winders at the bottom and no enclosure walls. Their construction and fire resistance rating (FRR) are inadequate in meeting the current fire safety requirements<sup>2</sup>.

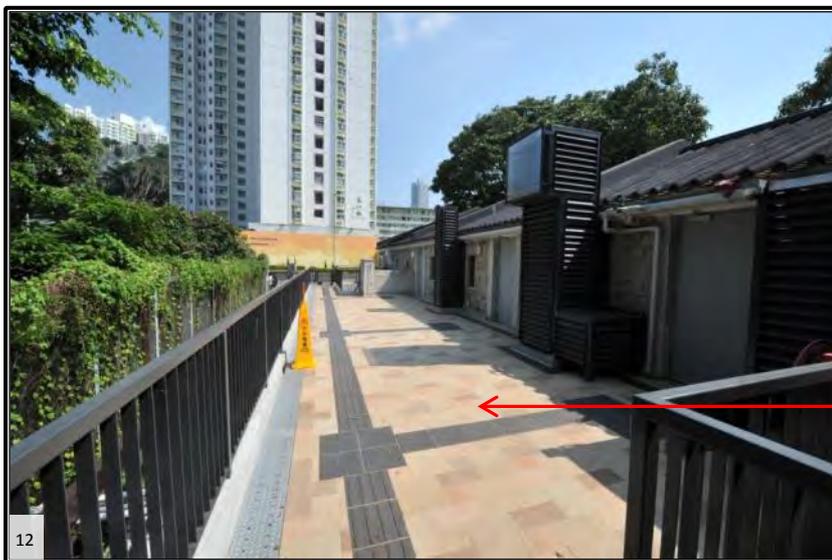
New metal deck

New metal deck at the rear

Two new code-compliant open staircases connecting the 1/F of the 5 houses via a structurally independent deck are constructed at the back to serve as the MOE, without intervening the main facade which carries higher heritage value. The new metal deck with new footings is structurally separated from the existing masonry structures. No additional loading from the new metal deck is transferred to the existing masonry walls. The original internal timber staircases are repaired and retained for circulation only.

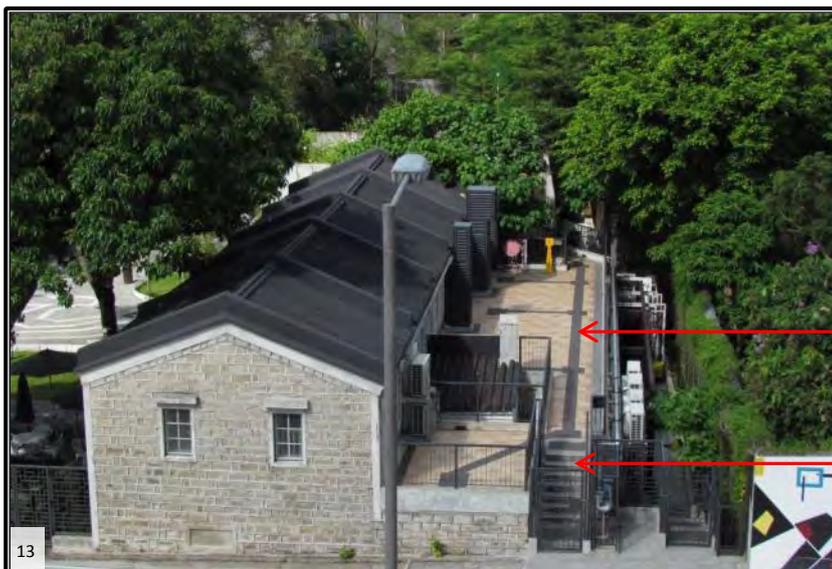
New metal deck

One of the new open staircases serving 1/F of Stone Houses

New metal deck connecting to open staircases

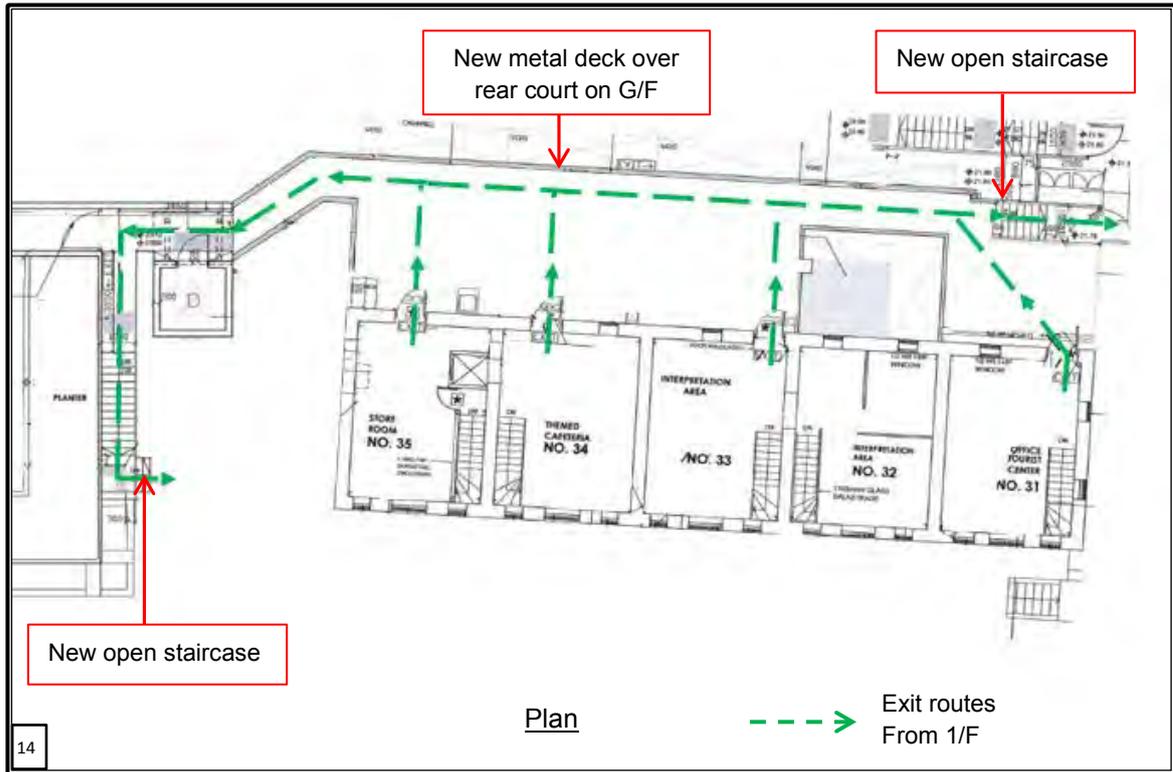
MOE Routing on 1/F

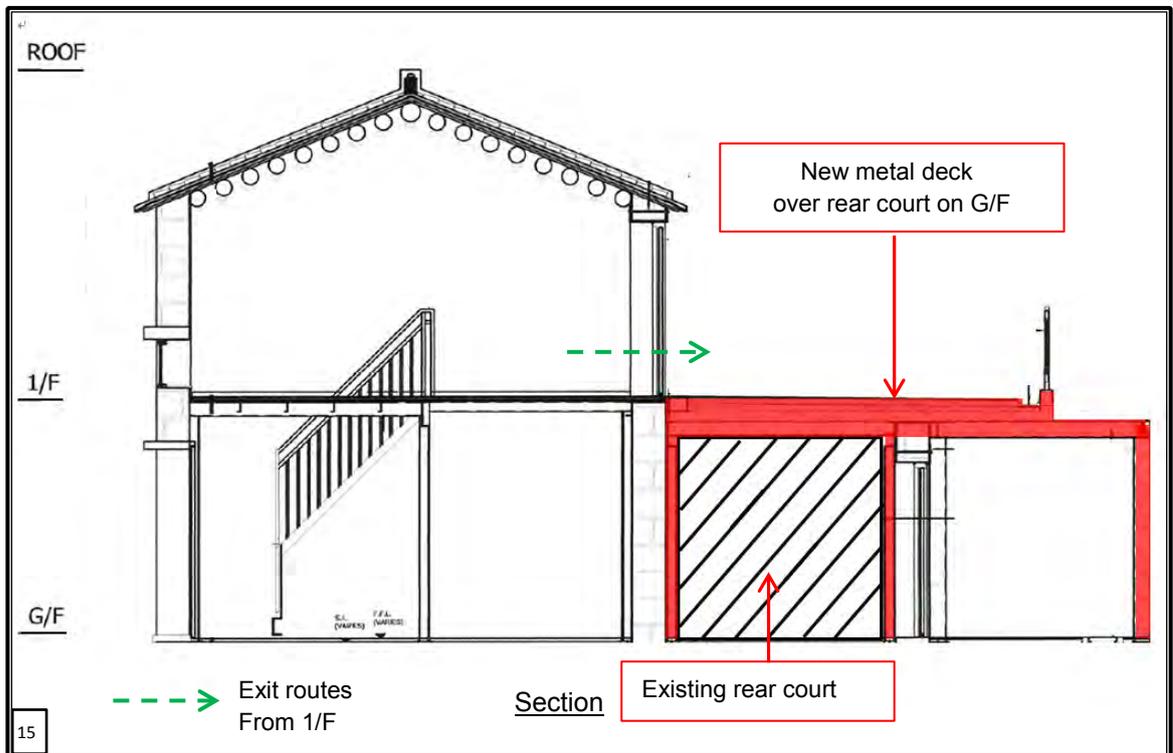
New metal deck detail

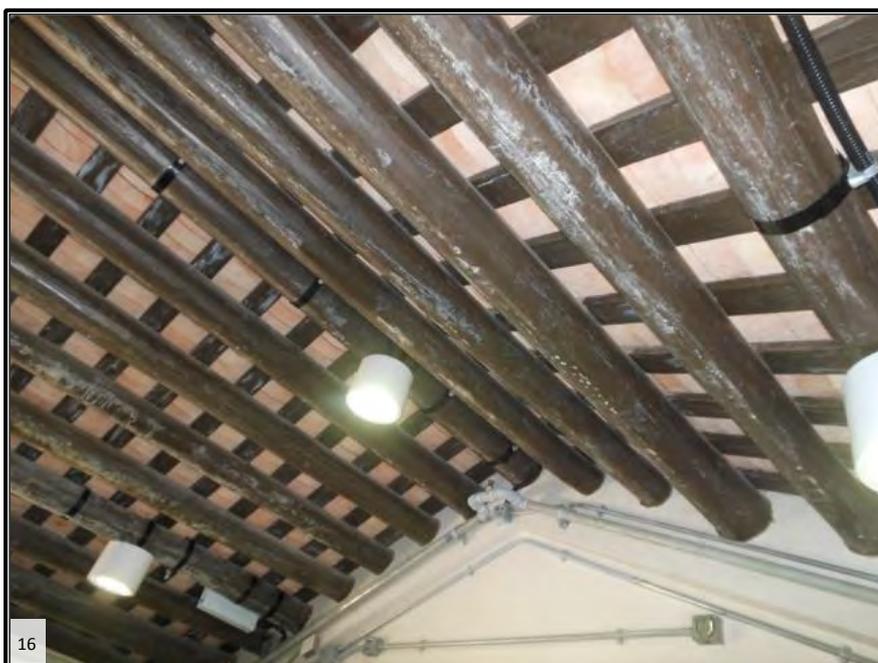
Existing timber pitch roof are retained for appreciation but timber elements are painted with fire retardant paint

All timber elements of the roof are repaired and protected with fire retardant paint to meet the Class 1 standard on surface spread of flame tested in accordance with the requirements of BS 476 Part 7, and then covered with the original non-combustible clay tiles.

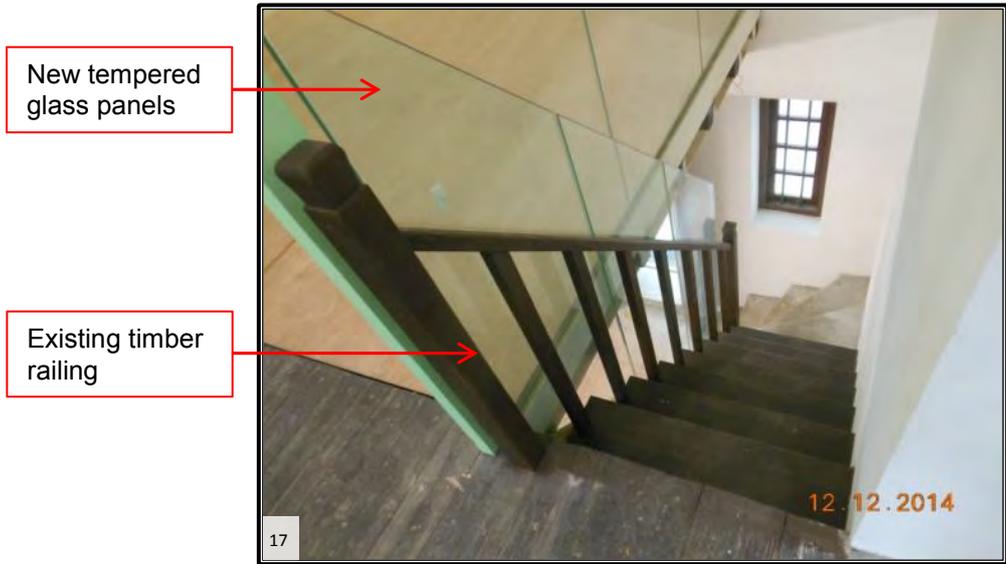
New tempered glass panels

Existing timber railing

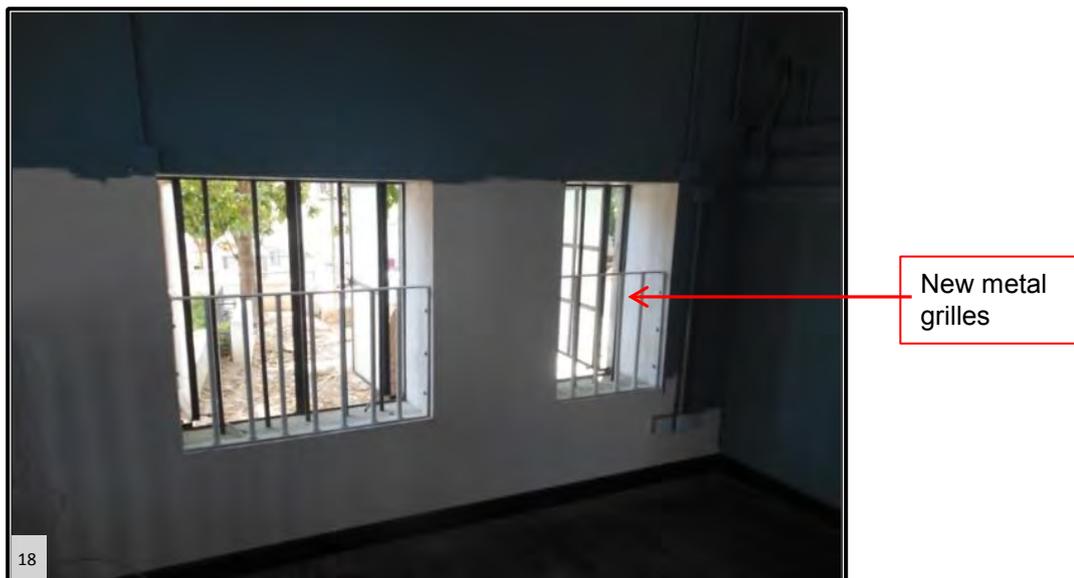
New metal grilles added at the existing window openings

To avoid making irreversible changes to the components of the original timber framed windows which are CDE, the protection against the danger of falling is achieved by adding new metal grilles on the walls behind the windows.

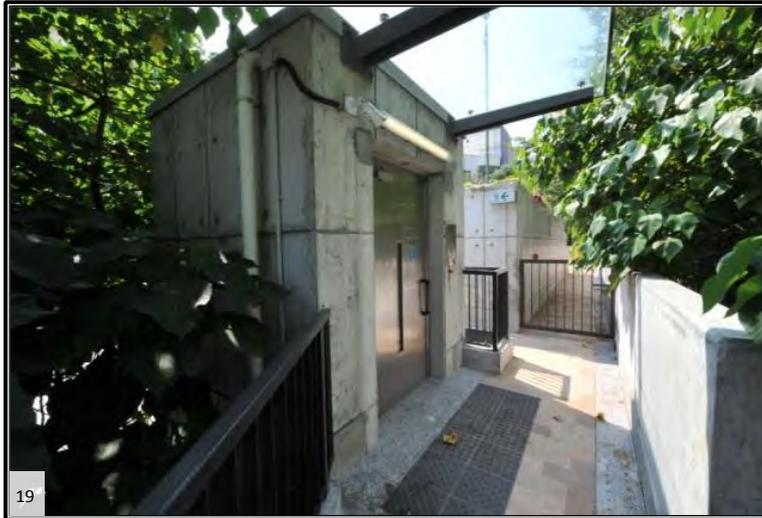
19

New lifting platform, 1/F

A new vertical lifting platform is installed between SH and the New Annex Block to provide access to 1/F of SH through the new metal deck at the back.

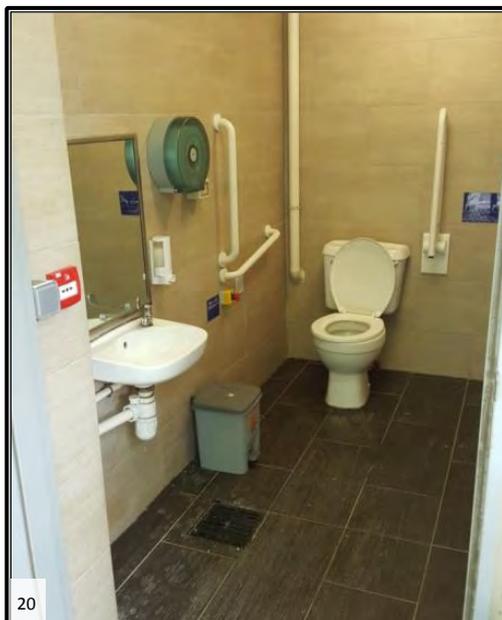
20

New accessible toilet, New Annex Block

An accessible toilet and other ancillary facilities are provided in the New Annex Block next to SH.

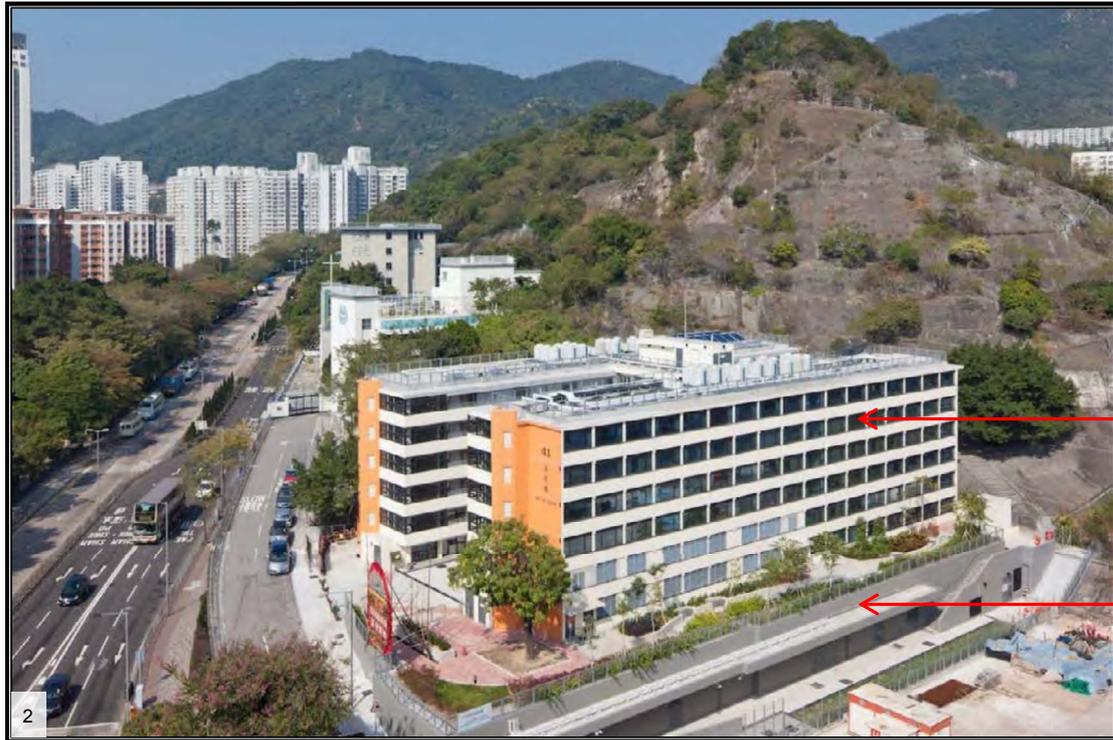
New 1-storey plant room on LG/F

Revitalised Mei Ho House over new plant rooms on LG/F (Source: AD+RG)

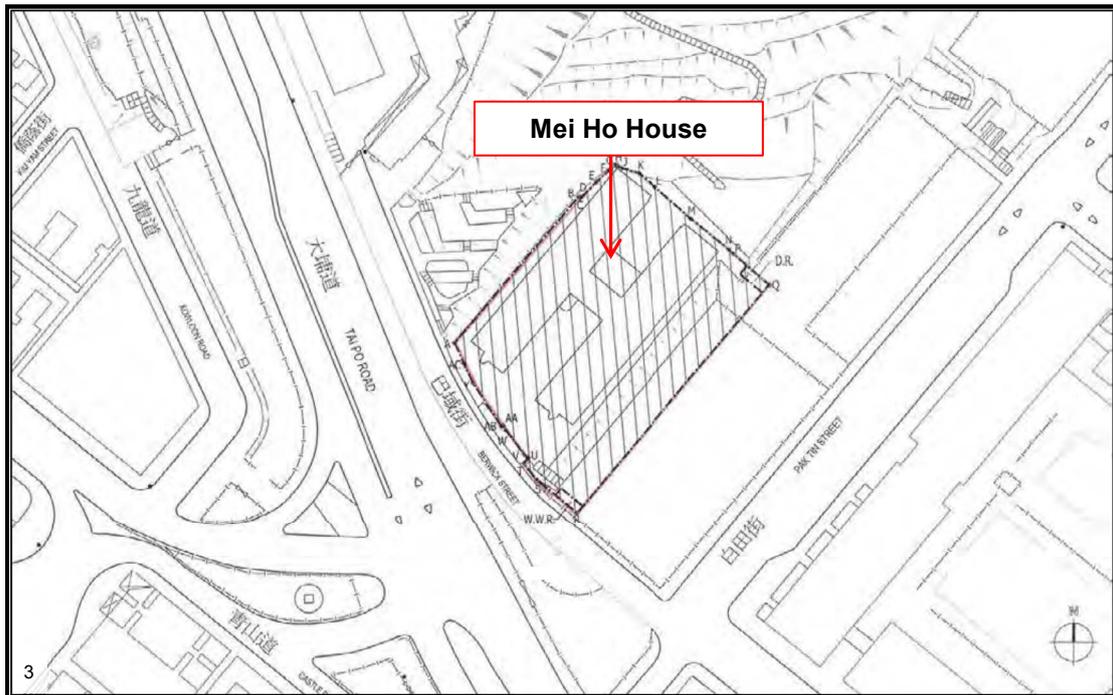
Site Plan

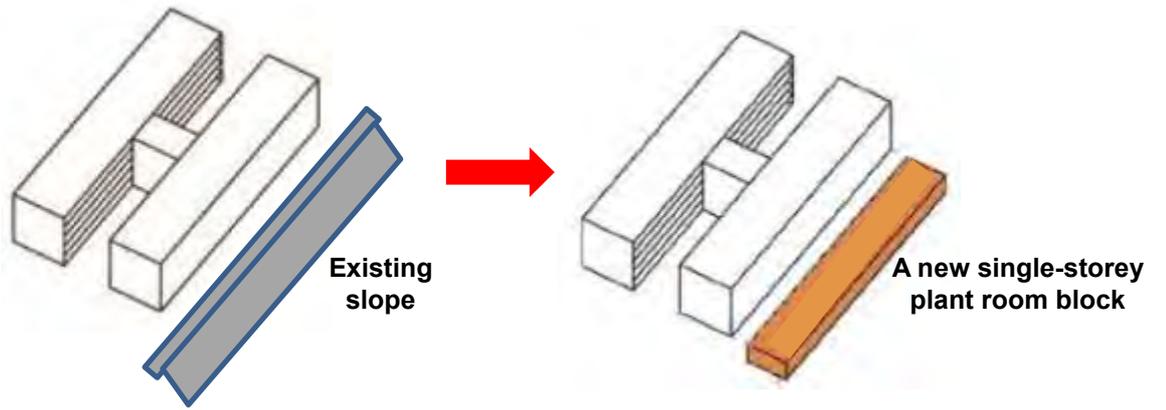
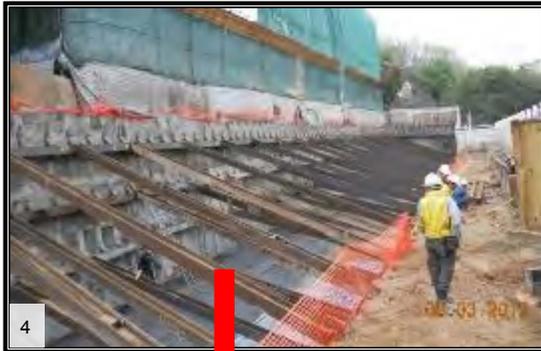
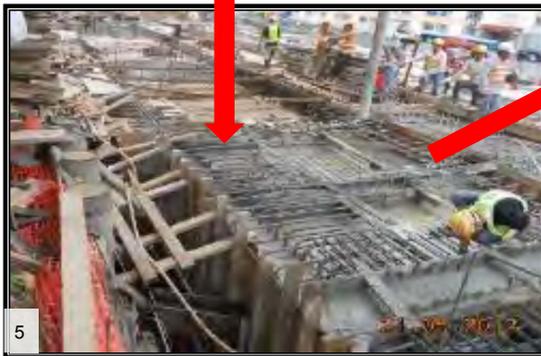
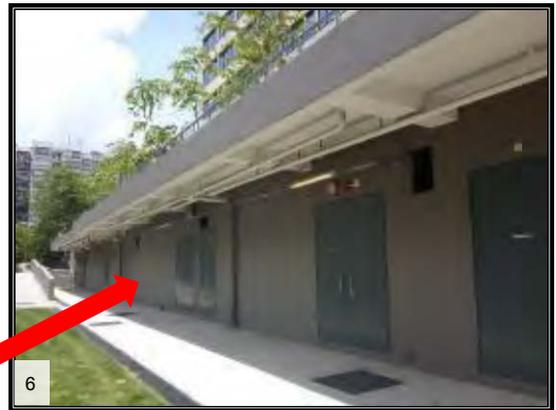
Removal of the existing slope to make room for new plant rooms  
 (Source: Hong Kong Youth Hostels Association)

A new single-storey block replacing the slope at the bottom of MHH, viz the Lower Ground Floor (LG/F), is created for housing fire service/ fire sprinkler water tanks and mechanical plant rooms. Roof of the single-storey block (i.e. G/F) is finished as a landscaped area.

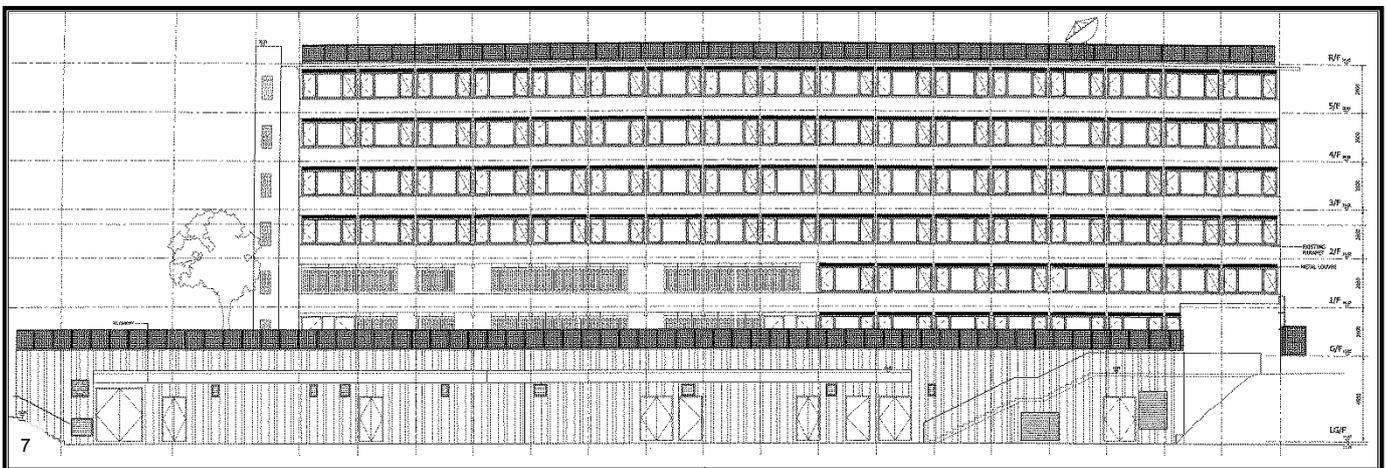
Elevation showing new plant rooms on LG/F

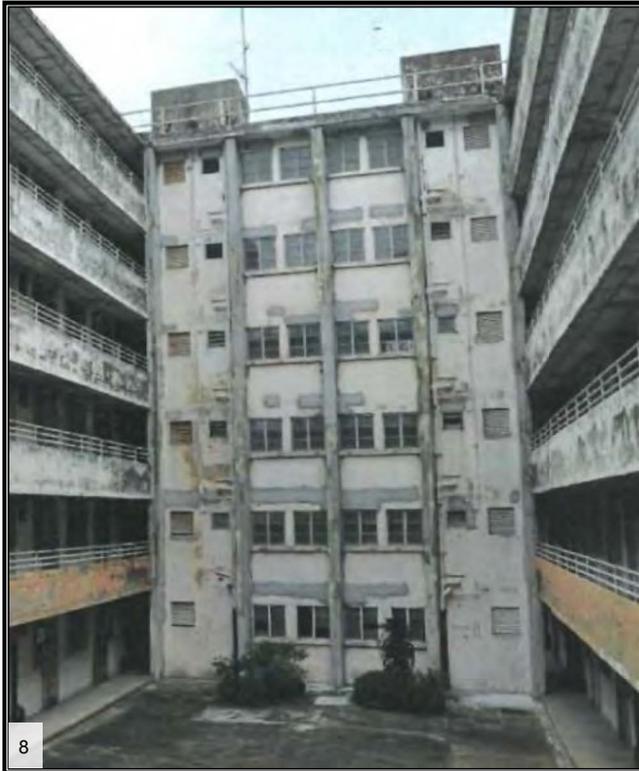
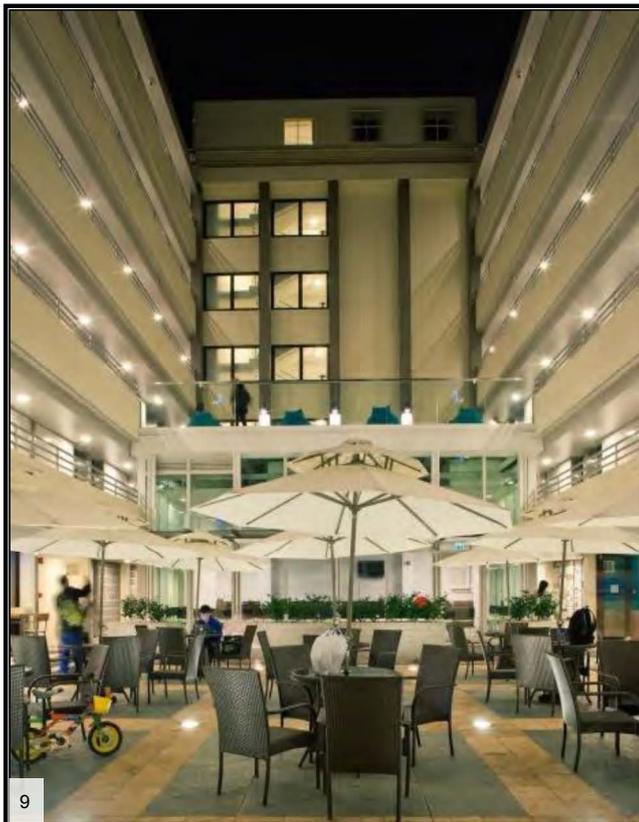
The central block before and after the revitalisation  
(Source: Hong Kong Youth Hostels Association UNESCO Report (Top); AD+RG (Bottom))

In addition, the central block is rebuilt with new lifts and required staircases to meet the latest statutory requirements.

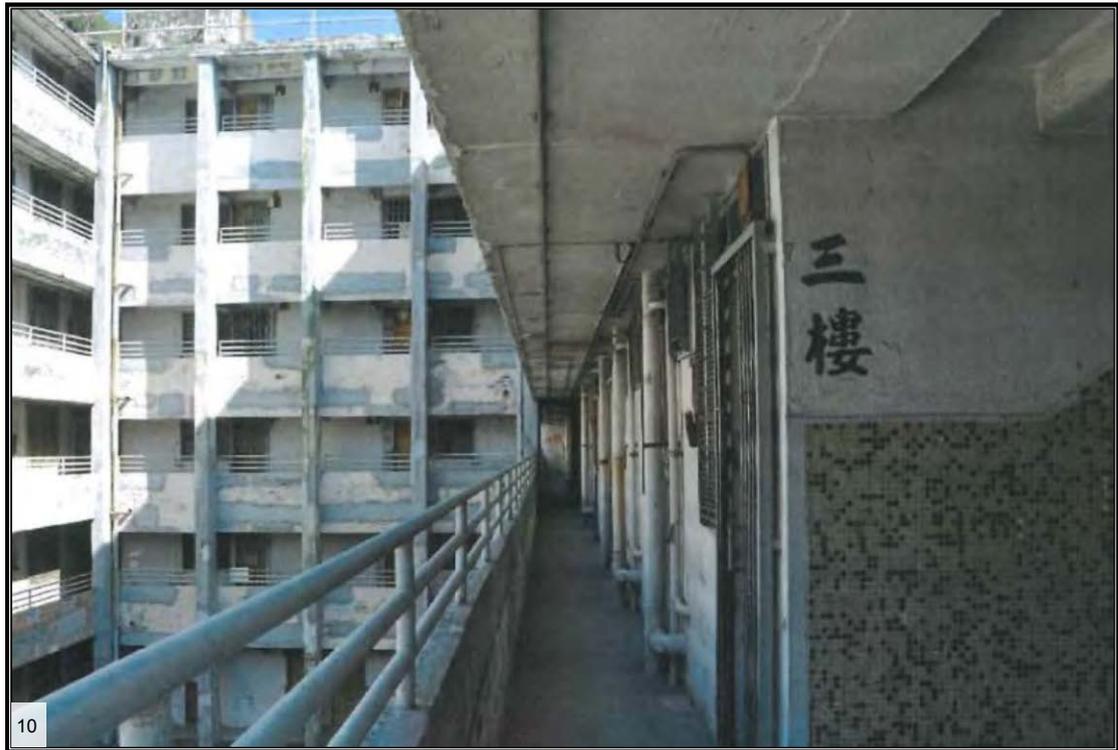
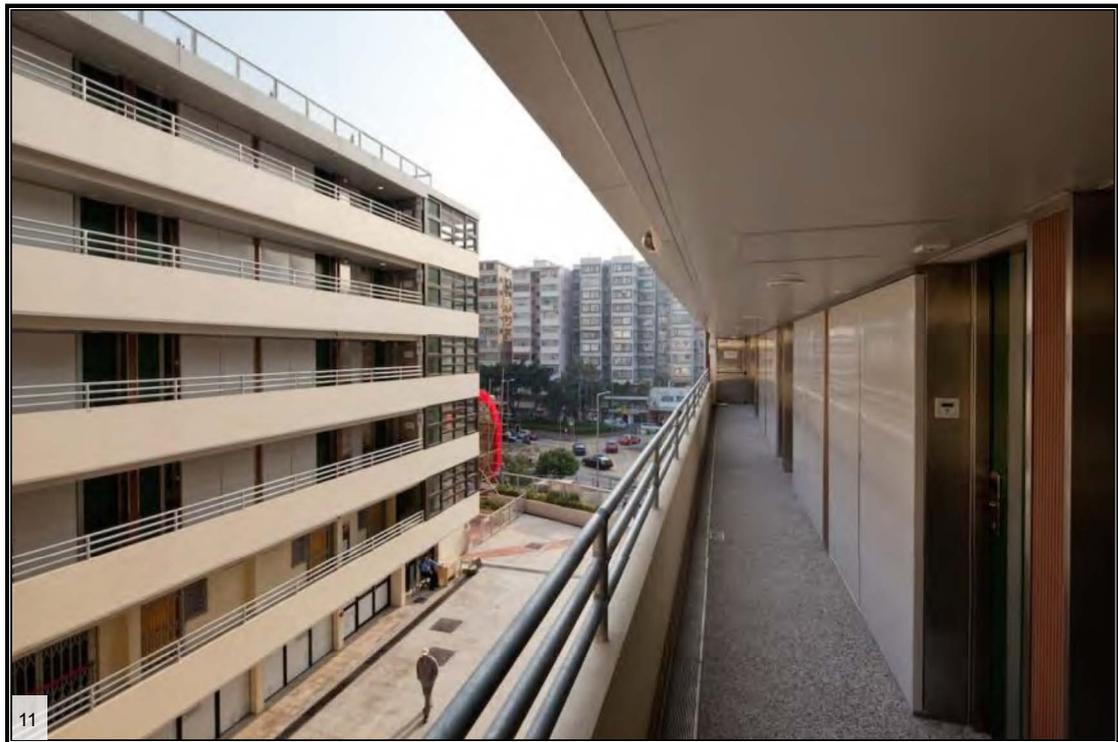
The corridor before and after the revitalisation  
(Source: Hong Kong Youth Hostels Association UNESCO Report (Top); AD+RG (Bottom))

The existing corridors facing the courtyards were cantilevered slab structures. They were in poor condition and their structural capacity was inadequate to meet the loading requirements for the adaptive re-use. Moreover, sufficient spaces along the corridors were also required to accommodate the building services for the hostel.

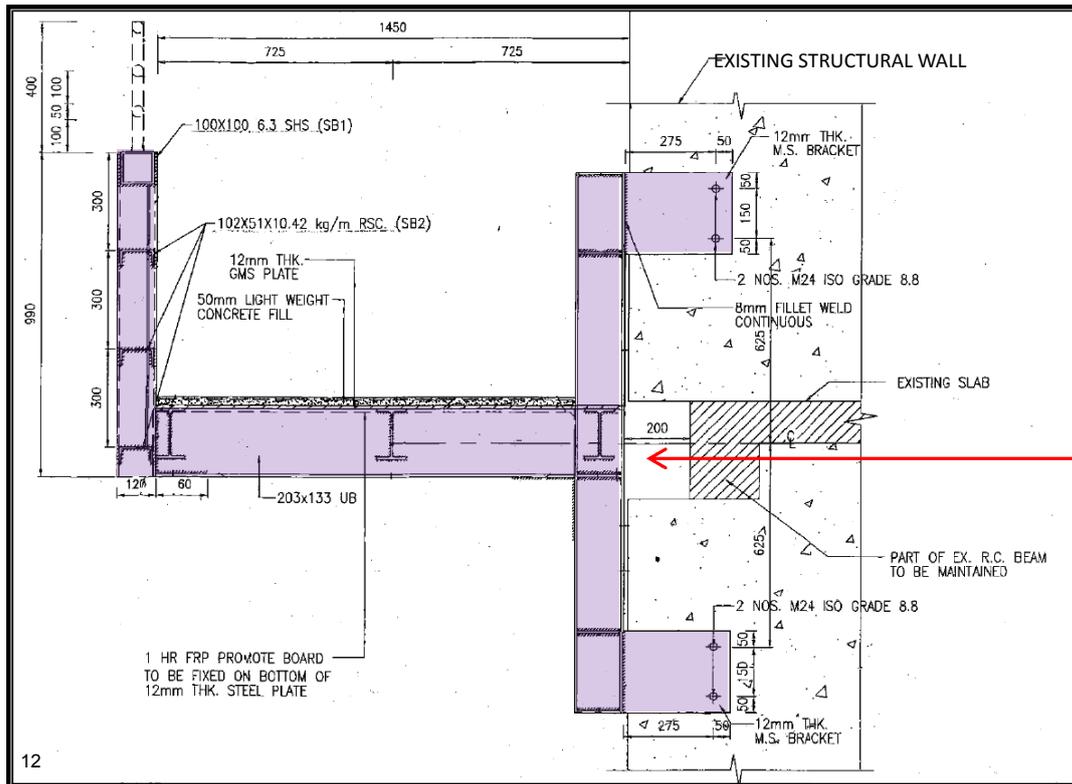
Space for building services

Section showing the new structural steel deck (in purple) fixed to the structural wall

In view of the drawback of the abovementioned traditional strengthening methods, the existing corridor slabs on each floor are demolished and replaced with structural steel decks with supporting beams cantilevered from the end of the existing structural walls of the building. After the revitalisation, a 1100mm wide corridor is provided as MOE for both wings. The adoption of relatively light-weight steel for the reconstruction of the corridors also has relieved the loading capacity limited by the existing structural walls. Such alteration works also have facilitated partial removal of the existing concrete floor beams so that a 200mm gap is left between the newly constructed corridors and the remaining floor beams for installation of building services. With this design, staff can access the building services from the corridors for maintenance purpose without the need of entering the hostel rooms.

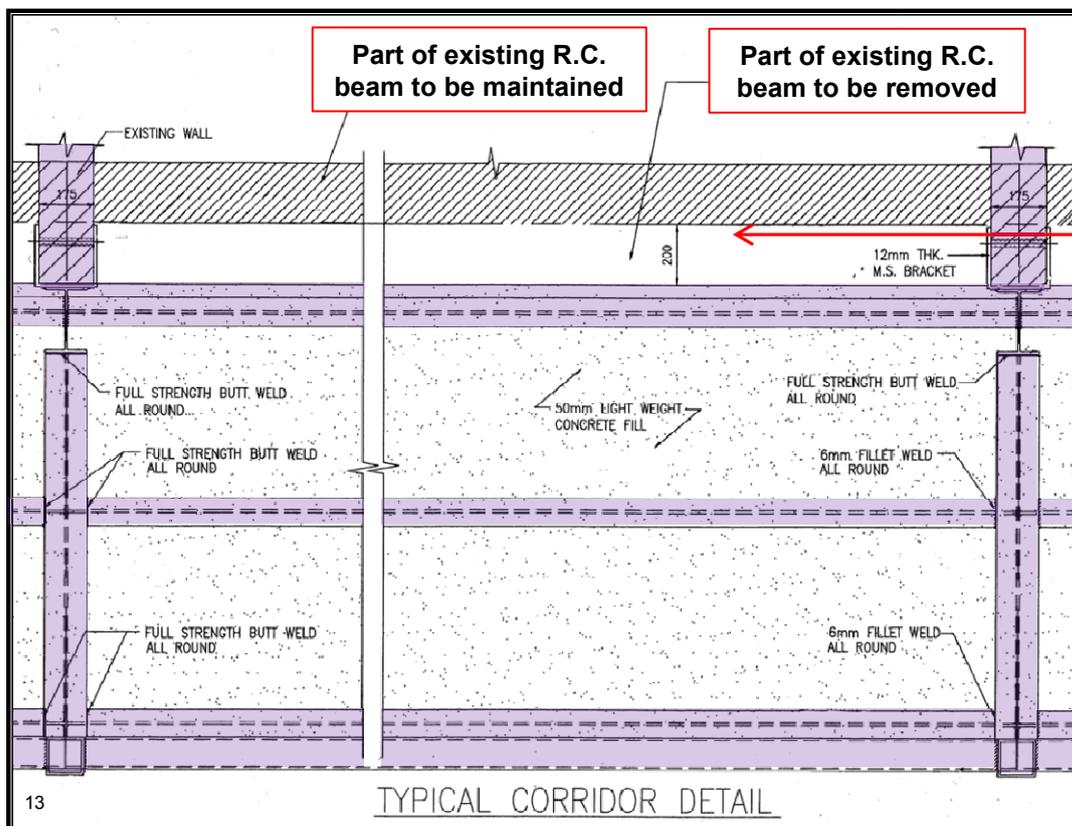
Details showing the new structural steel deck (in purple colour) fixed to the structural wall

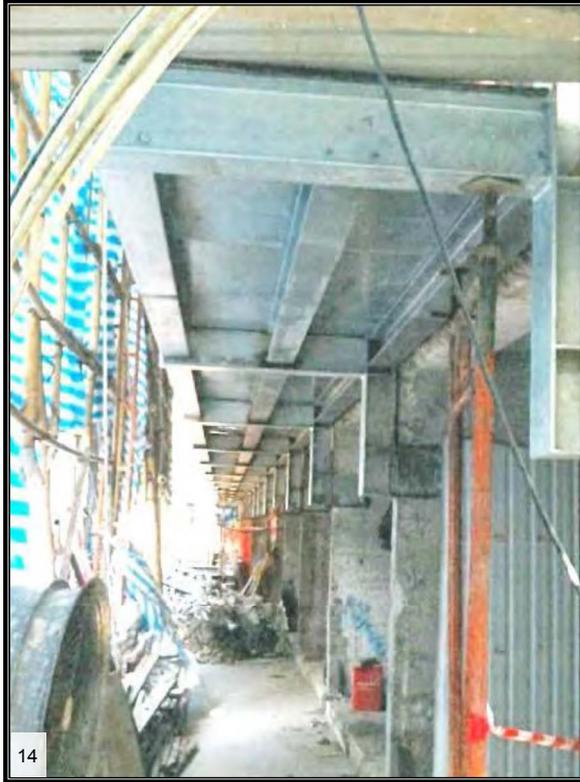
Corridor slabs were demolished and replaced by new structural steel decks  
(Source: Hong Kong Youth Hostels Association UNESCO Report)

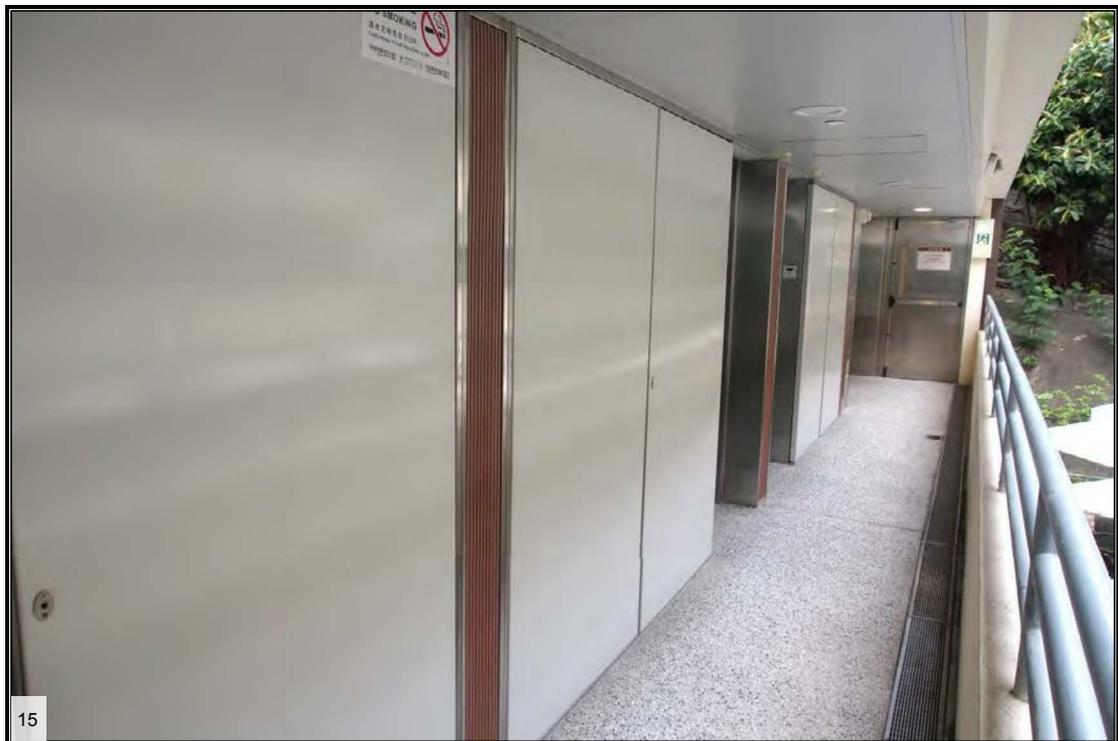
Access panels of pipe ducts facing the corridor

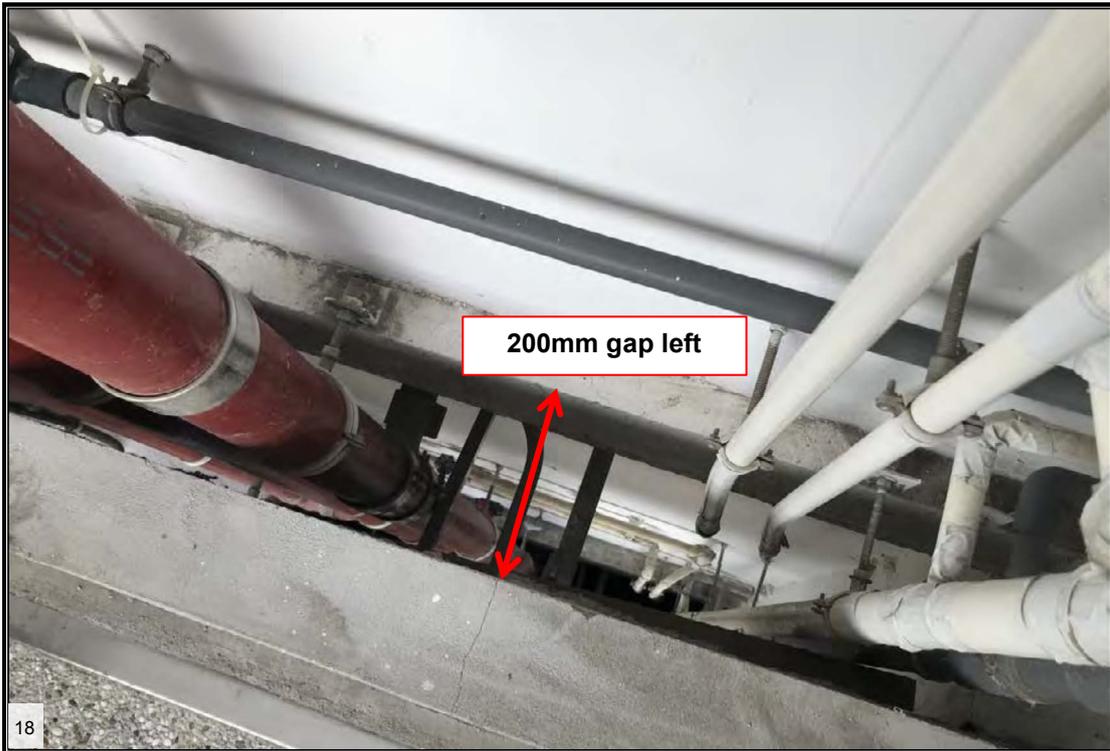
200mm gap was left after partial removal of the existing floor beams

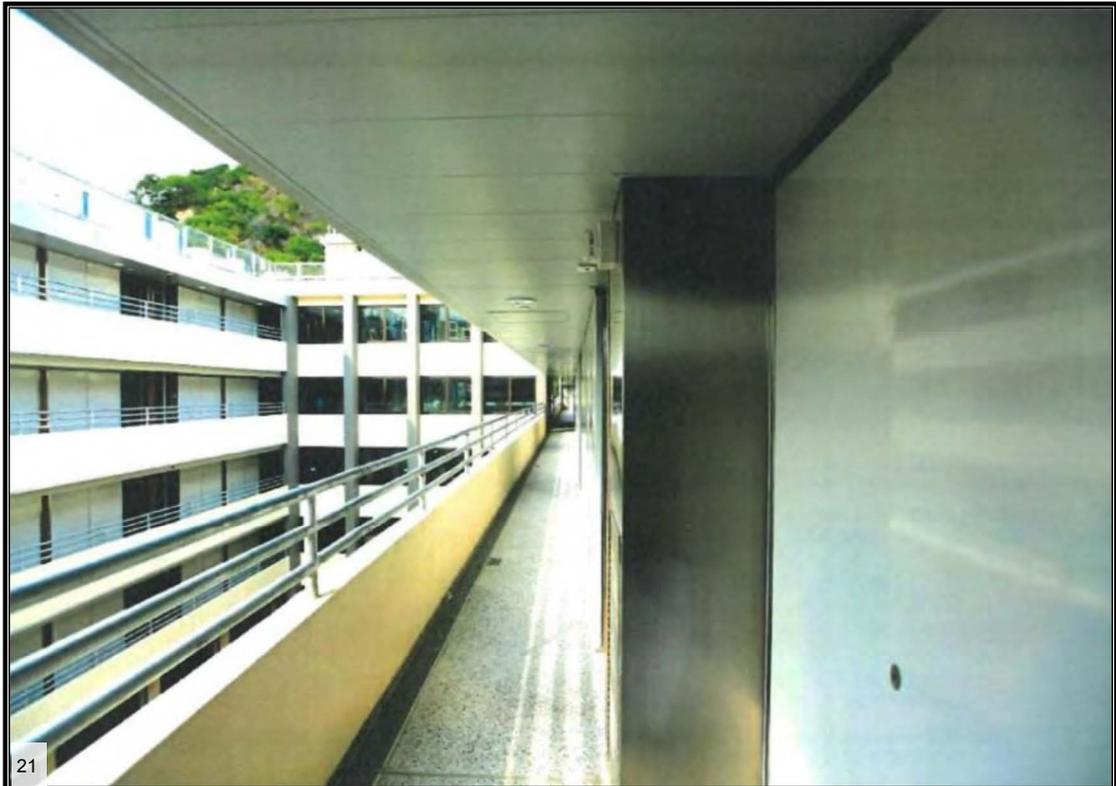
Parapet is rebuilt along corridors (Source: AD+RG)

New parapets along corridors emulating the original parapets and complying with the current statutory requirements in all aspects are rebuilt during the reconstruction of the new cantilevered corridor slabs as mentioned in section (b) above.

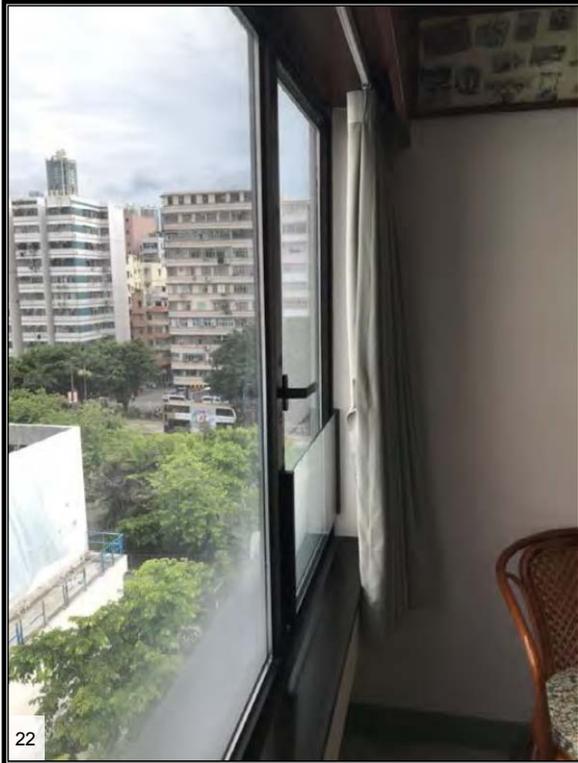
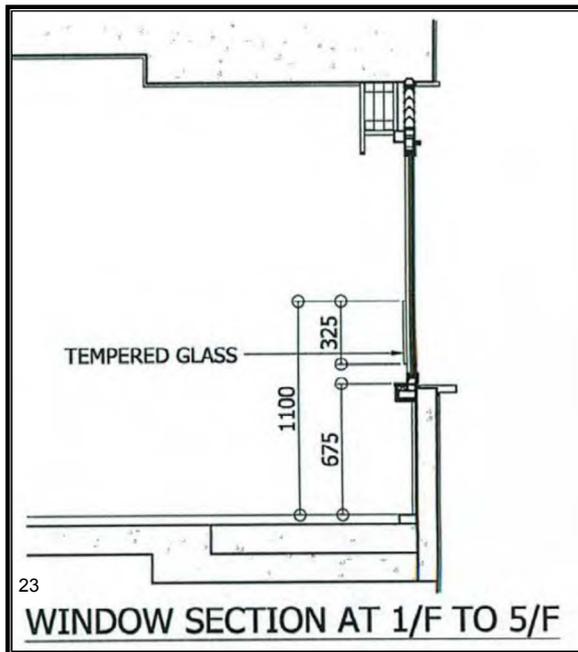
Tempered glass panel is installed above the existing parapet as protective barrier

New openable or fixed aluminium windows are installed on the existing parapets in previous domestic flats, which are not extended vertically in order to avoid too much disturbance to the external walls of MHH. Secondary protective barriers made of tempered glass panels are installed across new openable windows above existing low parapets to meet the current statutory dimensional requirement on protection against falling.

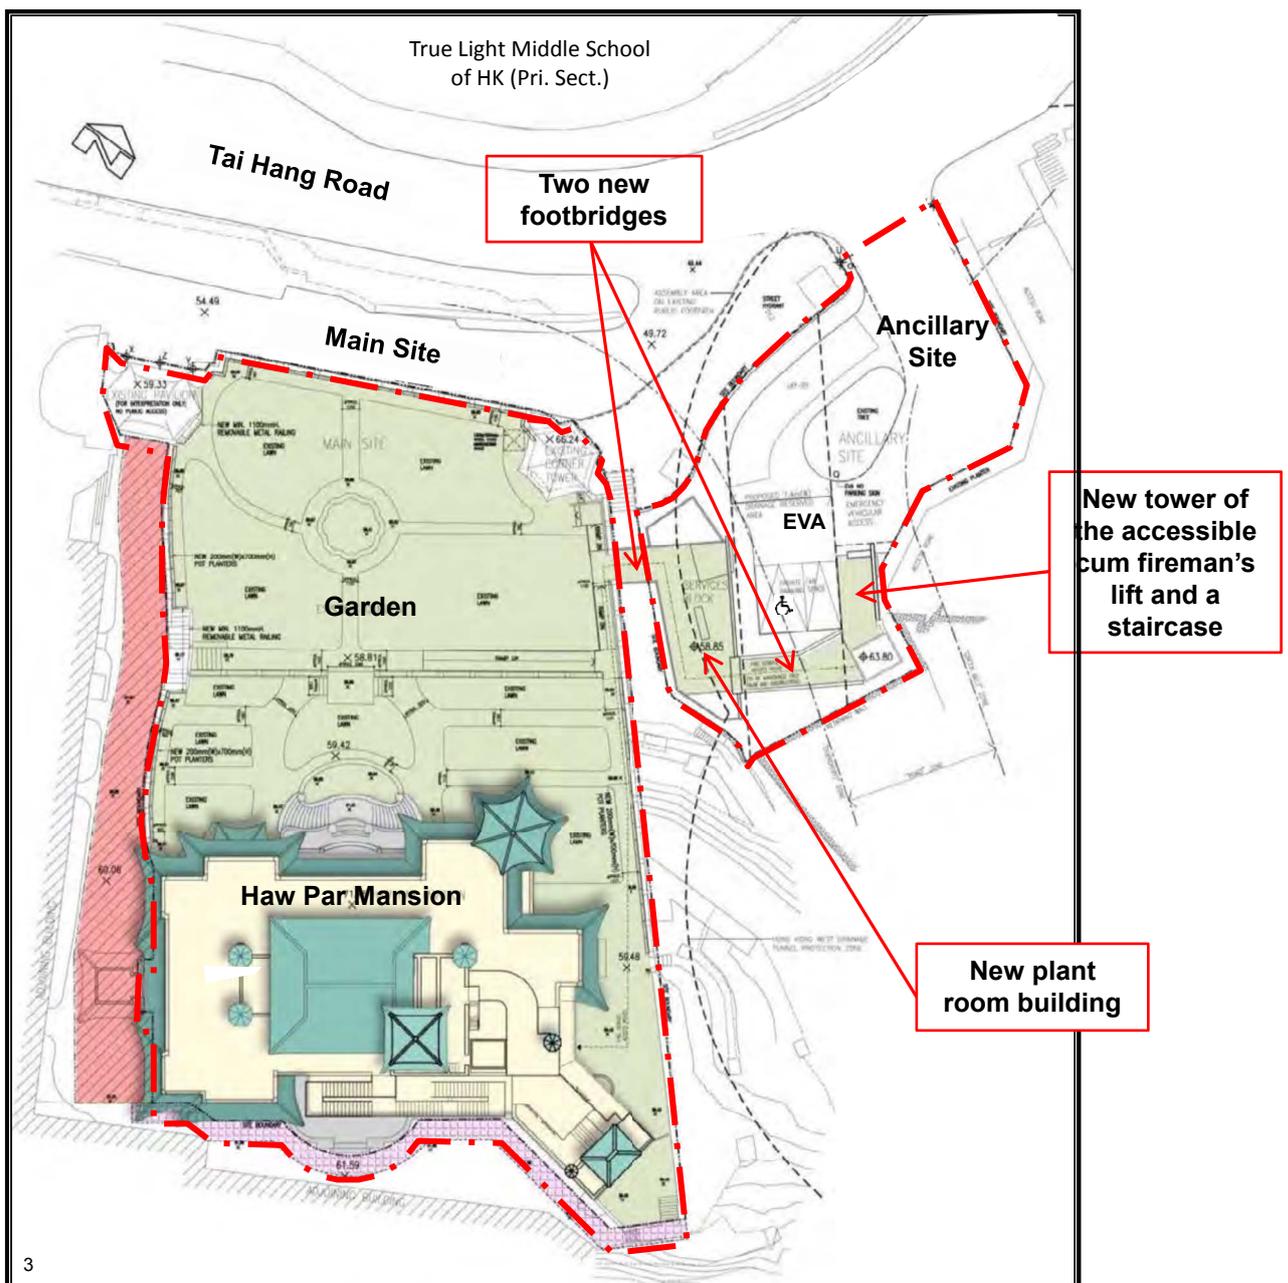
Site plan of the Main Site and the Ancillary Site  
(Source: Design 2 (HK) Limited)

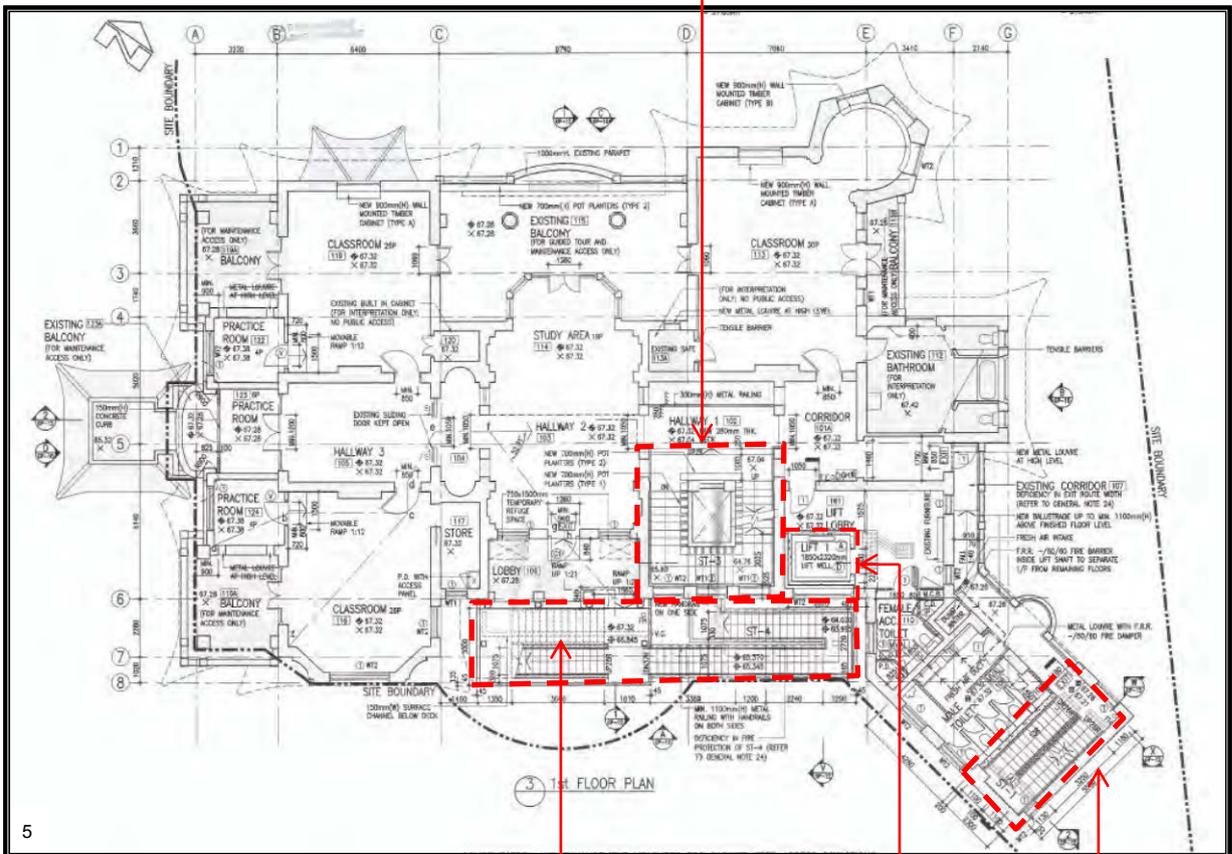
**Internal staircase  
(ST-3) for circulation**

1/F layout plan of HPM

**New open metal  
exit staircase  
(ST-4) is added at  
the rear**
