# Practice Guidebook for Adaptive Re-use of and Alteration and Addition Works to Heritage Buildings 2012

**Practice Guidebook**  
**on**  
**Compliance with**  
**Building Safety and Health Requirements**  
**under the Buildings Ordinance for**  
**Adaptive Re-use of and**  
**Alteration and Addition Works to**  
**Heritage Buildings**

**Buildings Department**  
**Hong Kong**

**(2019 Edition)**

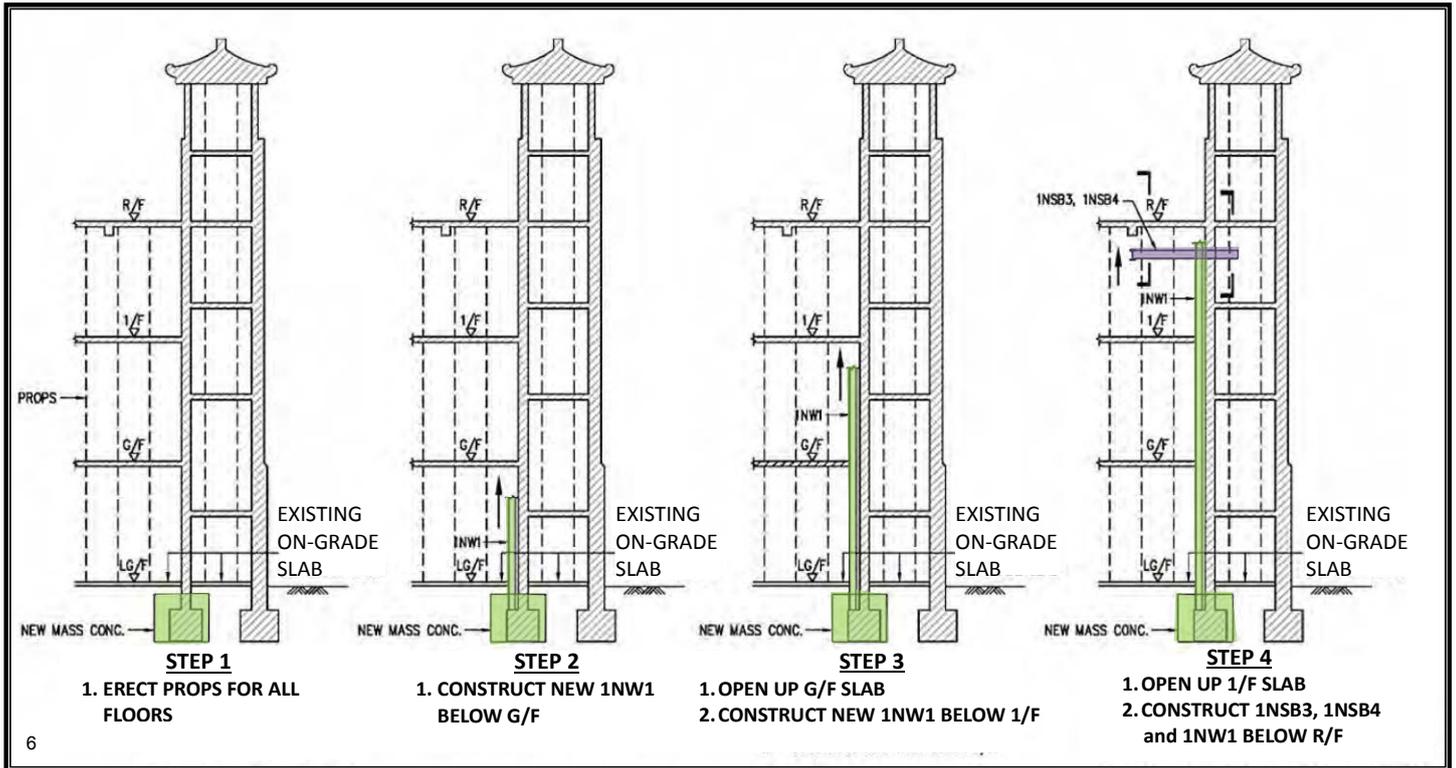
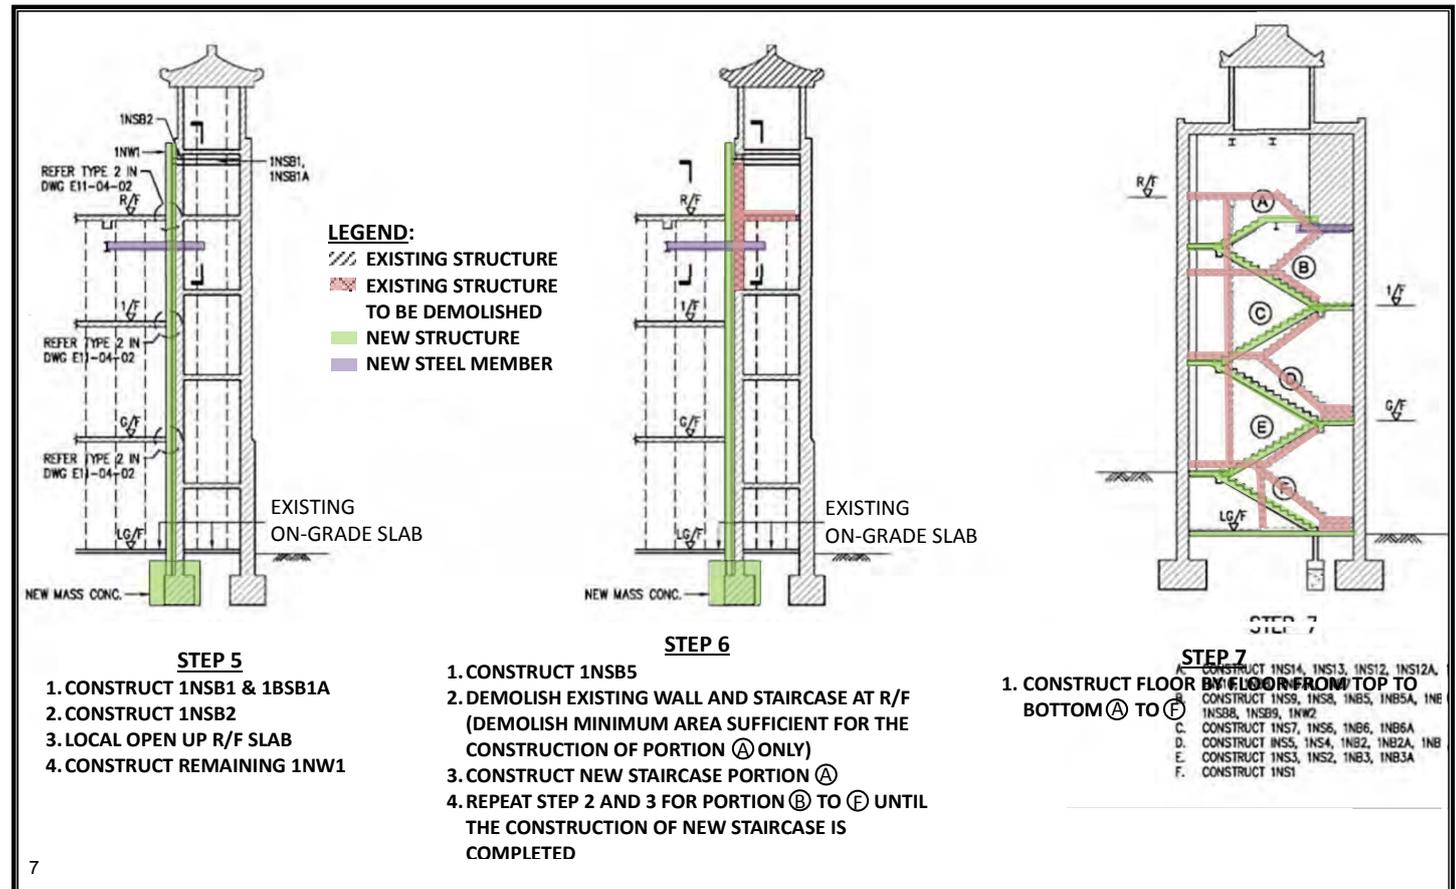
Sequence of rebuilding the exit staircase (ST-1) within the existing staircase tower

A new mass concrete has been added to strengthen the foundation of the existing staircase tower. Then, a new reinforced concrete wall is firstly erected outside one of the existing walls of the staircase tower to provide sufficient lateral and vertical stability of the structure of the staircase tower. After that, the existing staircase and the inner wall are demolished and re-built floor by floor with reinforced concrete stairs from top to bottom level together with partial steel works support at roof floor level to minimise the impact to the structure itself.

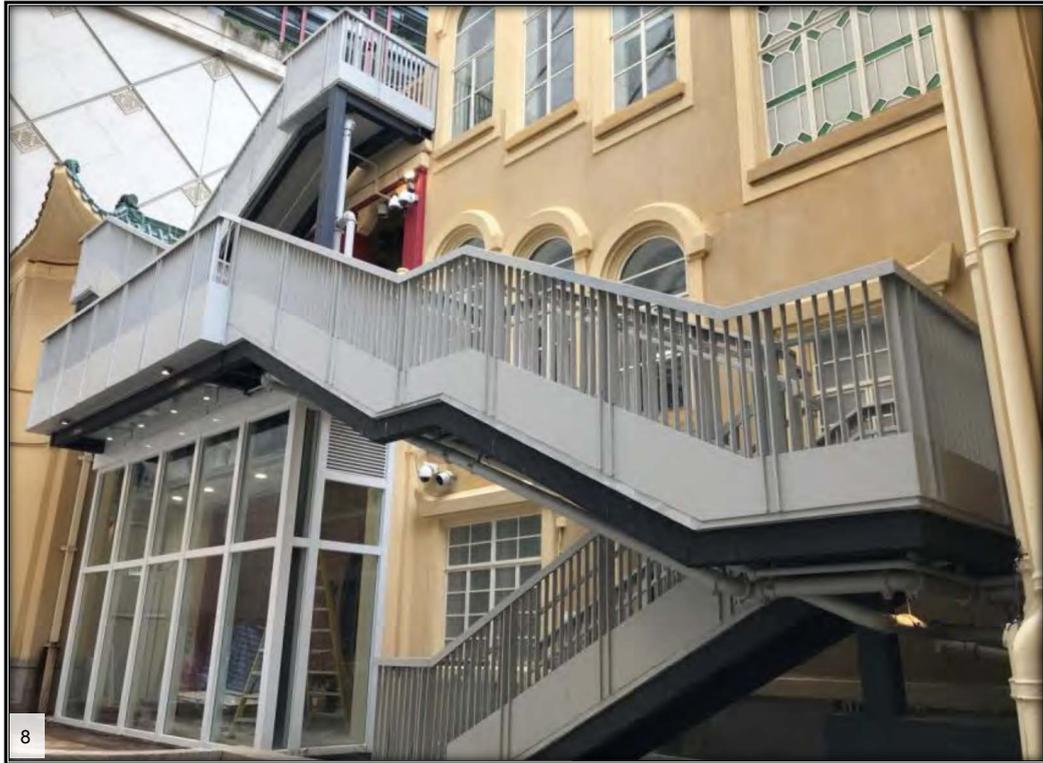
New open metal staircase (ST-4) added at the rear of HPM

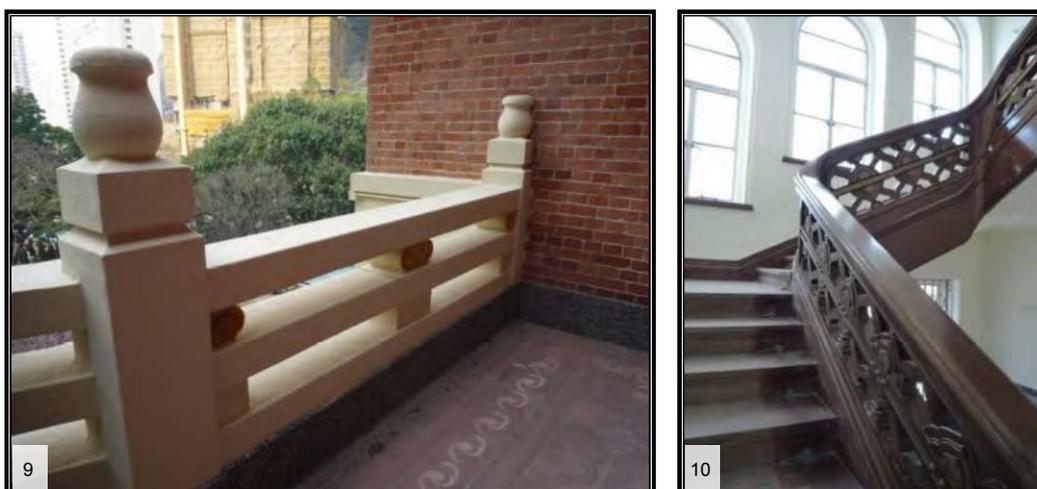
Existing parapets before revitalisation

The existing original parapets at various locations of less than 1.1m high and some even with gaps more than 100mm are not meeting the current standard<sup>5</sup>.

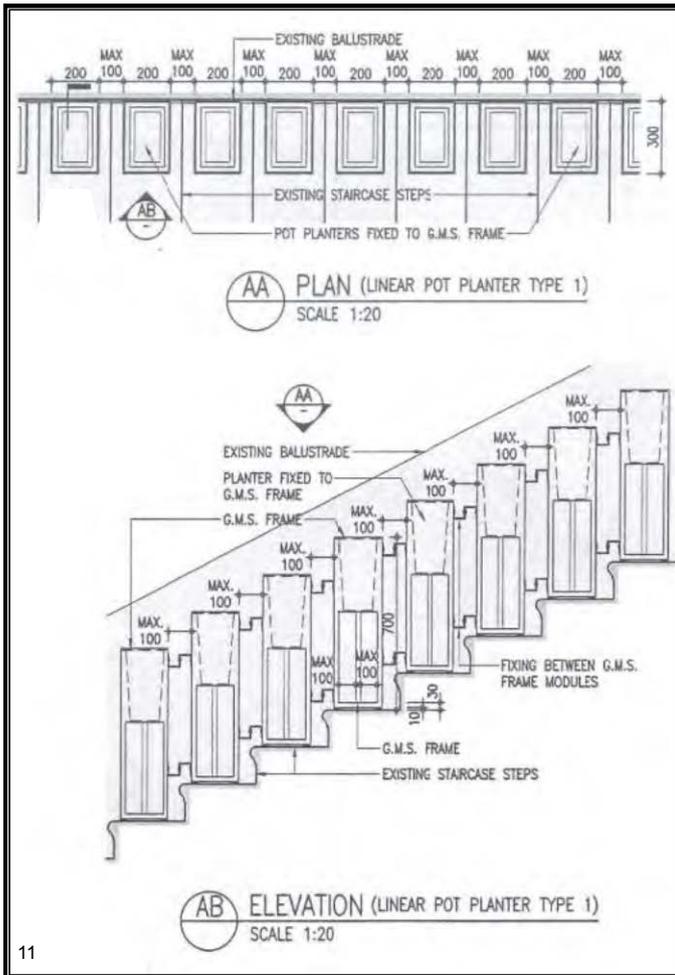
Plan and elevation showing Type 1 pot planters

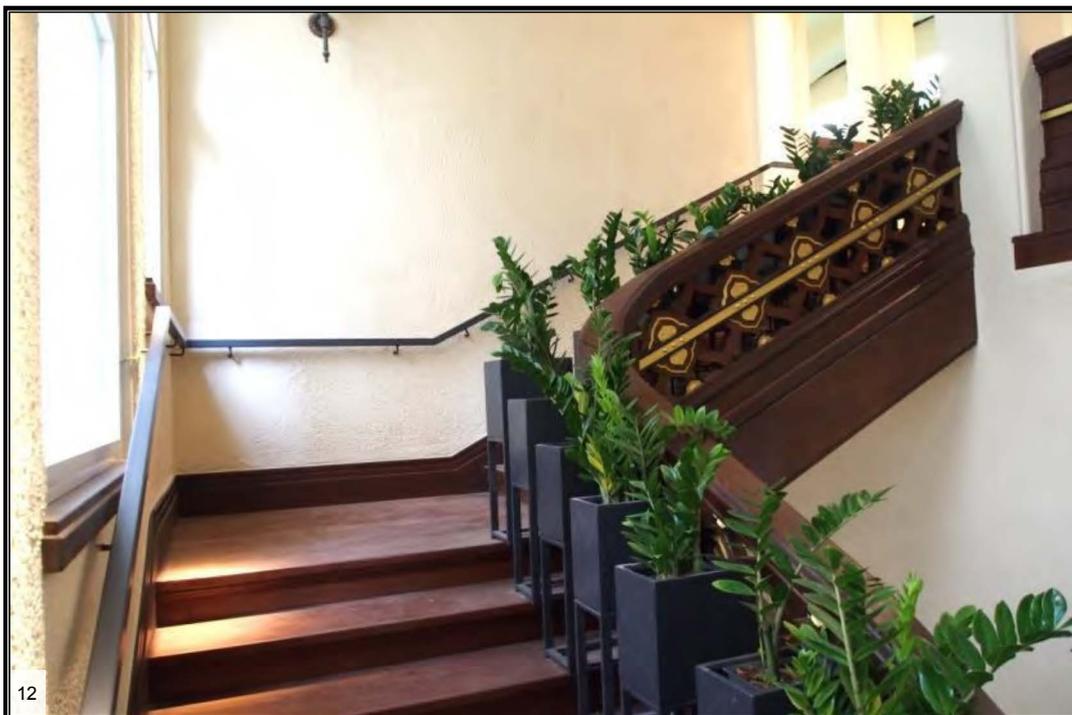
Type 1 pot planters along the circulation staircase (ST-3) (Source: Design 2 (HK) Limited)

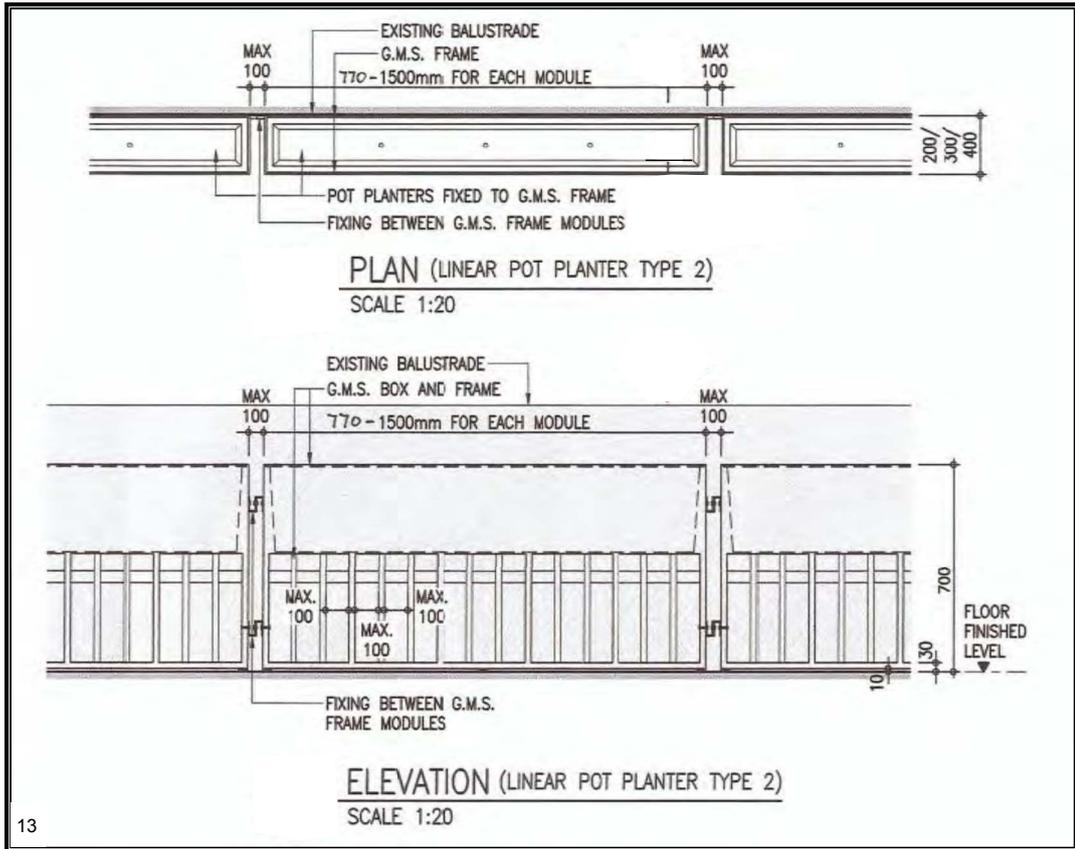
Plan and elevation showing Type 2 pot planters

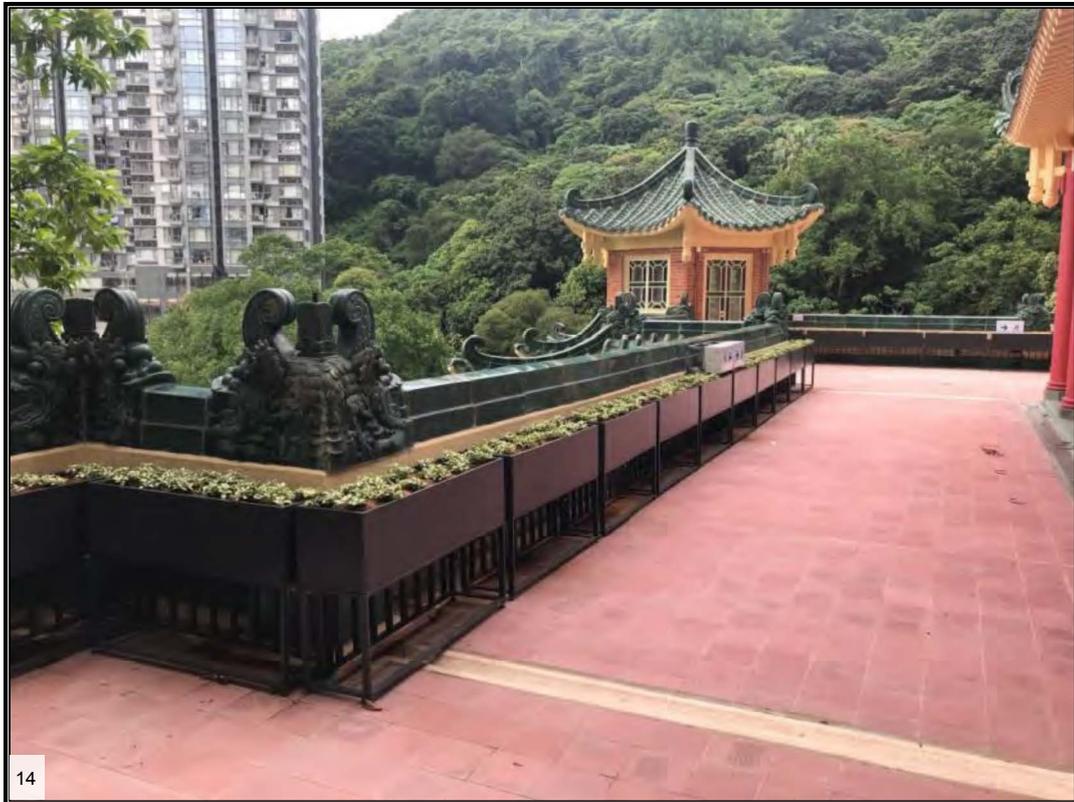
Type 2 pot planters along the parapet of the roof

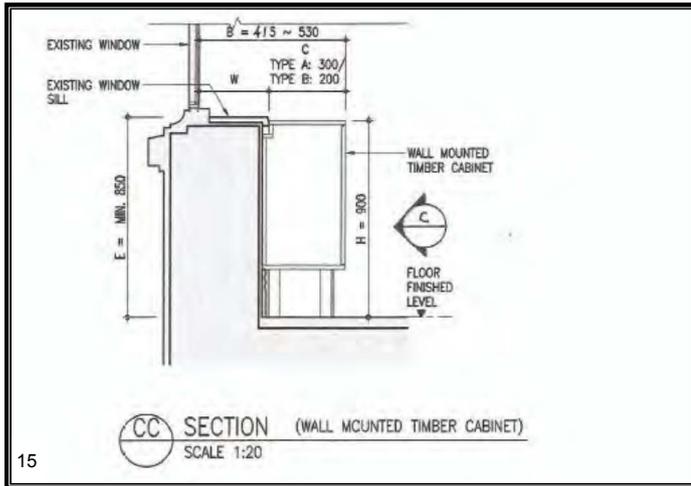
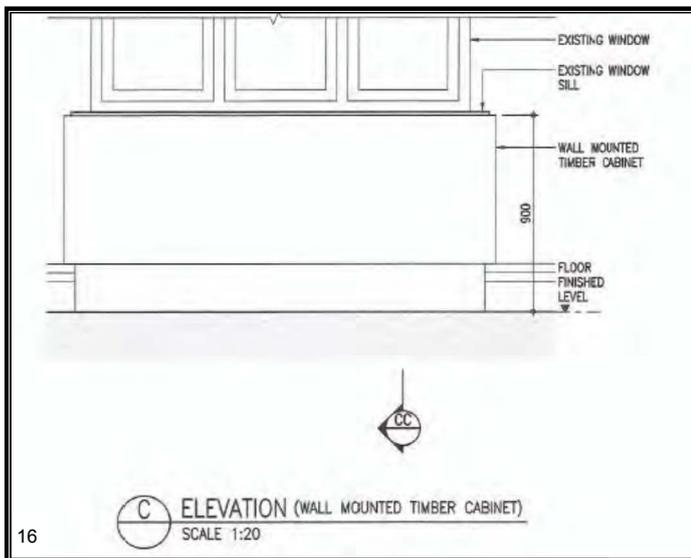
Section and elevation showing a cabinet installed in front of original window parapets

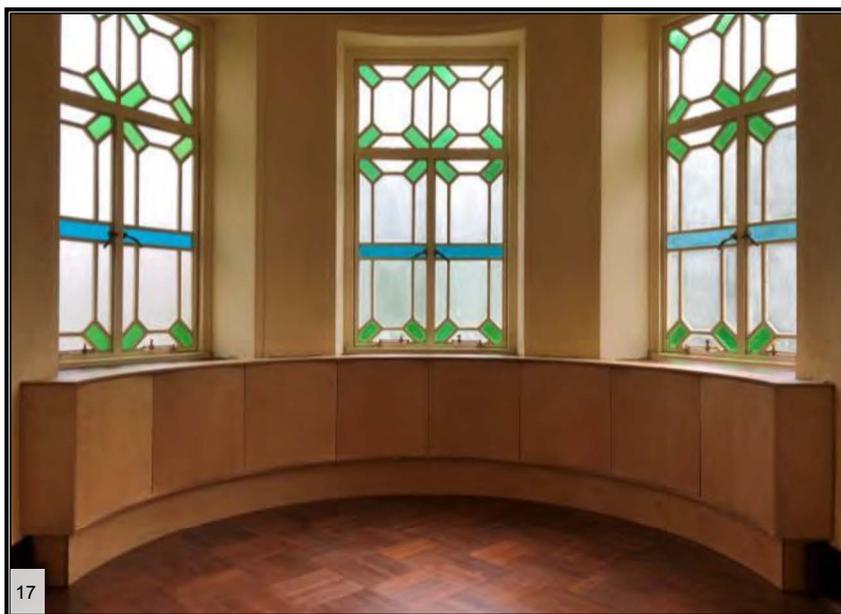
17

Cabinets fixed along the window parapet (Source: Design 2 (HK) Limited)

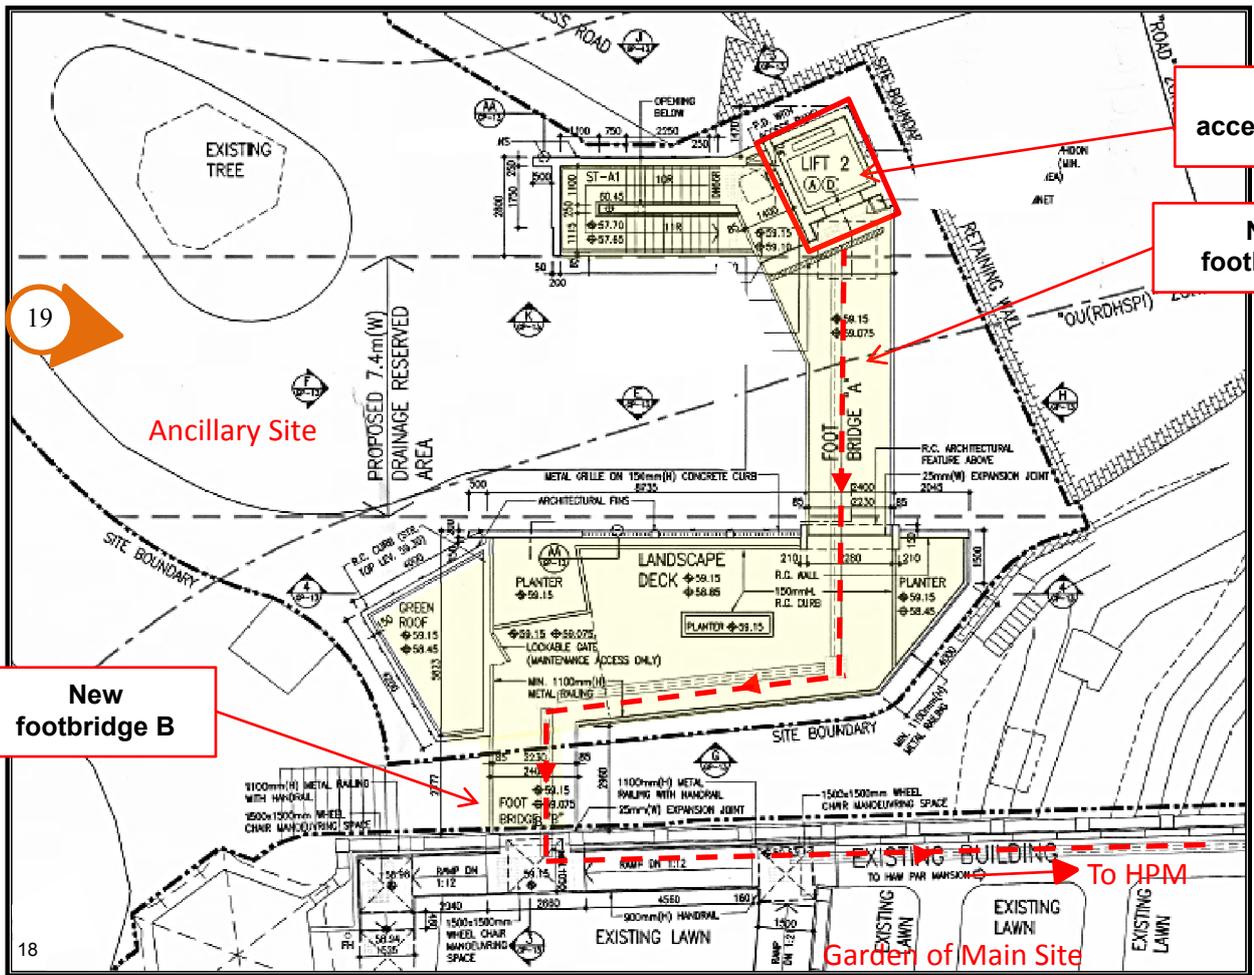
Routing of barrier free access

A piece of adjacent land (the Ancillary Site) has been allocated to HPM for enhancing such provision. A new accessible lift is constructed at the Ancillary Site linking to the garden of the Main Site by two new footbridges. A new accessible carpark is also provided at the Ancillary Site next to the accessible lift.

Once PwD reach the garden at the Main Site, they can follow a tactile guide path in the garden to enter HPM via a new main entrance door at the side on LG/F.

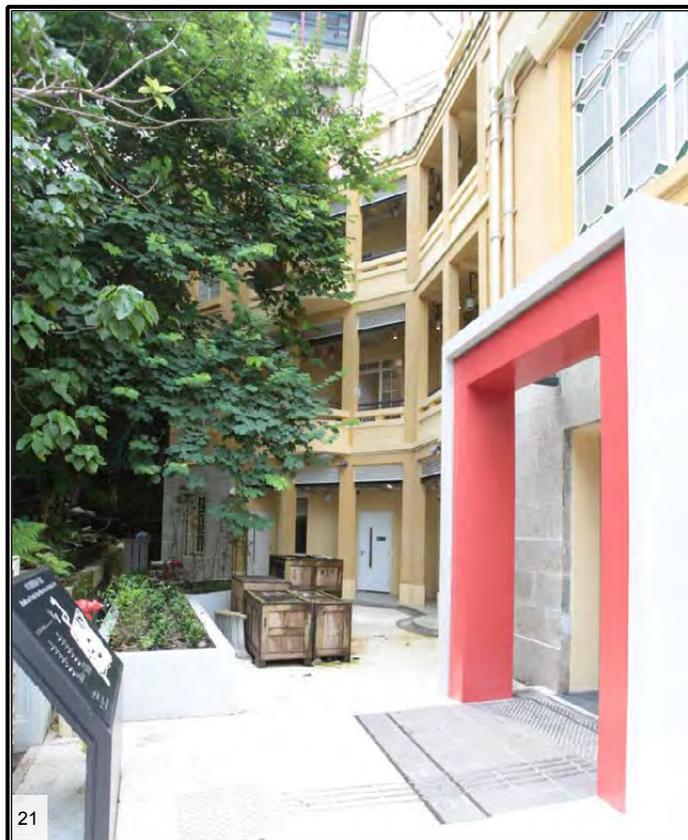
Photo of the new main entrance at the side of the mansion on LG/F
